Vehicle No. SHC 4734D  
Insured Veh. GBF 1861U  
Claim No. SNM21D205424/C02  
Policy No. DMCVSN00087352104  
Accident Date 22/09/2021  
Inspection Date 23/09/2021

## ADJUSTMENT ON REPAIR COST FOR VEHICLE NO. SHC 4734D

### PHOTOGRAPHS FOR VEHICLE NO. SHC 4734D

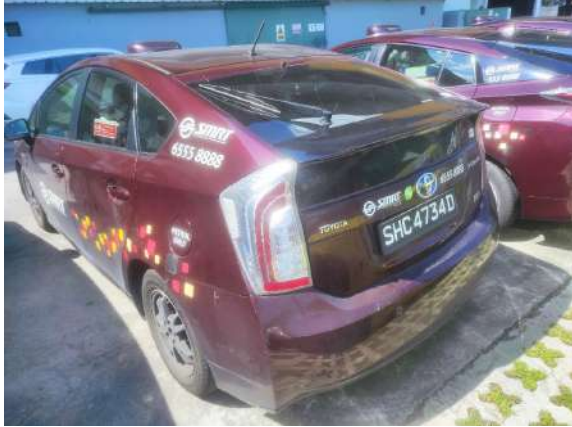
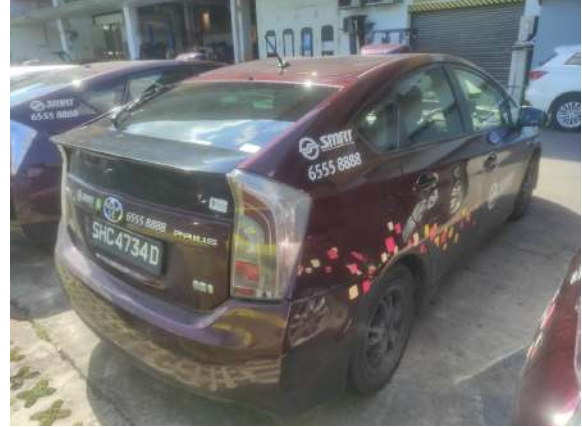
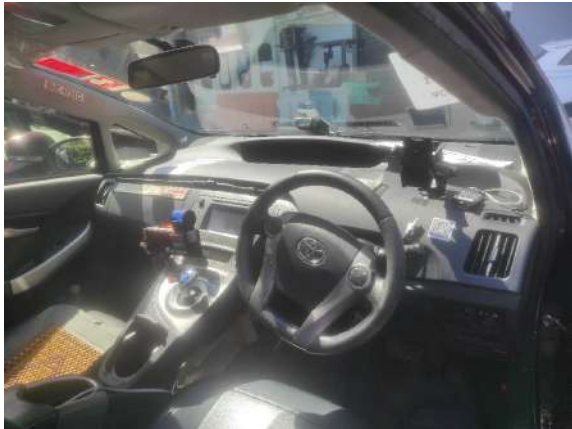
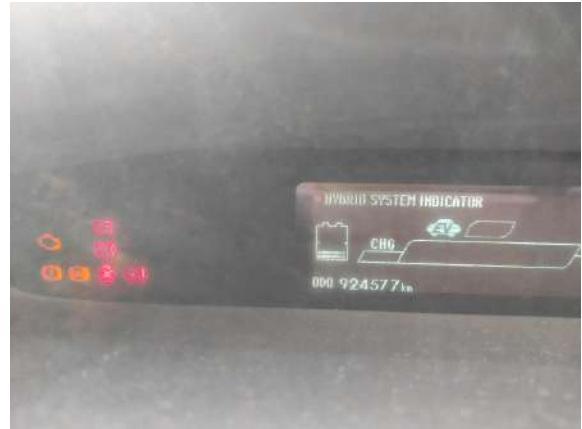
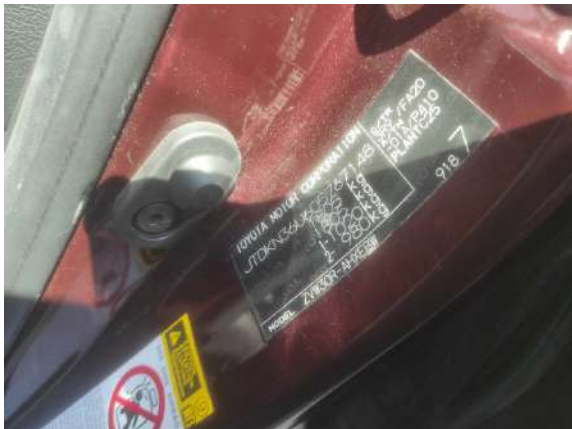
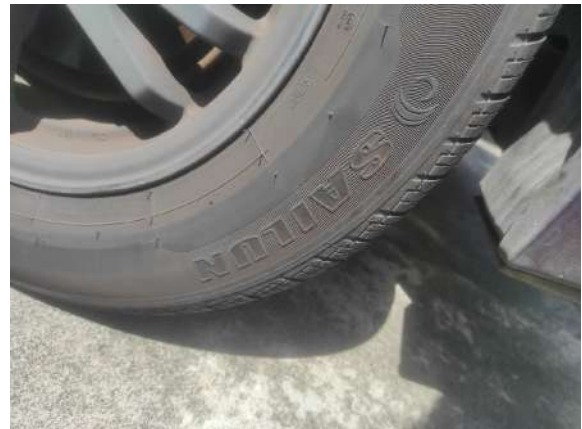
### INSPECTION

| Affiliated to Federation Internationale Des Experts En Automobile | | | | |
|---|---|---|---|---|
| | THE VEHICLE SUSTAINED DAMAGES AT THE O/S REAR PORTION.<br><br>DAMAGES SEE DETAILS. | | | |

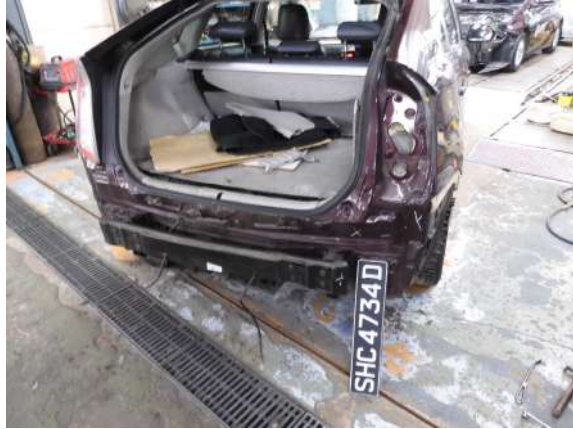
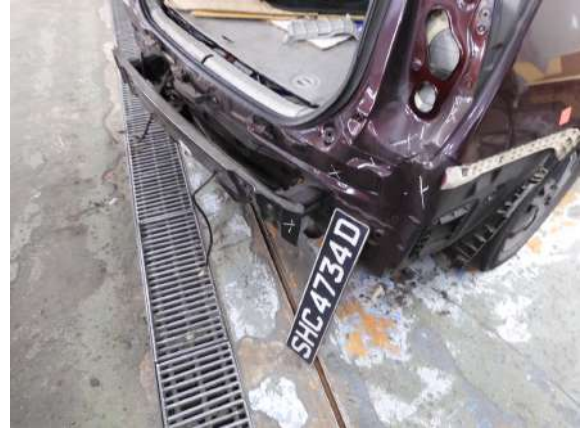
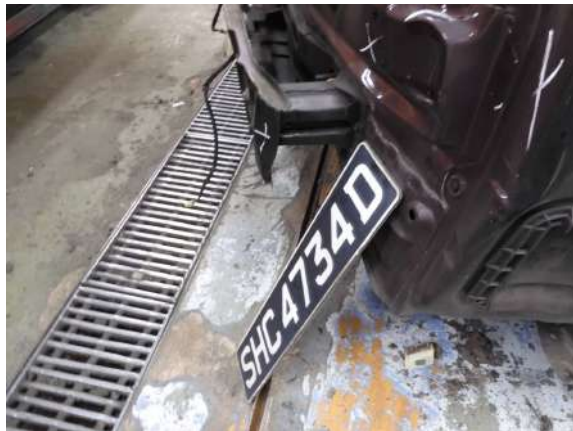
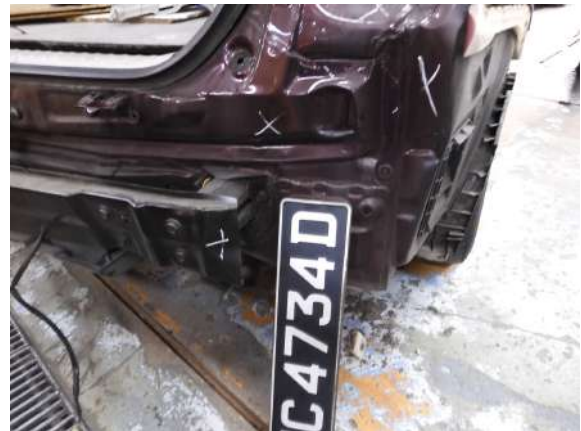
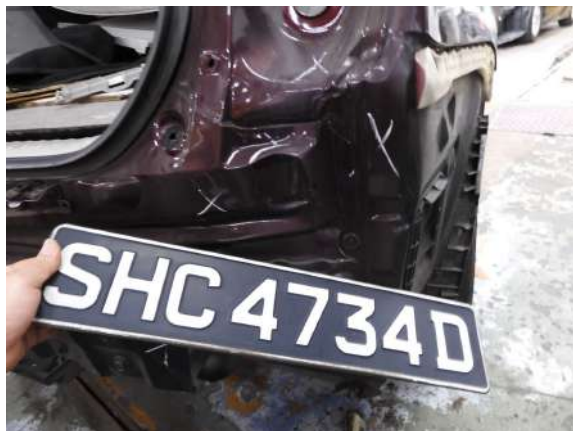
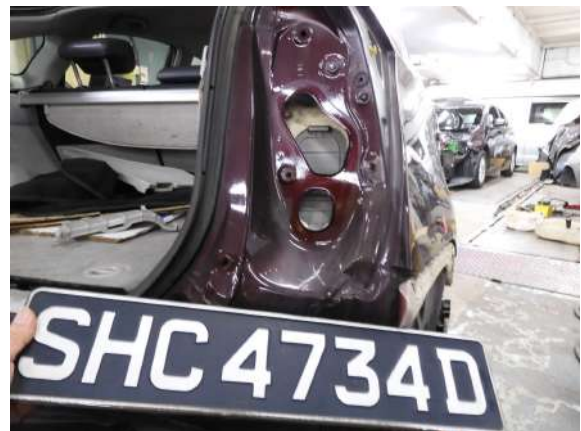
RE-INSPECTION

PHOTOGRAPHS FOR VEHICLE NO. SHC 4734D
