### PROFESSIONAL SERVICE FEE

Vehicle No. SLD 2656G  
Insured Veh. SLV 7794M  
Claim No. SNM21D205488/C02  
Policy No. DMPCSNW00197242000  
Accident Date 25/09/2021  
Inspection Date 27/09/2021

## ADJUSTMENT ON REPAIR COST FOR VEHICLE NO. SLD 2656G

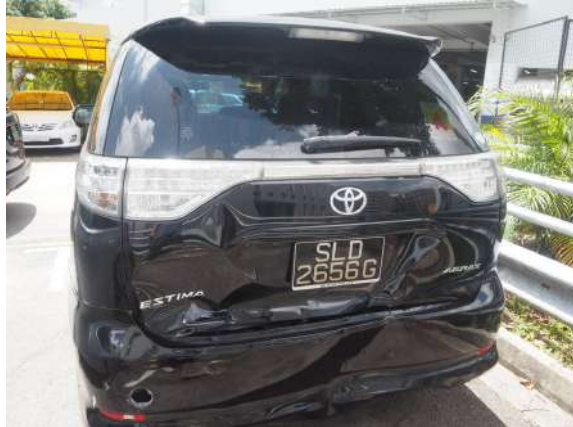
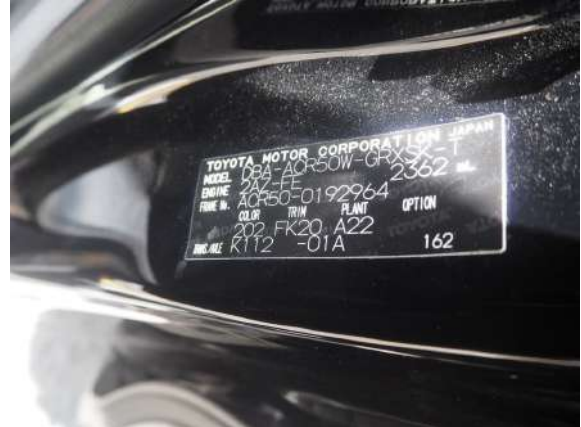
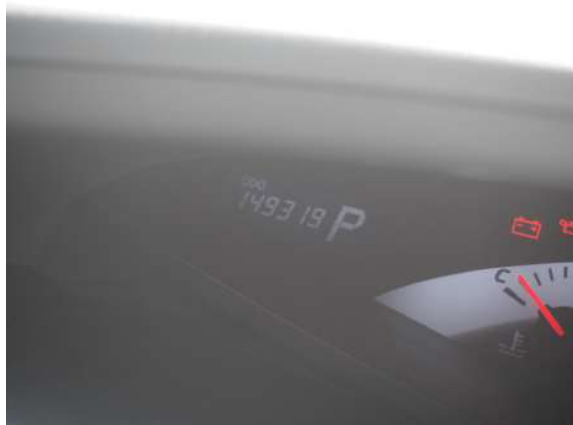
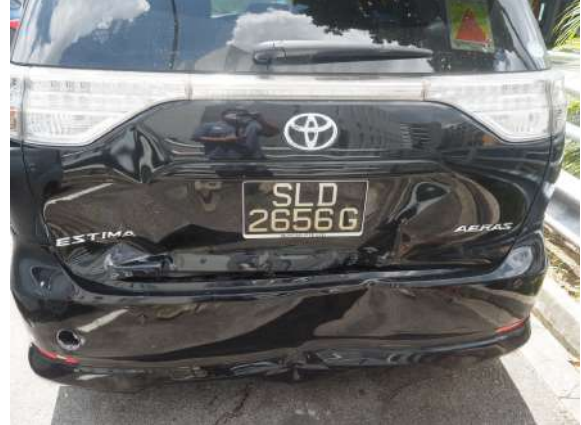
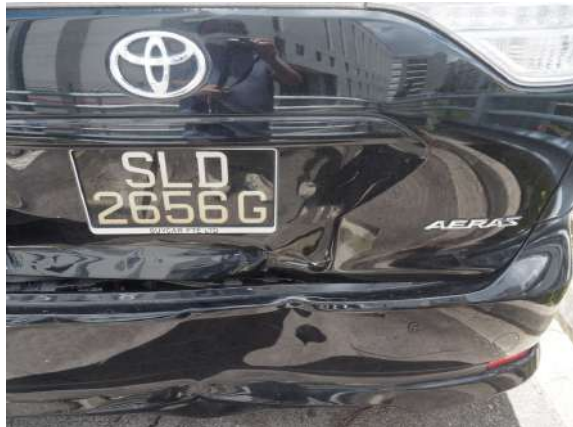
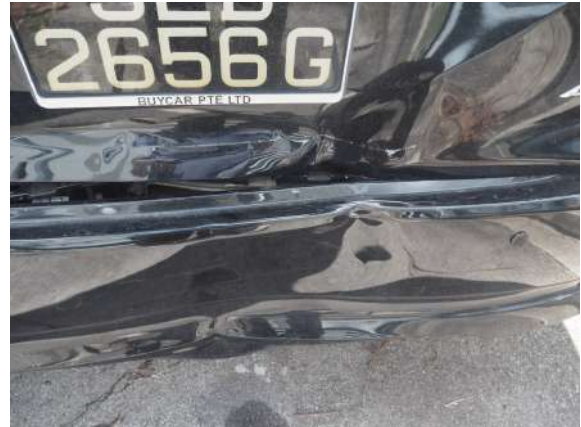
### INSPECTION

### PHOTOGRAPHS FOR VEHICLE NO. SLD 2656G

| Affiliated to Federation Internationale Des Experts En Automobile | | | | |
|---|---|---|---|--|
| THE VEHICLE SUSTAINED DAMAGES AT THE REAR PORTION.<br>DAMAGES SEE DETAILS. | | | | |
