## LKK Auto Consultants Pte Ltd

### PROFESSIONAL SERVICE FEE

Vehicle No. SH 7777D  
Insured Veh. GBK 8789Z  
Claim No. SNM21D205479/C02  
Policy No. DMCVSNW00126422000  
Accident Date 26/09/2021  
Inspection Date 27/09/2021

## ADJUSTMENT ON REPAIR COST FOR VEHICLE NO. SH 7777D

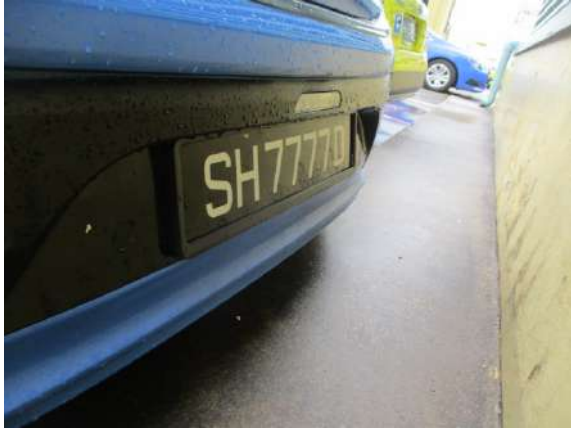
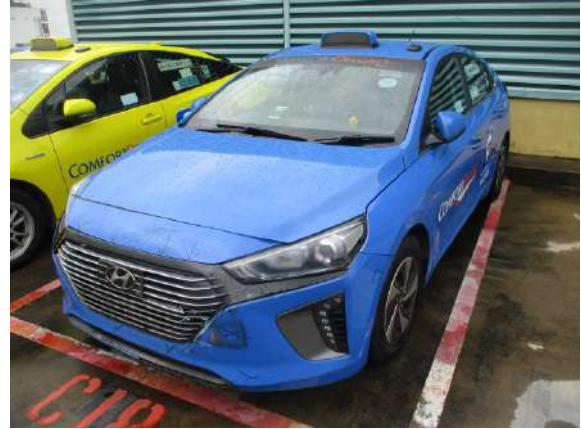
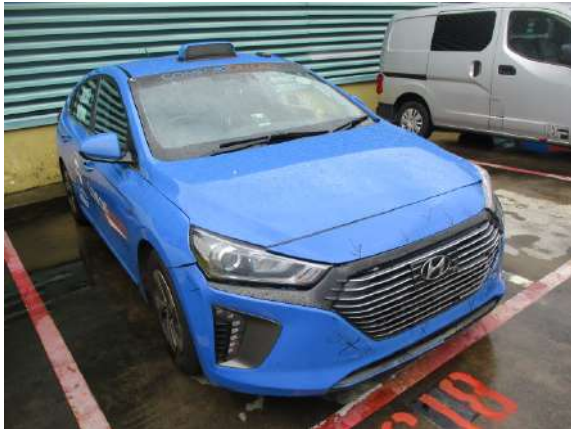
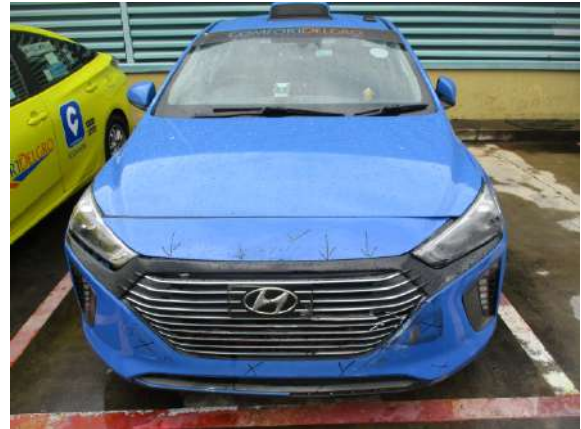
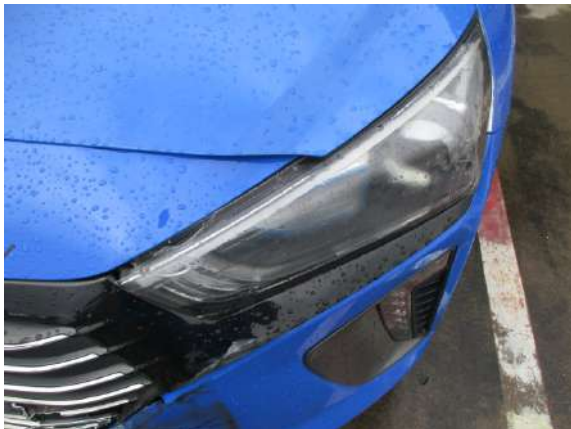
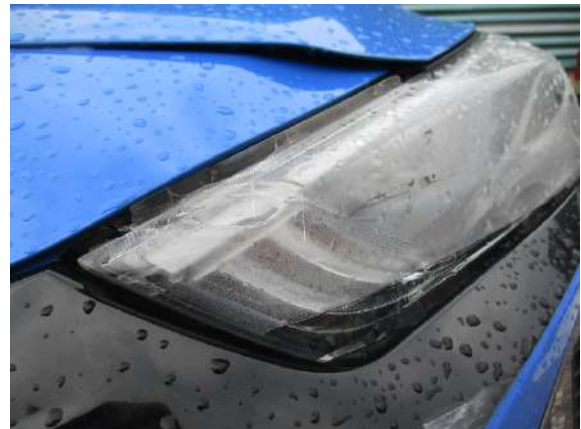
INSPECTION

| Affiliated to Federation Internationale Des Experts En Automobile | | | | |
|---|---|---|---|--|
| THE VEHICLE SUSTAINED DAMAGES AT THE FRONT PORTION.<br><br>DAMAGES SEE DETAILS. | | | | |

PHOTOGRAPHS FOR VEHICLE NO. SH 7777D

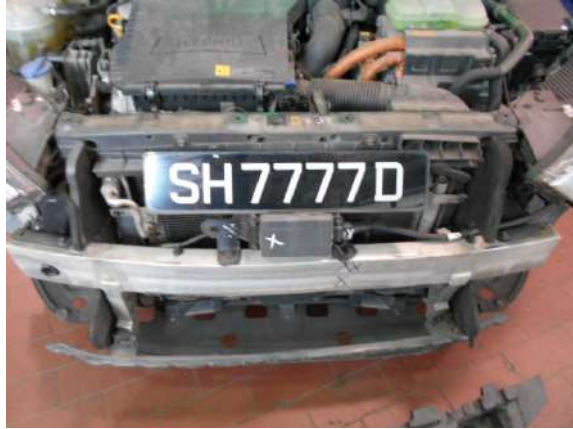
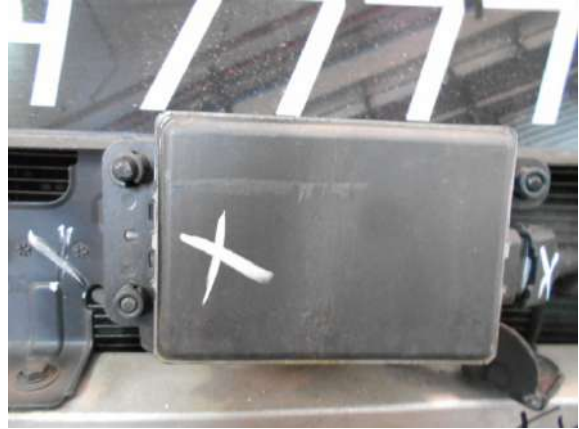
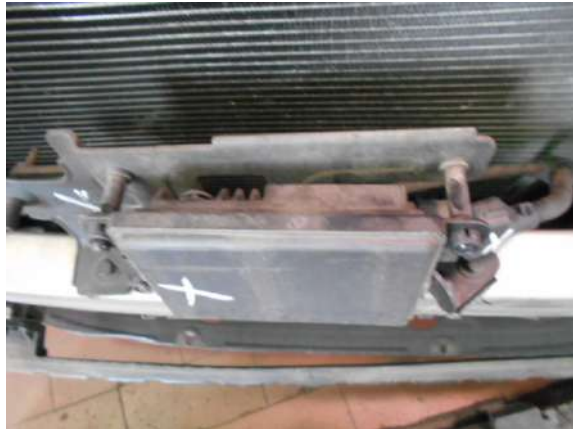
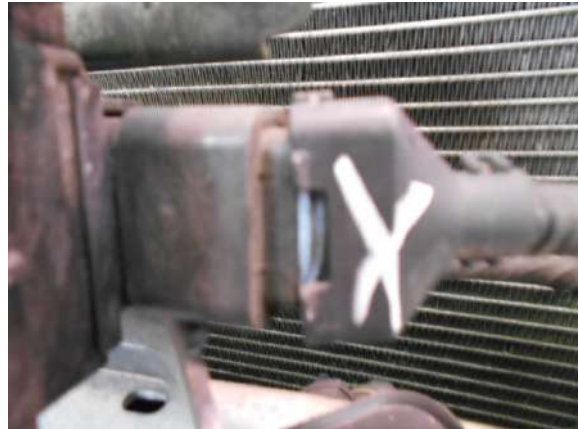
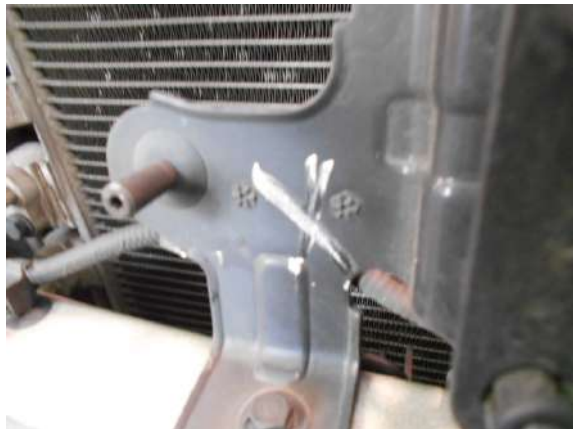
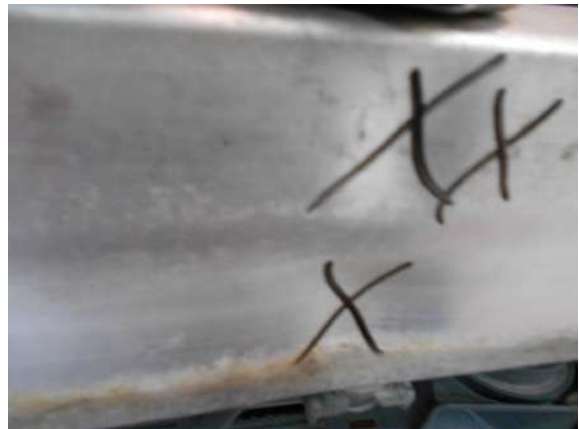
RE-INSPECTION

PHOTOGRAPHS FOR VEHICLE NO. SH 7777D
