LKK Auto Consultants Pte Ltd

ADJUSTMENT ON REPAIR COST FOR VEHICLE NO. SHA 4868L

PHOTOGRAPHS FOR VEHICLE NO. SHA 4868L

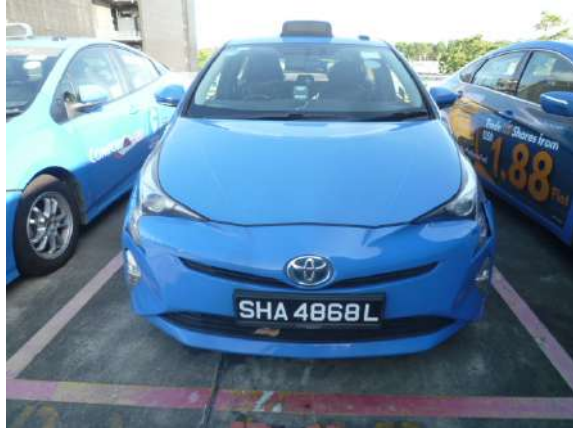
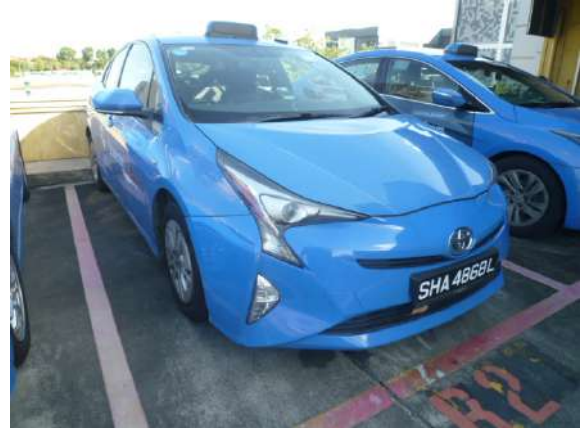
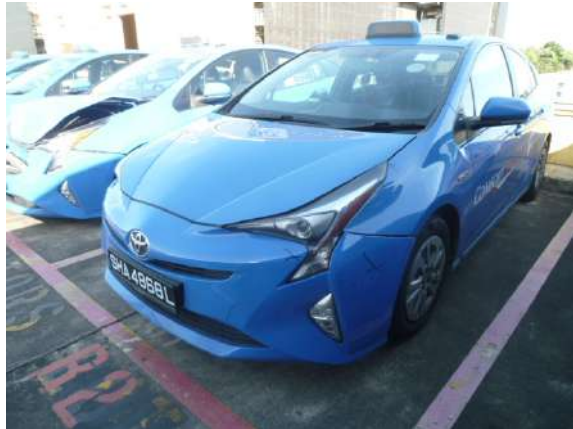
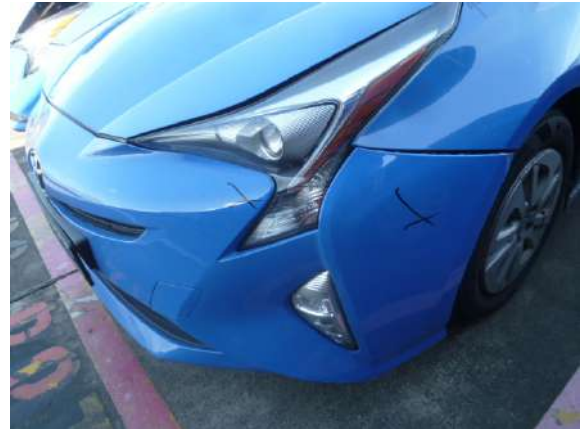
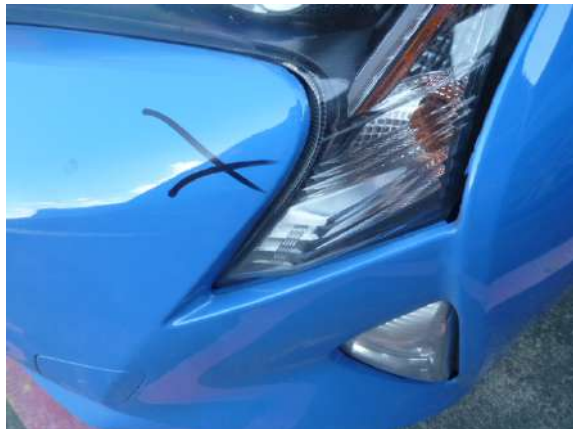
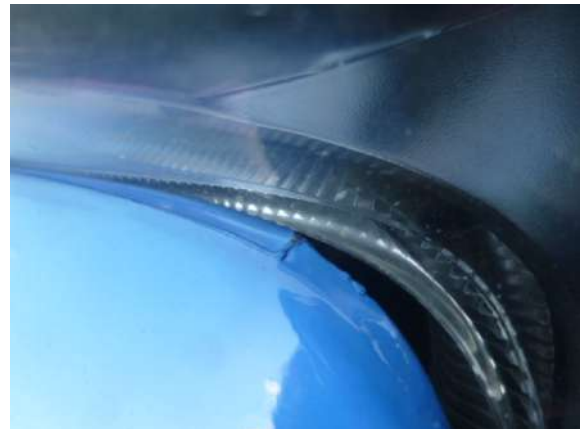
INSPECTION

4. Description of Damages				
THE VEHICLE SUSTAINED DAMAGES AT THE FRONT PORTION AND N/S BODY. DAMAGES SEE DETAILS.				
5. General Information				
Accident Date	23/09/2021	Inspection Date	23/09/2021	
Survey held at	COMFORTDELGRO ENGINEERING PTE LTD 59 LOYANG DRIVE SINGAPORE 508969			
5a. Remarks				
A)THE INSPECTION WAS CONDUCTED ON A"WITHOUT PREJUDICE" BASIS. B)IN ACCORDANCE TO YOUR INSTRUCTIONS, WE HAVE NOT AUTHORISED REPAIRS.				
5b. Estimate Days of Repair				
ESTIMATED NORMAL PERIOD FOR REPAIR:			2 Working Days

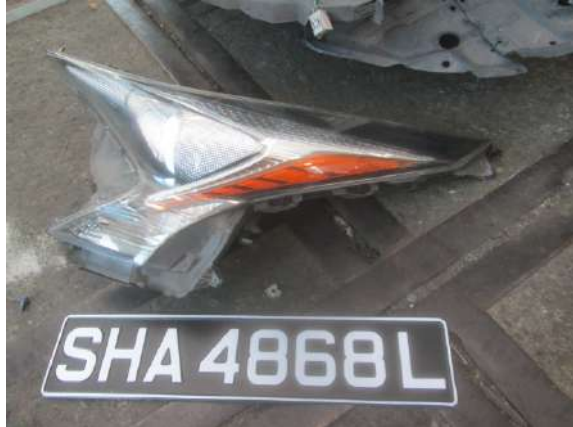
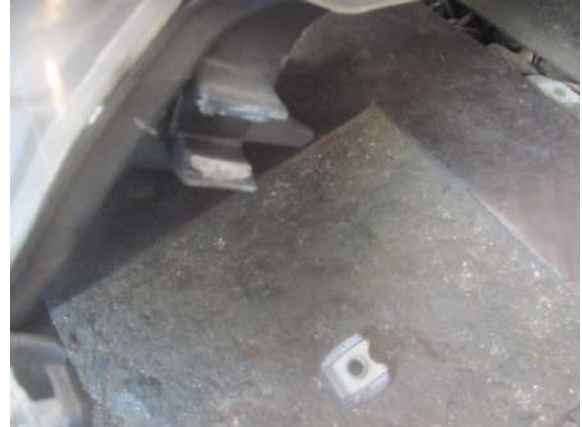
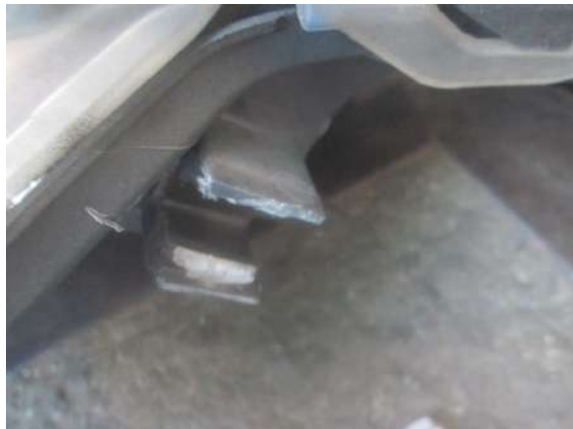
PHOTOGRAPHS FOR VEHICLE NO. SHA 4868L

RE-INSPECTION

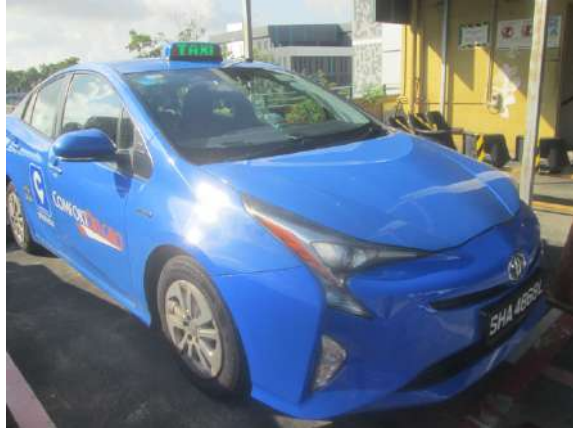
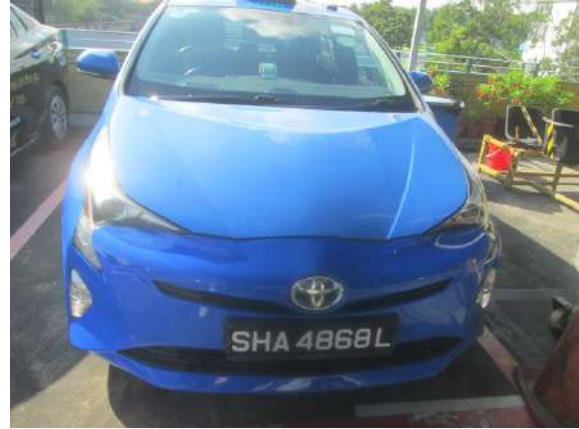
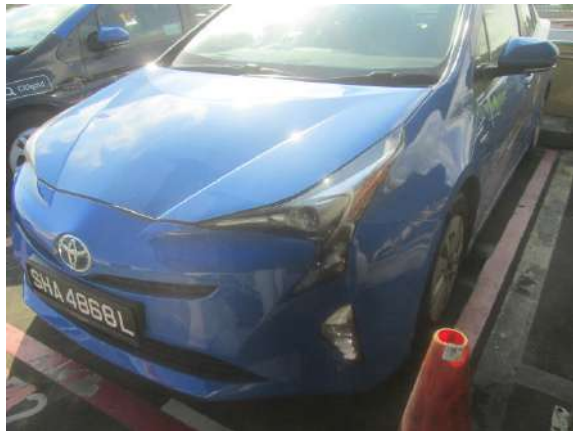
PHOTOGRAPHS FOR VEHICLE NO. SHA 4868L

RE-INSPECTION
