## LKK Auto Consultants Pte Ltd

### PROFESSIONAL SERVICE FEE

Vehicle No. SHC 4657T  
Insured Veh. YP 1471L  
Claim No. VC014803  
Policy No. 8-V0016982-MVA-R003  
Accident Date 01/10/2021  
Inspection Date 05/10/2021

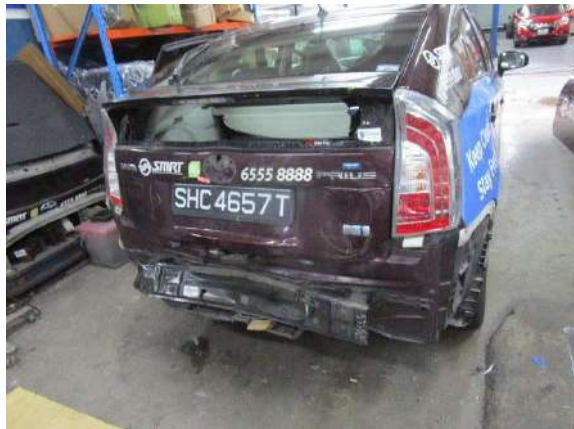
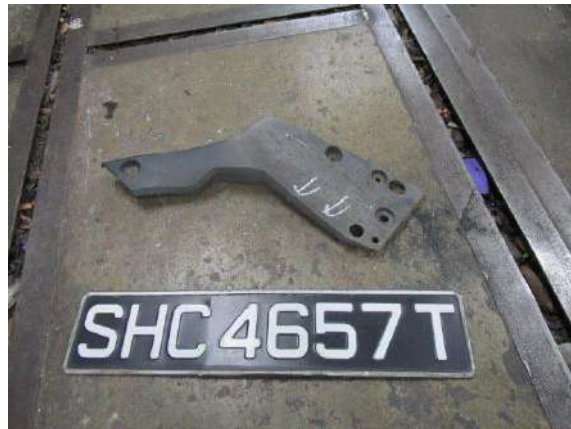
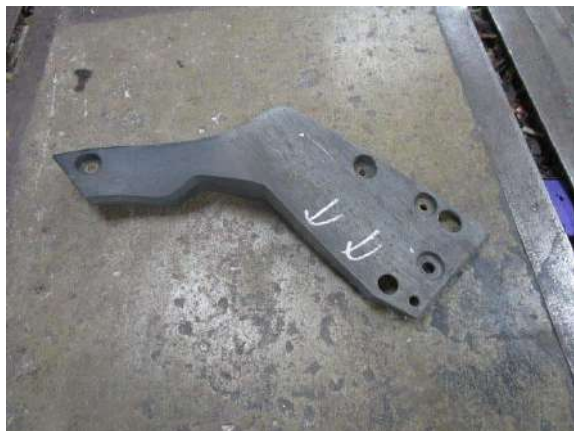
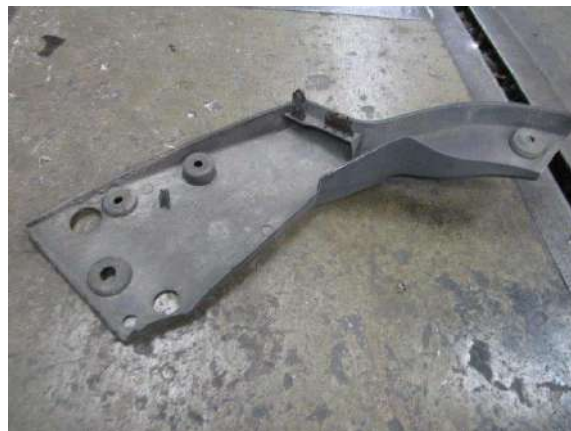
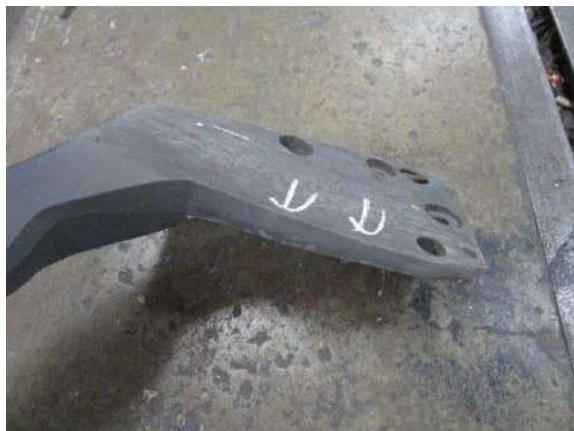
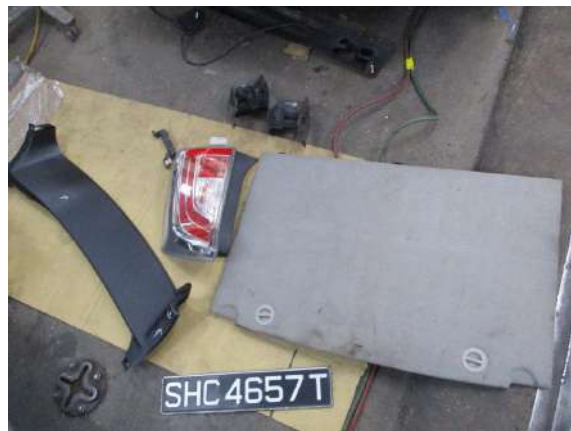
PHOTOGRAPHS FOR VEHICLE NO. SHC 4657T

| Affiliated to Federation Internationale Des Experts En Automobile | | | | |
|---|---|---|---|--|
| | THE VEHICLE SUSTAINED DAMAGES AT THE REAR PORTION.<br>DAMAGES SEE DETAILS. | | | |

RE-INSPECTION
