Vehicle No. SLL 9044J  
Insured Veh. XD 7971X  
Claim No. 21/21/21/VC00/025021  
Policy No. Z/21/VC00/112477  
Accident Date 08/10/2021  
Inspection Date 13/10/2021

## ADJUSTMENT ON REPAIR COST FOR VEHICLE NO. SLL 9044J

### PHOTOGRAPHS FOR VEHICLE NO. SLL 9044J

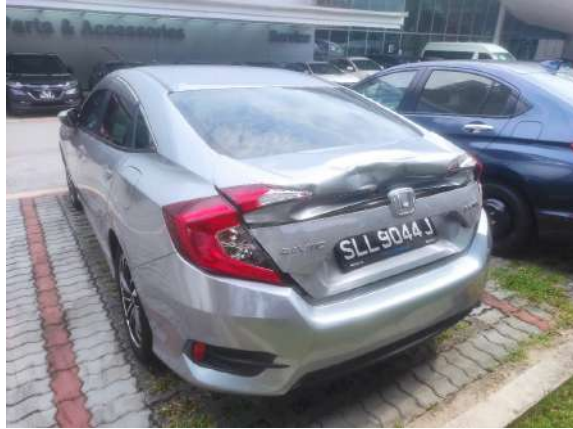
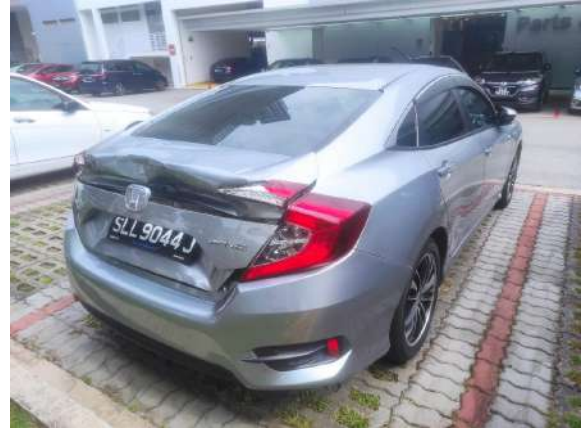
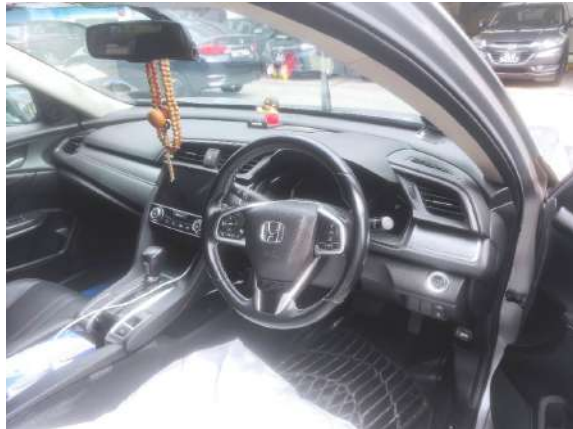
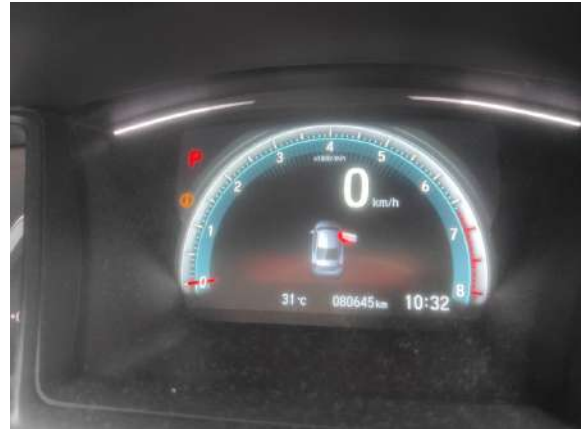
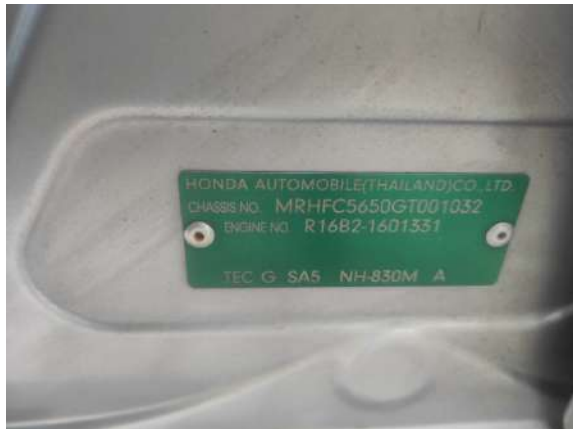
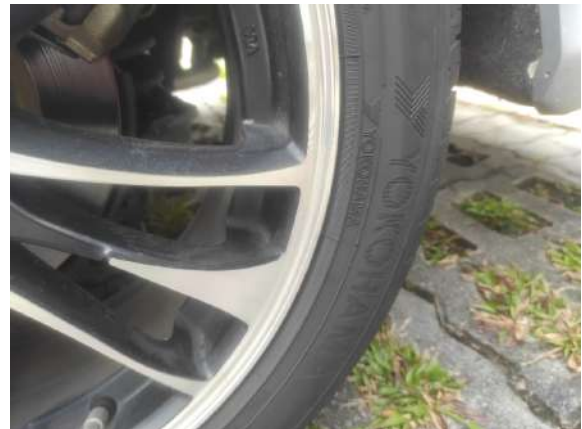
### INSPECTION

| Affiliated to Federation Internationale Des Experts En Automobile | | | | |
|---|---|---|---|--|
| THE VEHICLE SUSTAINED DAMAGES AT THE REAR PORTION.<br>DAMAGES SEE DETAILS. | | | | |

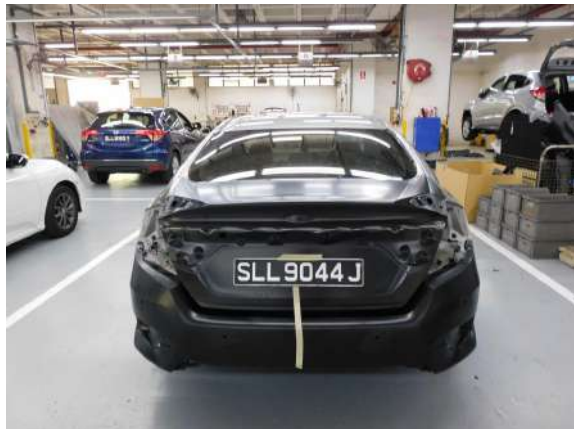
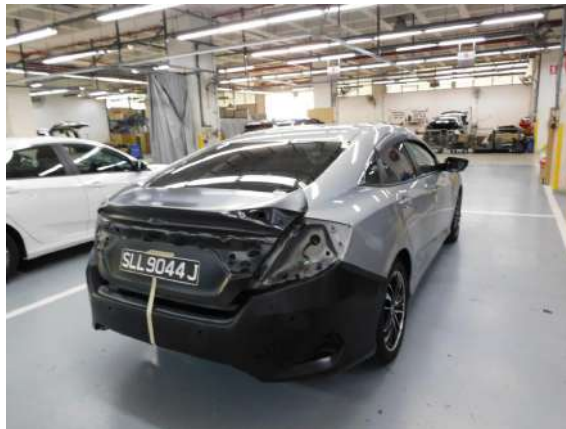
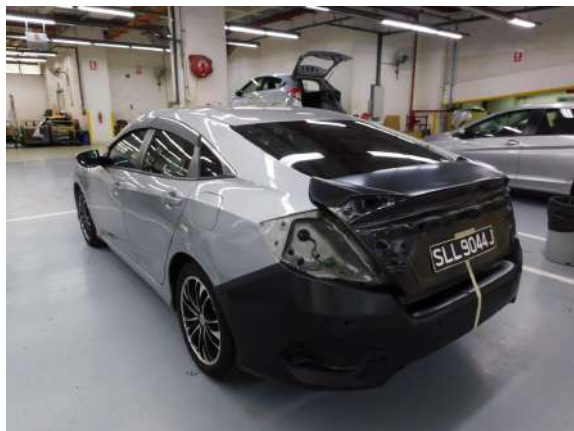
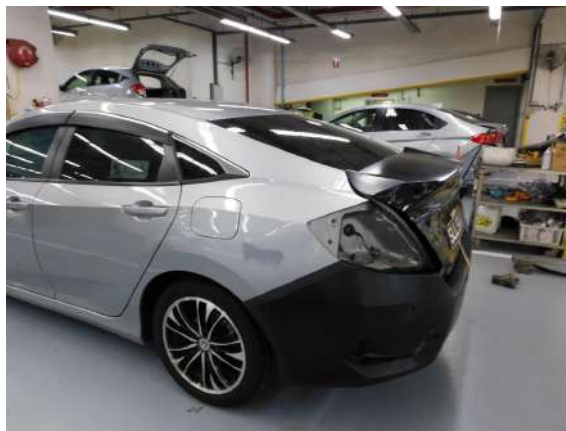
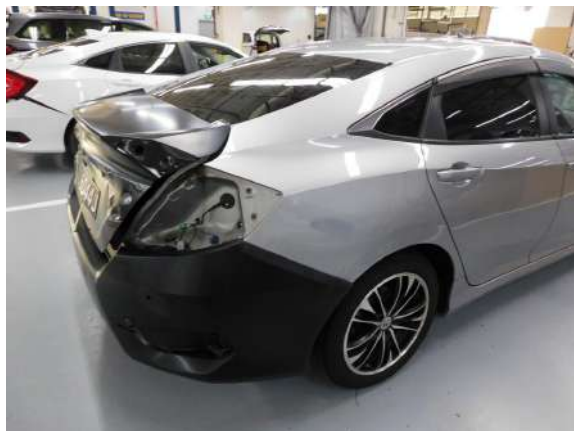
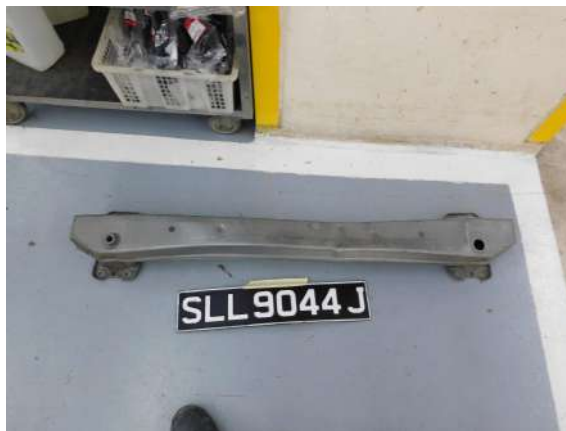
PHOTOGRAPHS FOR VEHICLE NO. SLL 9044J

RE-INSPECTION
