## LKK Auto Consultants Pte Ltd

### PROFESSIONAL SERVICE FEE

## ADJUSTMENT ON REPAIR COST FOR VEHICLE NO. SKT 3686R

### PHOTOGRAPHS FOR VEHICLE NO. SKT 3686R

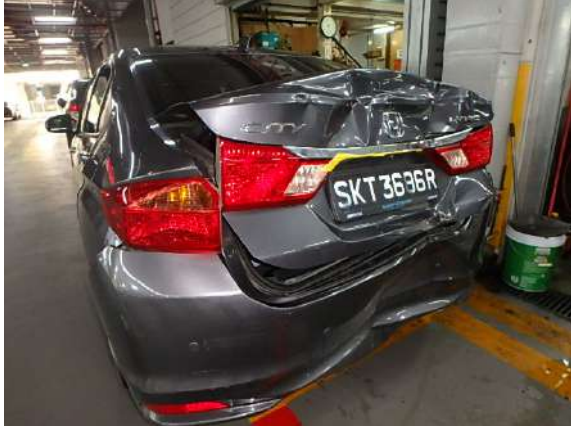
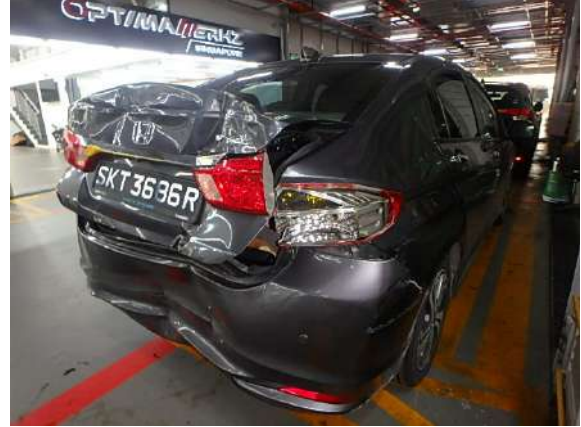
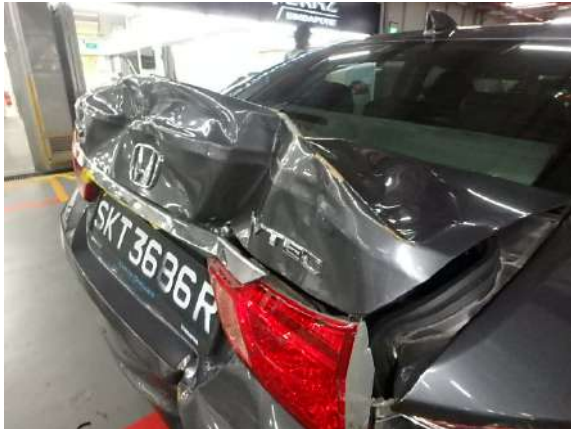
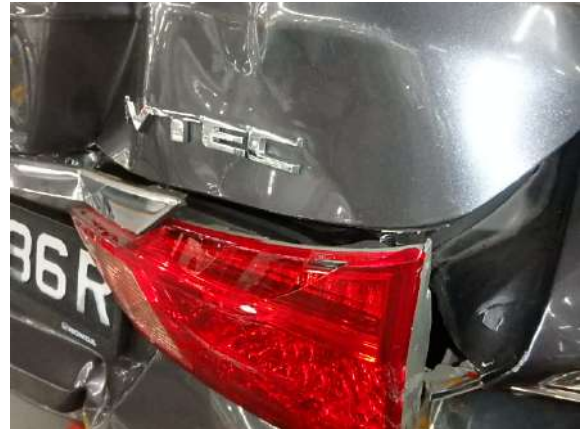
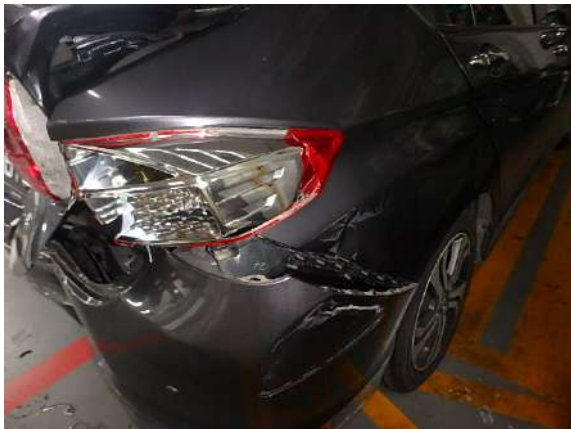
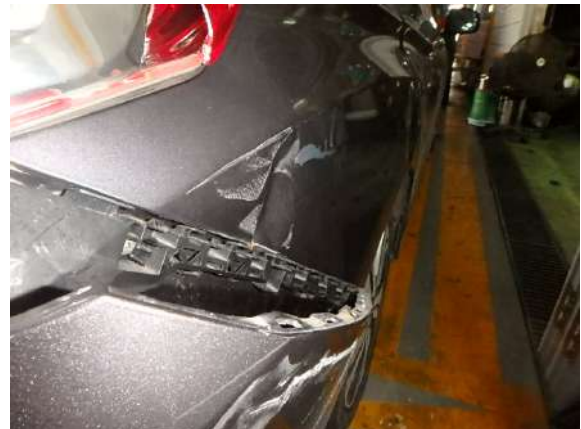
### INSPECTION

| Affiliated to Federation Internationale Des Experts En Automobile | | | | |
|---|---|---|---|--|
| THE VEHICLE SUSTAINED DAMAGES AT THE REAR PORTION.<br>DAMAGES SEE DETAILS. | | | | |

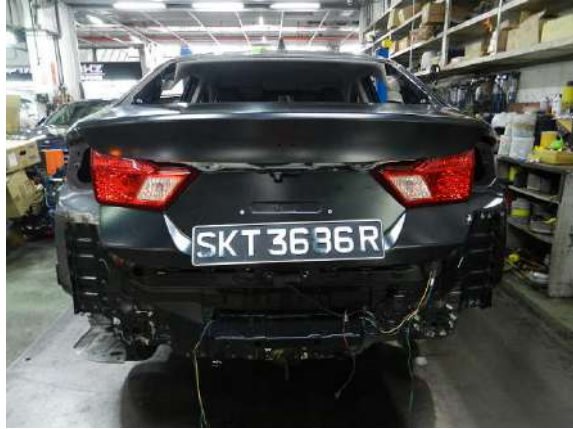
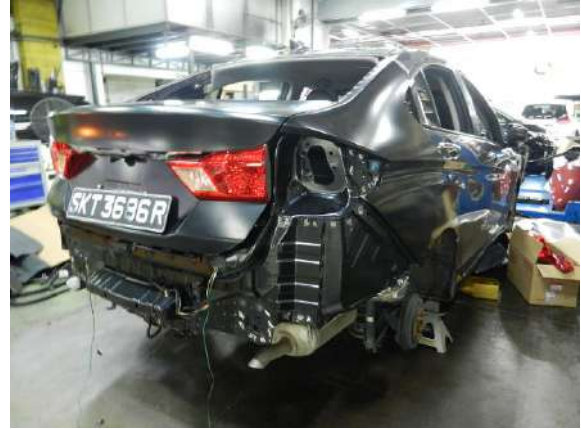
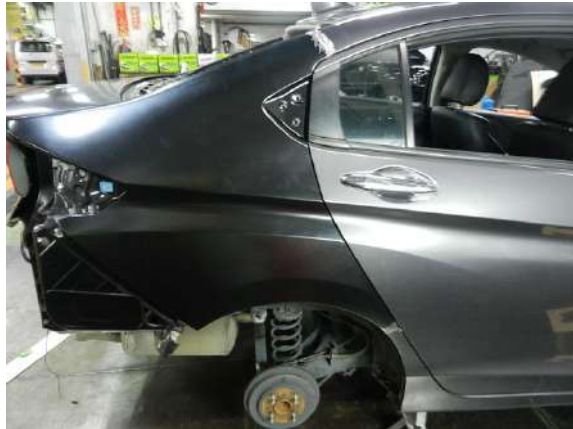
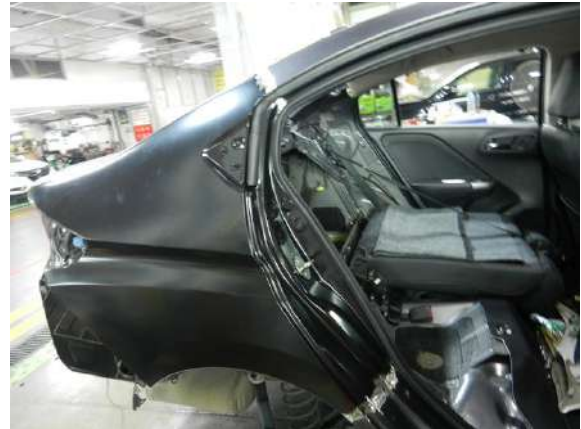
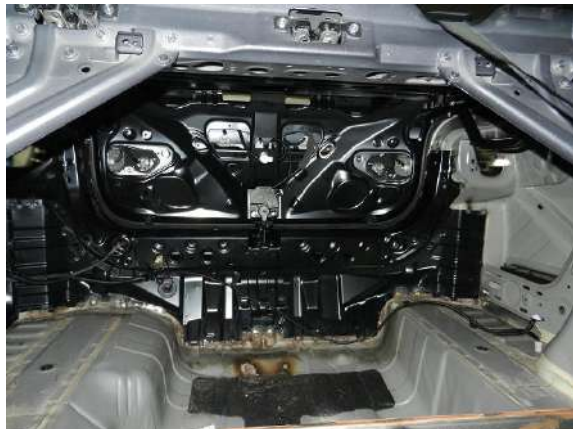
### RE-INSPECTION

### PHOTOGRAPHS FOR VEHICLE NO. SKT 3686R

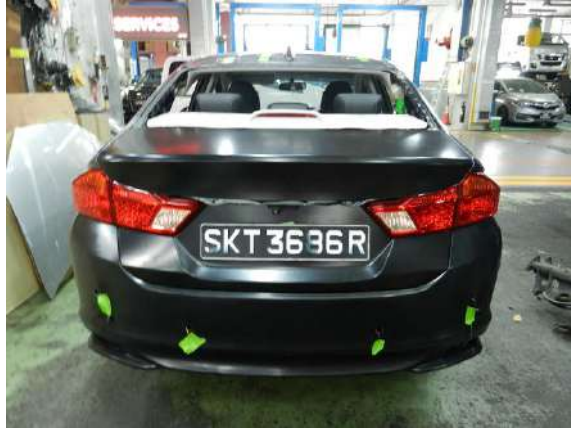
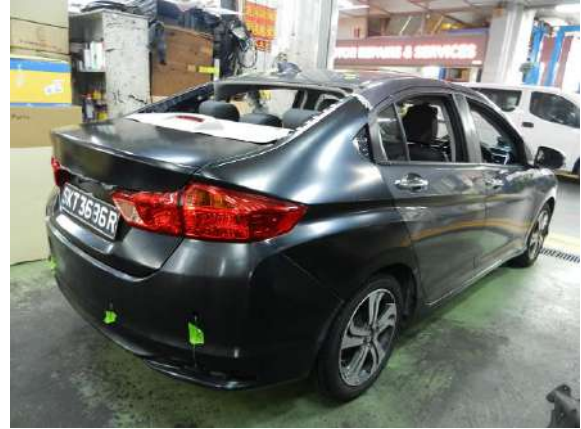
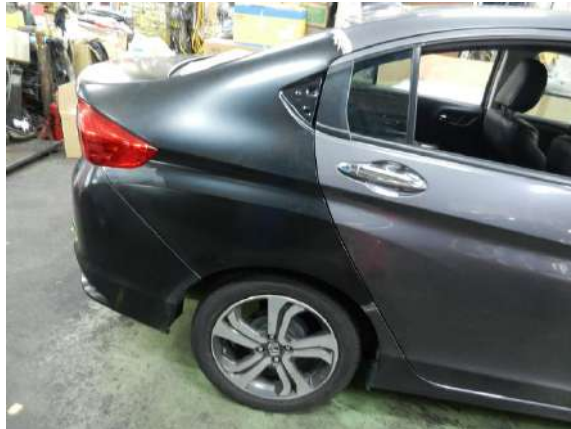
**PHOTOGRAPHS FOR VEHICLE NO. SKT 3686R**

**RE-INSPECTION**

| Qty | Description of Parts | Condition | Estimate By Workshop (\$) | Our Adjusted (\$) |
|---|---|---|---|---|
| | TO DISMANTLE ALL DAMAGED PARTS .TO CUT & WELD END PANEL,SPARE TYRE PANEL ,REAR FENDER RH ,REAR CHASSIS RH,TAILLAMP PANEL LH & RH TO KNOCK & REPAIR REAR FENDER LH ,REAR CHASSIS LH INNER PANELS AND AFFECTED AREAS .TO REFIT LISTED PARTS BACK SAME. | | 1,600.00 | 1,400.00 |
