Vehicle No. SMN 4851G  
Insured Veh. YP 1808A  
Claim No. 21/21/21/VC06/025108  
Policy No. Z/21/VC06/110907  
Accident Date 01/11/2021  
Inspection Date 03/11/2021

## ADJUSTMENT ON REPAIR COST FOR VEHICLE NO. SMN 4851G

### PHOTOGRAPHS FOR VEHICLE NO. SMN 4851G

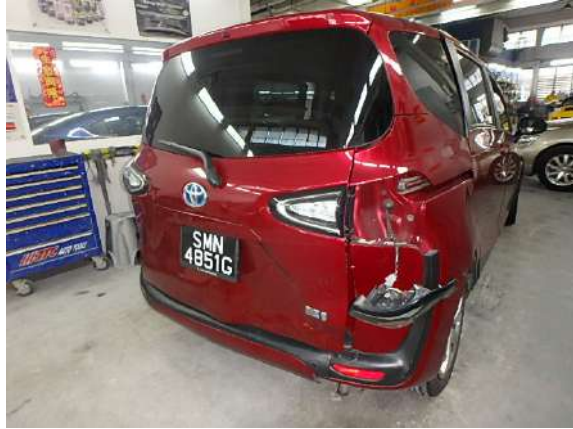
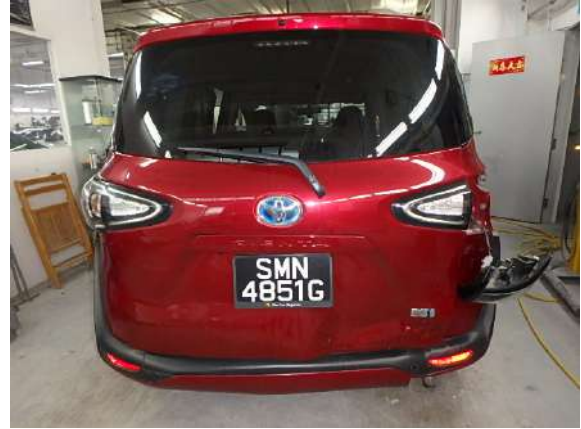
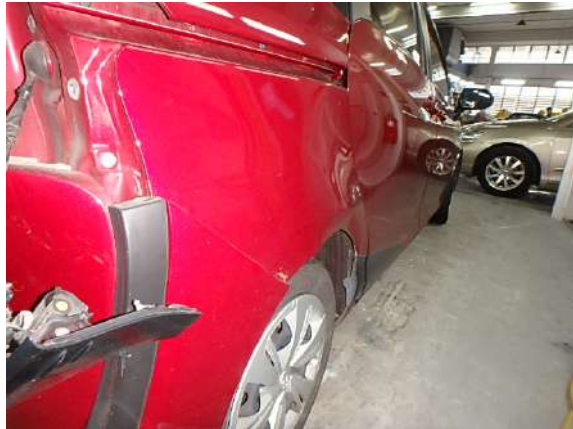
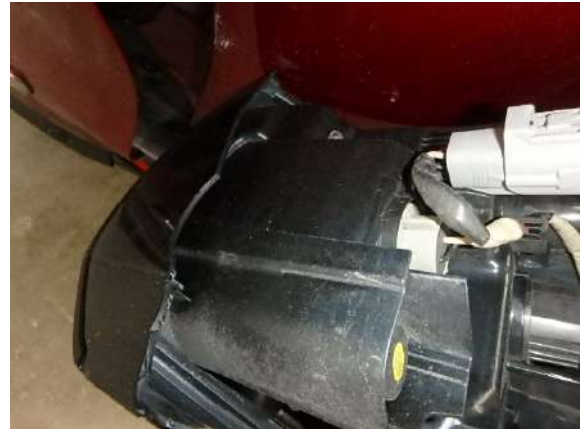
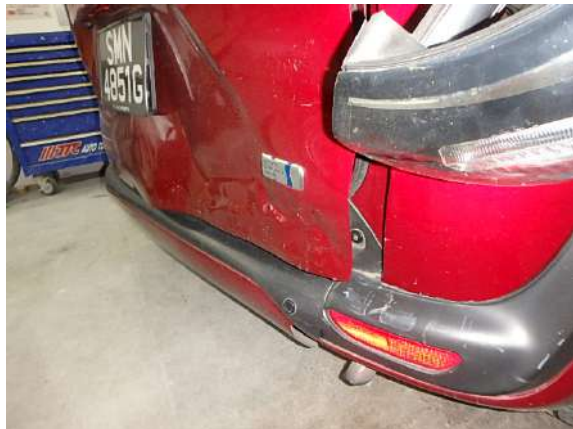
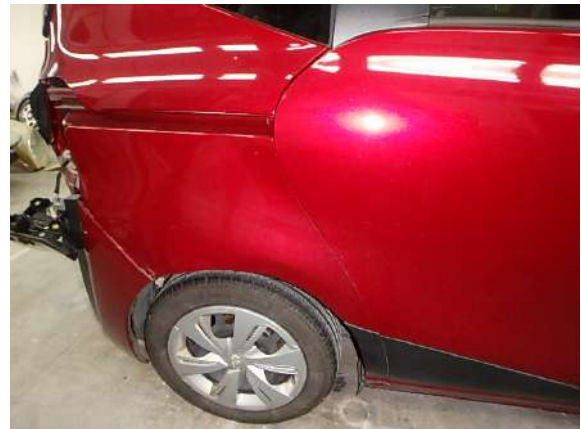
| Affiliated to Federation Internationale Des Experts En Automobile | | | | |
|---|---|---|---|--|
| THE VEHICLE SUSTAINED DAMAGES AT THE REAR O/S PORTION AND N/S BODY.<br>DAMAGES SEE DETAILS. | | | | |

### INSPECTION

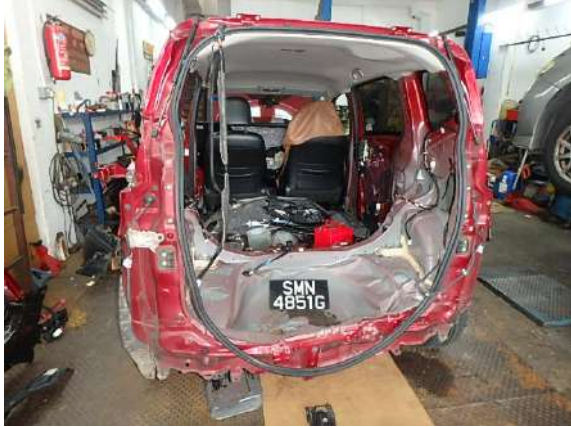
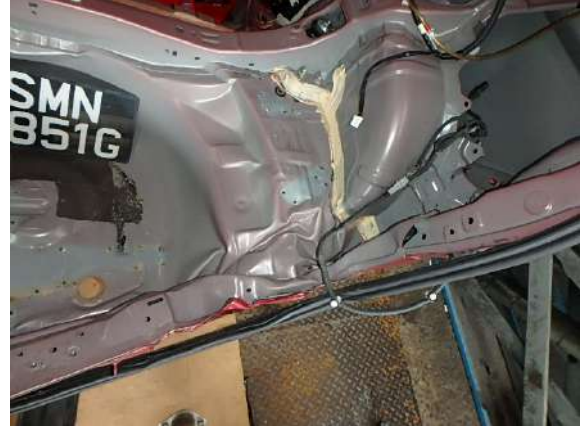
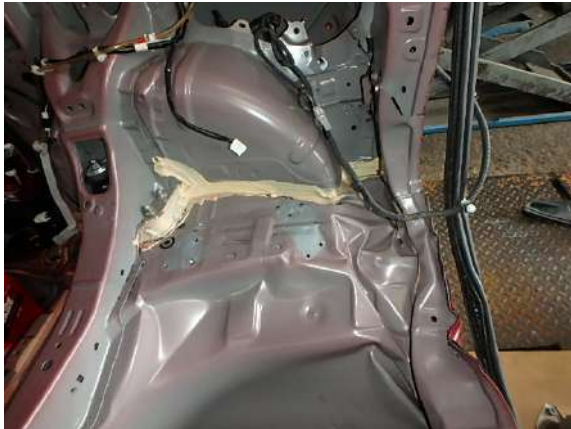
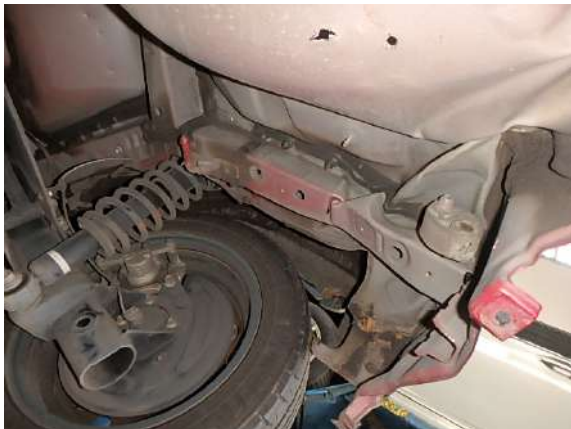
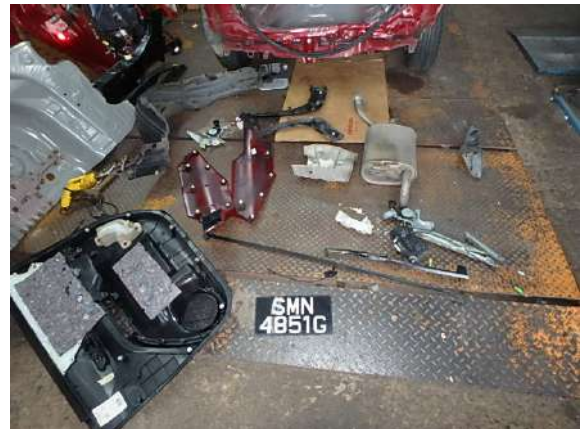
PHOTOGRAPHS FOR VEHICLE NO. SMN 4851G

RE-INSPECTION
