## LKK Auto Consultants Pte Ltd

### PROFESSIONAL SERVICE FEE

Vehicle No. SFN 4808R  
Insured Veh. XE 4233H  
Claim No. SNM21D206255/LKKDS  
Policy No. DMCVSNW00090032101  
Accident Date 01/11/2021  
Inspection Date 02/11/2021

## ADJUSTMENT ON REPAIR COST FOR VEHICLE NO. SFN 4808R

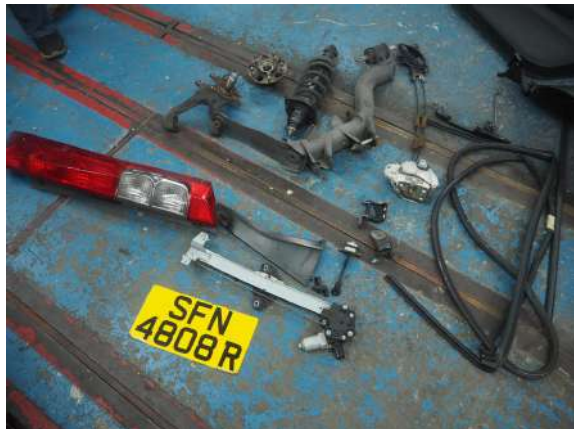
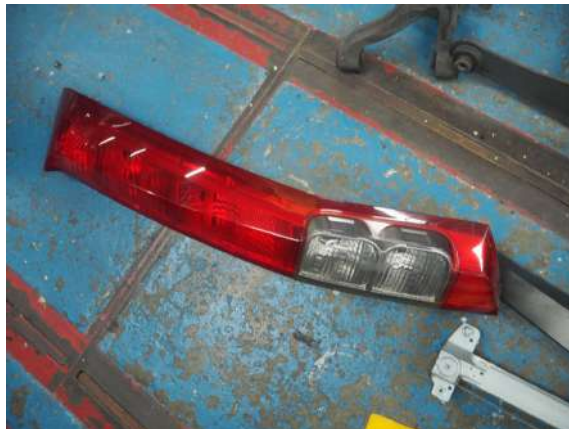
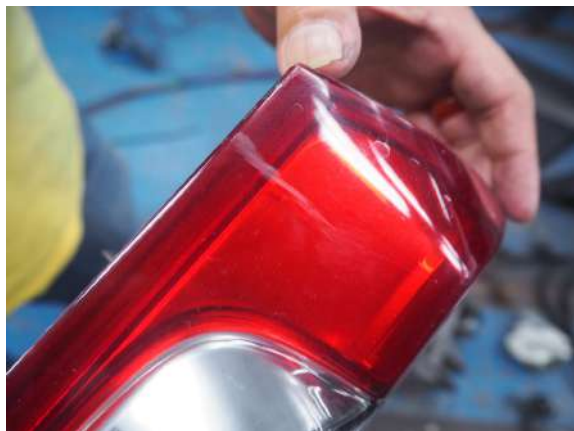
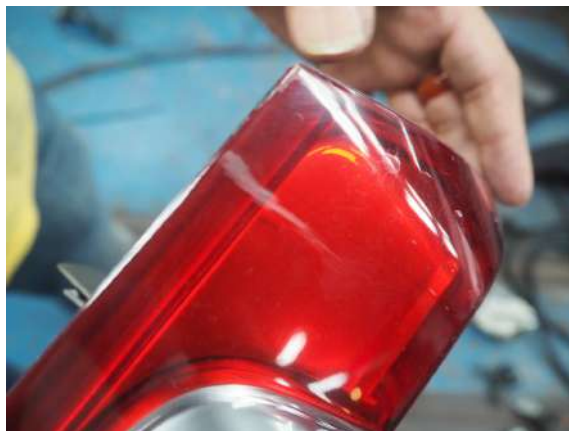
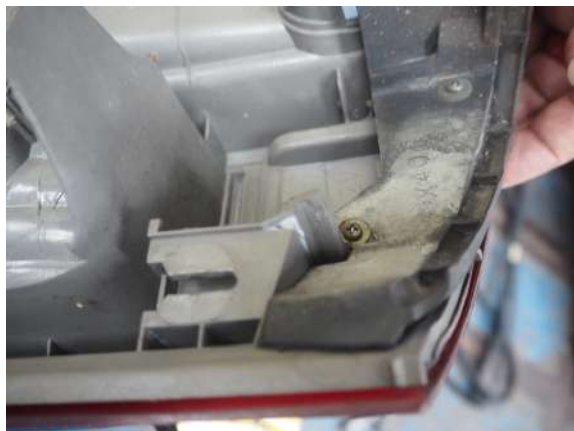
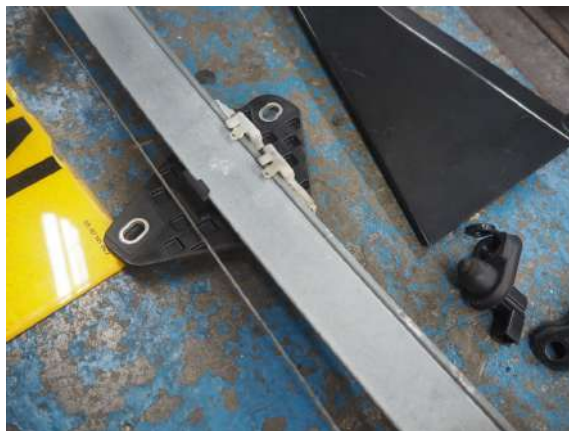
PHOTOGRAPHS FOR VEHICLE NO. SFN 4808R

| Affiliated to Federation Internationale Des Experts En Automobile | | | | |
|---|---|---|---|--|
| THE VEHICLE SUSTAINED DAMAGES AT THE O/S BODY AND UNDERCARRIAGE.<br>DAMAGES SEE DETAILS. | | | | |

RE-INSPECTION
