LKK Auto Consultants Pte Ltd

ADJUSTMENT ON REPAIR COST FOR VEHICLE NO. SMX 3051C

PHOTOGRAPHS FOR VEHICLE NO. SMX 3051C

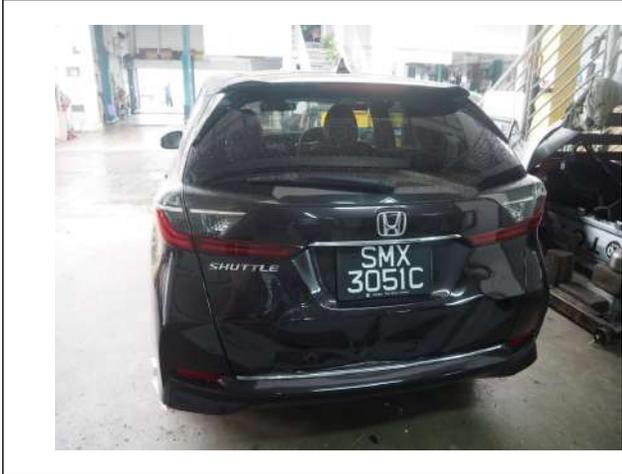
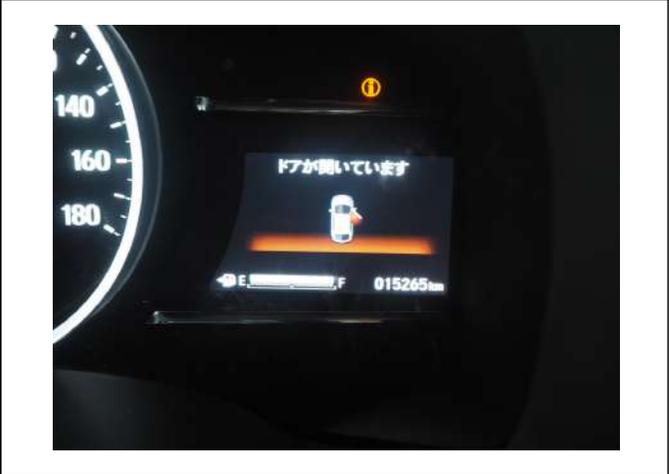
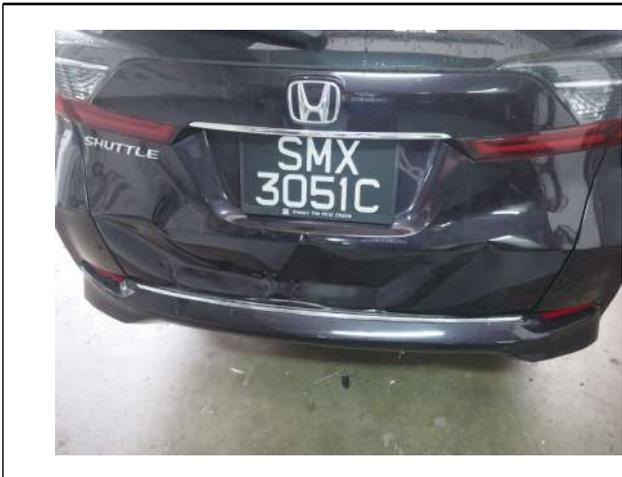
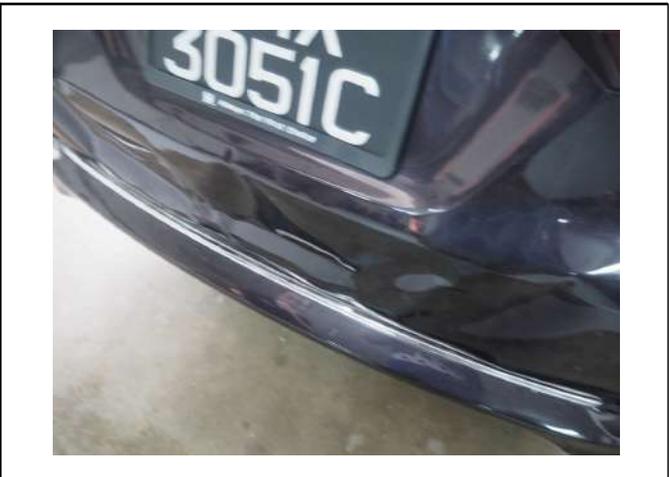
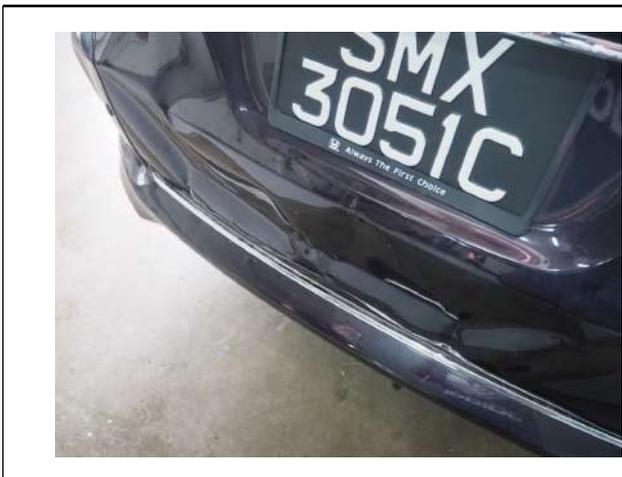
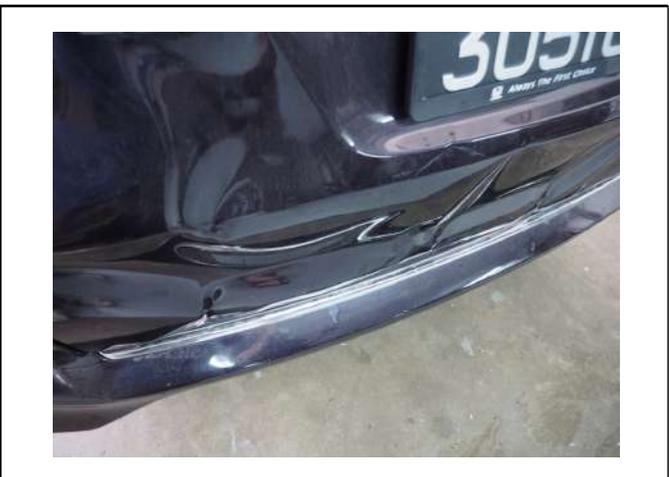
INSPECTION

4. Description of Damages			
THE VEHICLE SUSTAINED DAMAGES AT THE REAR PORTION. DAMAGES SEE DETAILS.			
5. General Information			
Accident Date	06/11/2021	Inspection Date	08/11/2021
Survey held at	R&CO MOTORWERKS LLP 1 KAKI BUKIT AVENUE 6 #02-22 AUTOBAY @ KAKI BUKIT SINGAPORE 417883		
5a. Remarks			
A)THE INSPECTION WAS CONDUCTED ON A"WITHOUT PREJUDICE" BASIS. B)IN ACCORDANCE TO YOUR INSTRUCTIONS, WE HAVE NOT AUTHORISED REPAIRS.			
5b. Estimate Days of Repair			
ESTIMATED NORMAL PERIOD FOR REPAIR:		6 Working Days

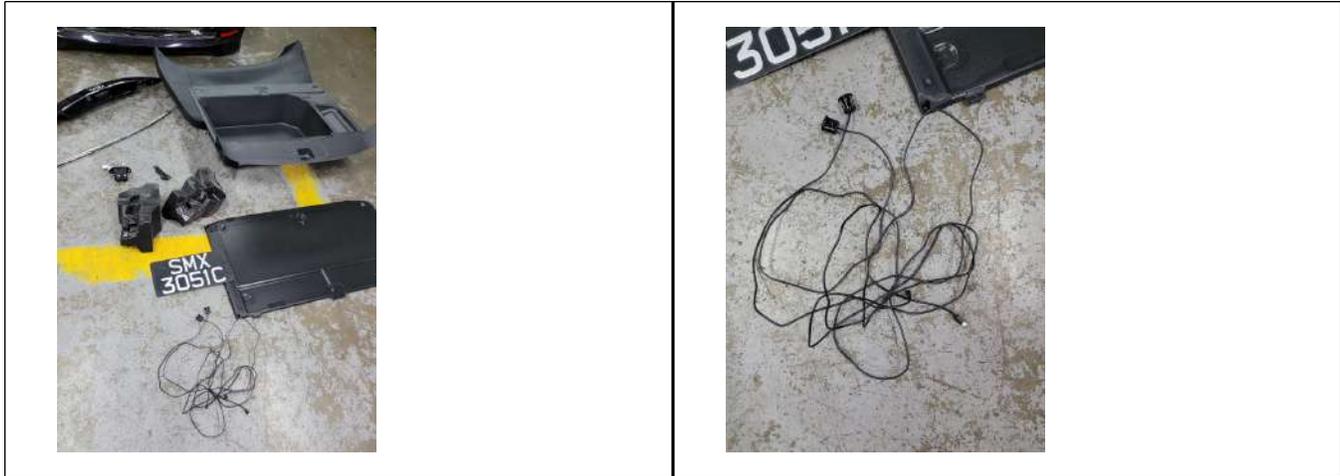
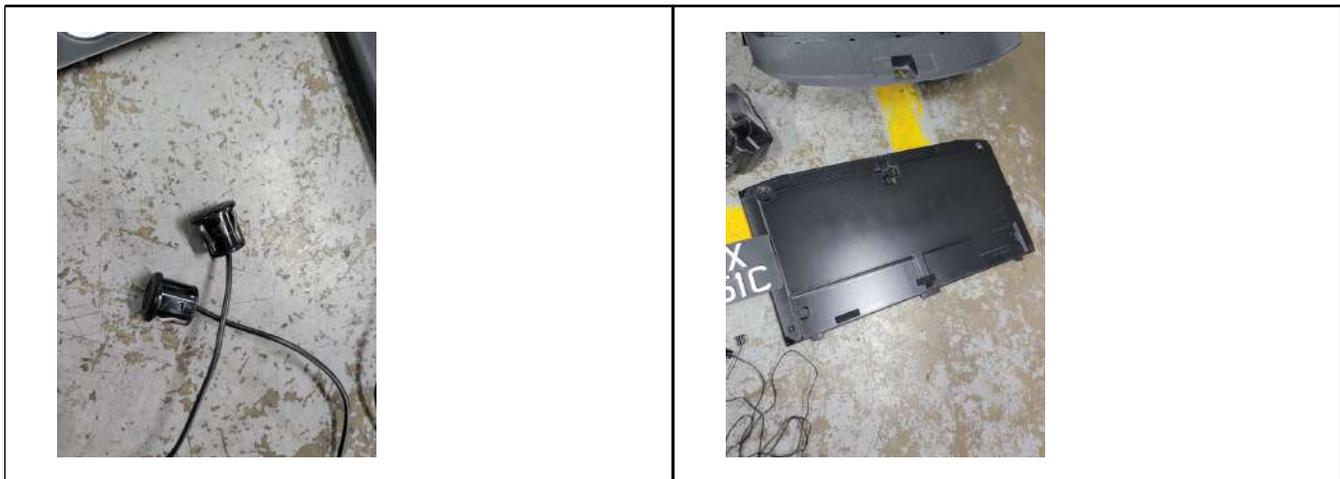
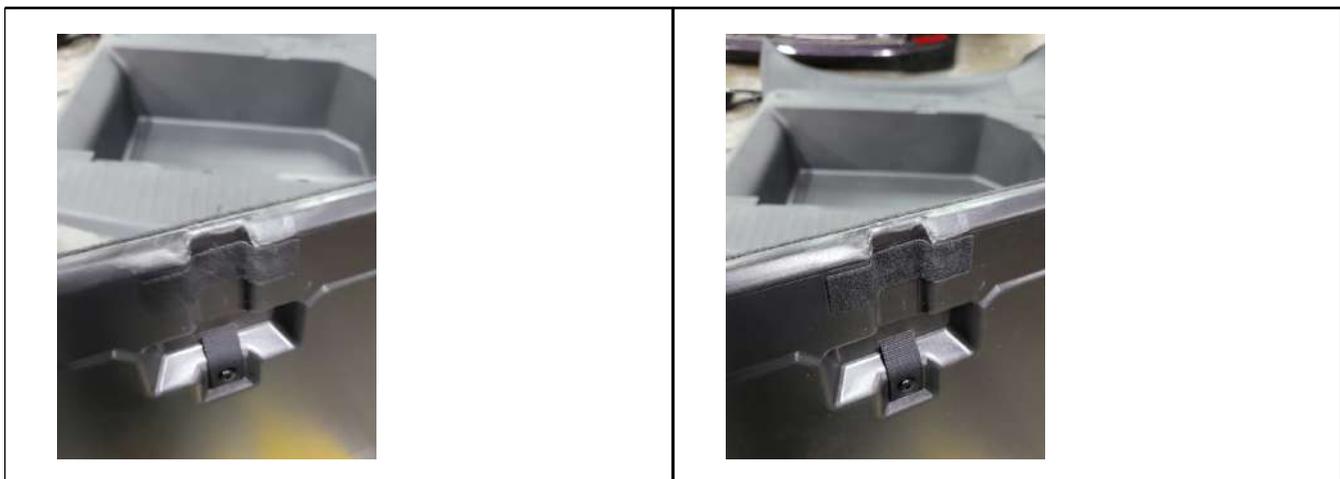
PHOTOGRAPHS FOR VEHICLE NO. SMX 3051C

RE-INSPECTION
