## LKK Auto Consultants Pte Ltd

Vehicle No.	SLM 5344P
Insured Veh.	SJK 1702A
Claim No.	SNM21D206612/C02
Policy No.	DMPCSNW00066712101
Accident Date	15/11/2021
Inspection Date	16/11/2021

## ADJUSTMENT ON REPAIR COST FOR VEHICLE NO. SLM 5344P

## PHOTOGRAPHS FOR VEHICLE NO. SLM 5344P

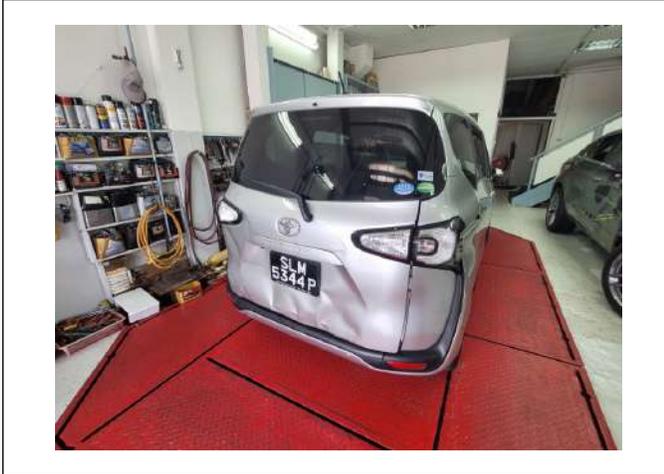
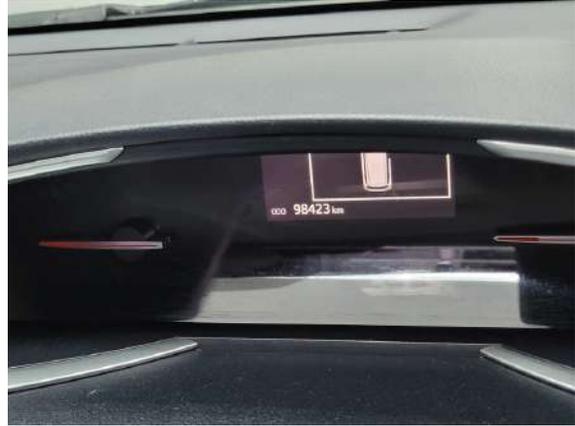
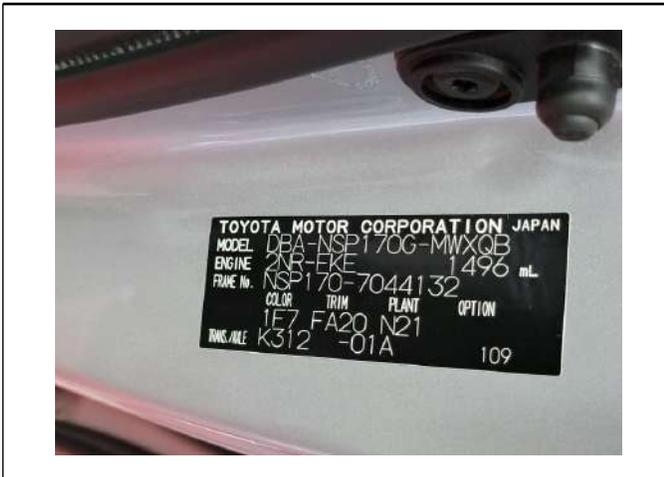
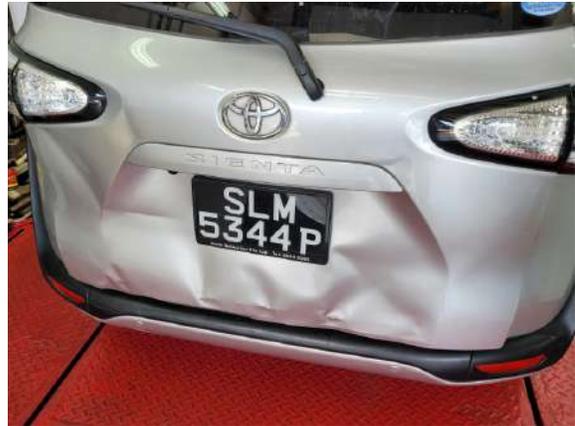
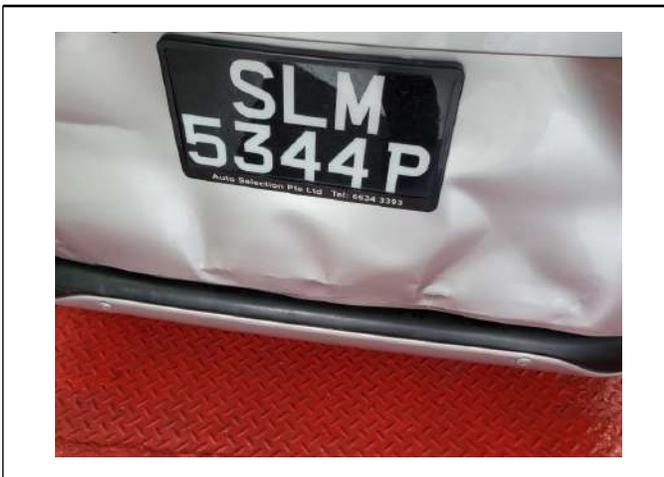
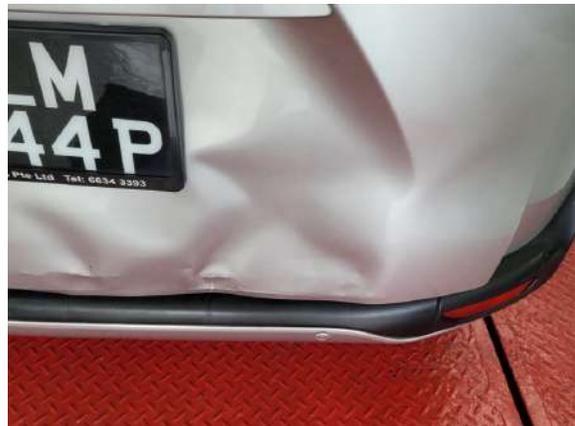
## INSPECTION

4. Description of Damages			
THE VEHICLE SUSTAINED DAMAGES AT THE REAR PORTION. DAMAGES SEE DETAILS.			
5. General Information			
Accident Date	15/11/2021	Inspection Date	16/11/2021
Survey held at	J-MART MOTOR PTE LTD BLK 5 DEFU LANE 10 #01-578 DEFU INDUSTRIAL PARK C SINGAPORE 539186		
5a. Remarks			
A)THE INSPECTION WAS CONDUCTED ON A"WITHOUT PREJUDICE" BASIS. B)IN ACCORDANCE TO YOUR INSTRUCTIONS, WE HAVE NOT AUTHORISED REPAIRS.			
5b. Estimate Days of Repair			
ESTIMATED NORMAL PERIOD FOR REPAIR:		6 Working Days

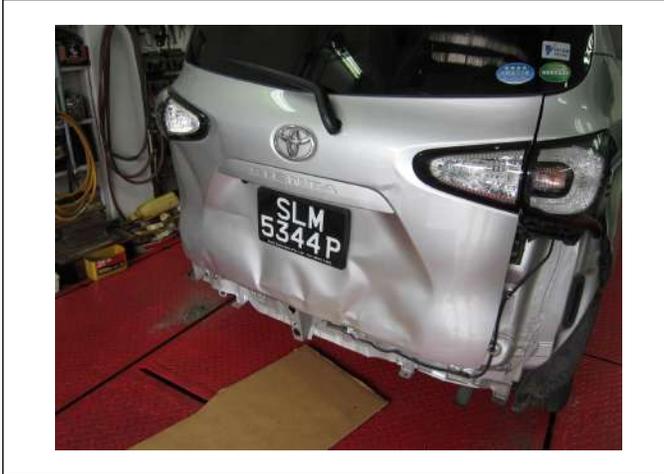
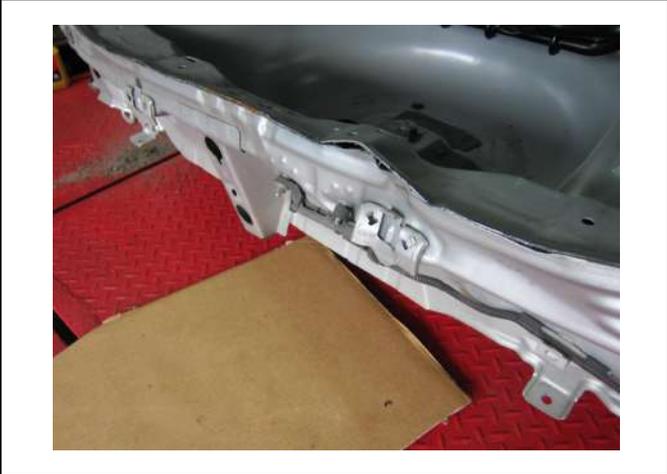
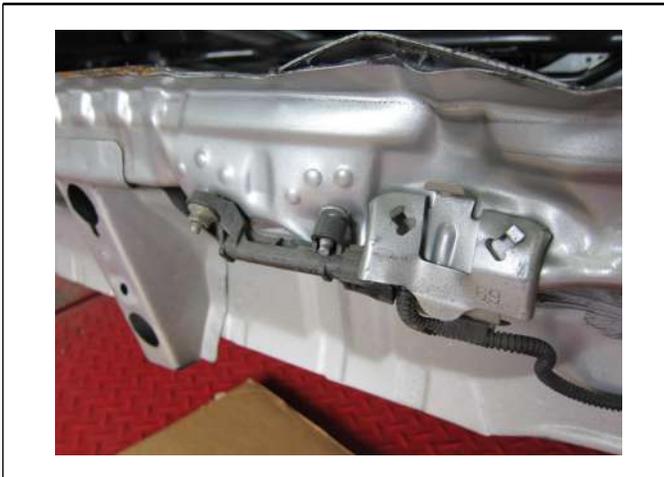
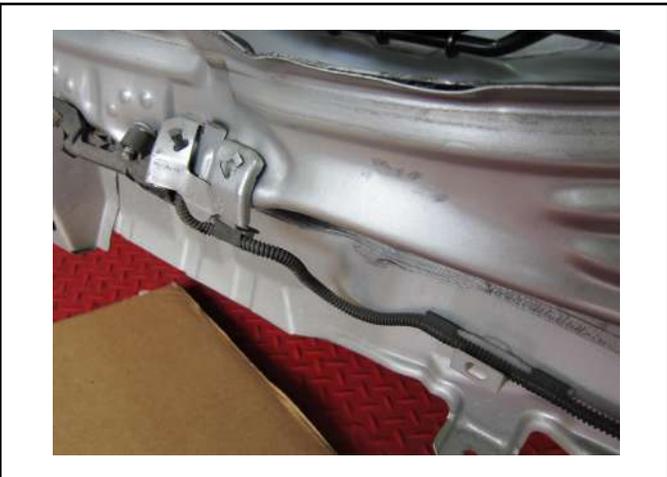
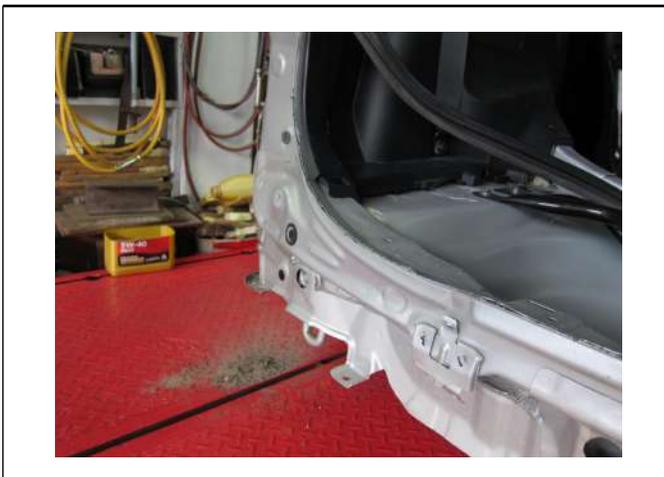
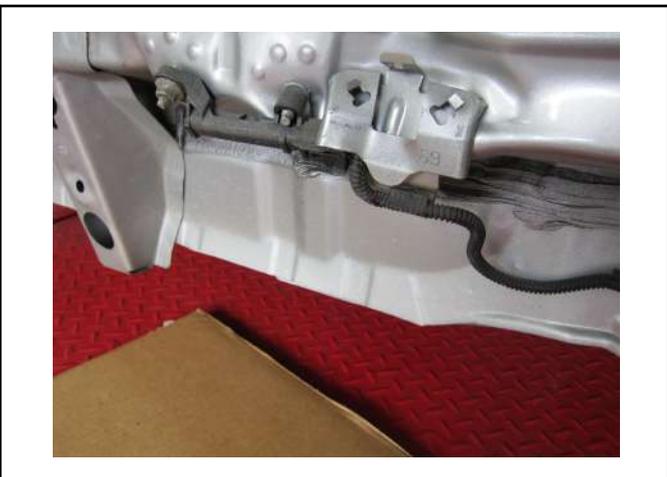
RE-INSPECTION

PHOTOGRAPHS FOR VEHICLE NO. SLM 5344P
