### PROFESSIONAL SERVICE FEE

## ADJUSTMENT ON REPAIR COST FOR VEHICLE NO. SHF 1029K

### PHOTOGRAPHS FOR VEHICLE NO. SHF 1029K

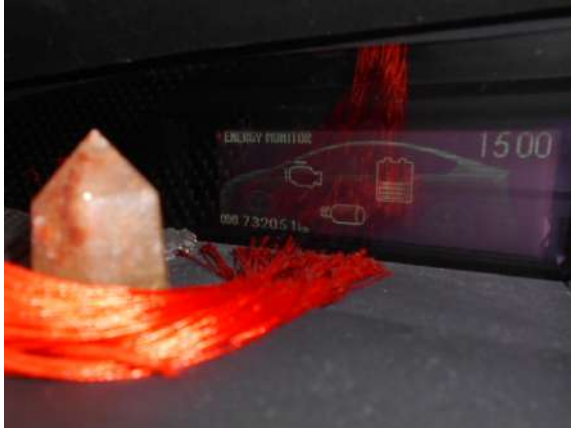
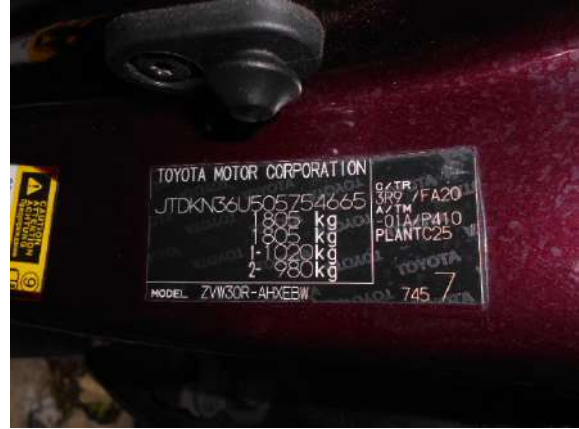
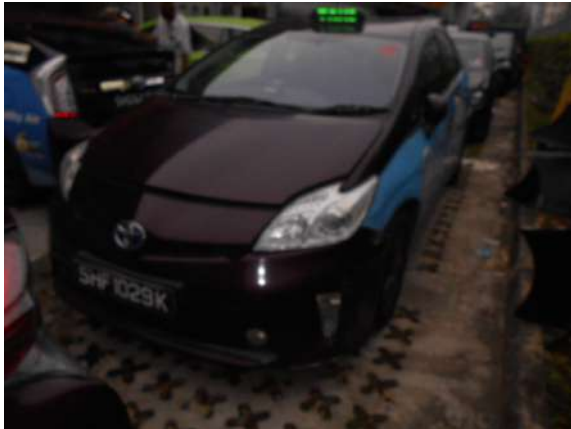
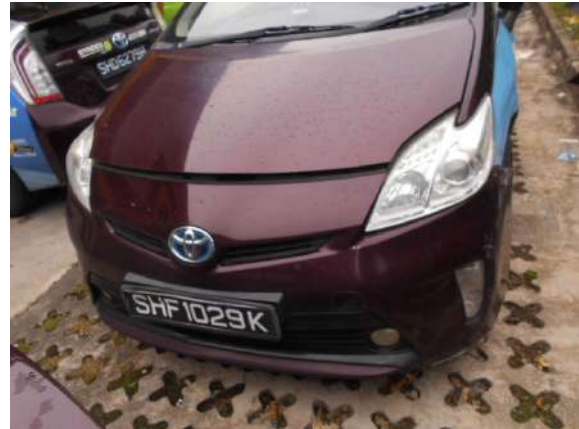
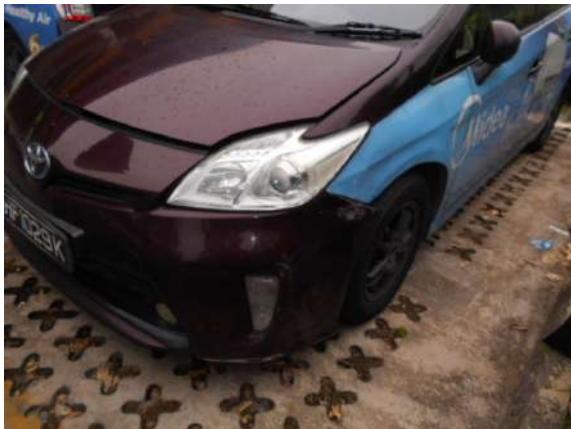
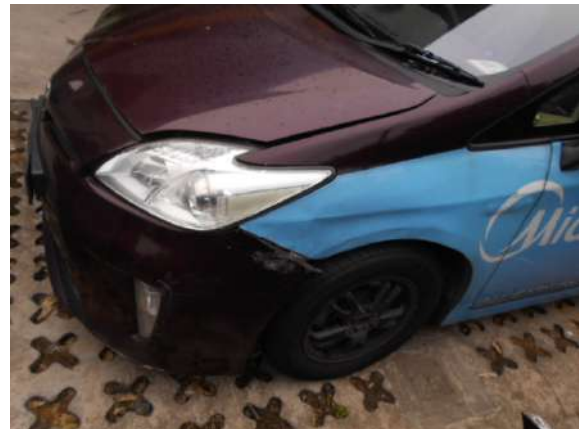
### INSPECTION

| Affiliated to Federation Internationale Des Experts En Automobile | | | | |
|---|---|---|---|---|
| | THE VEHICLE SUSTAINED DAMAGES AT THE N/S FRONT PORTION.<br><br>DAMAGES SEE DETAILS. | | | |
