## LKK Auto Consultants Pte Ltd

| Affiliated to Federation Internationale Des Experts En Automobile | | | | |
|---|---|---|---|--|
| THE VEHICLE SUSTAINED DAMAGES AT THE REAR O/S PORTION.<br>DAMAGES SEE DETAILS. | | | | |

## ADJUSTMENT ON REPAIR COST FOR VEHICLE NO. SKX 6121M

### PHOTOGRAPHS FOR VEHICLE NO. SKX 6121M

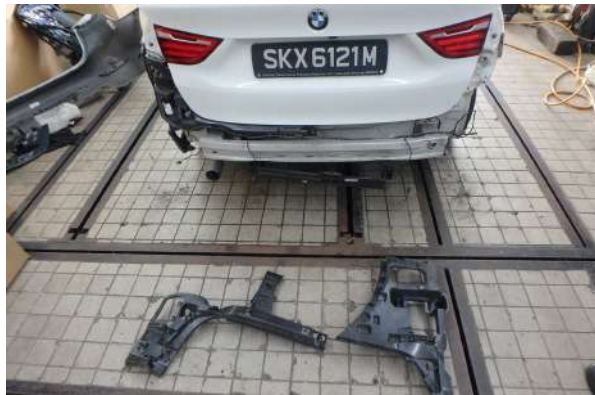
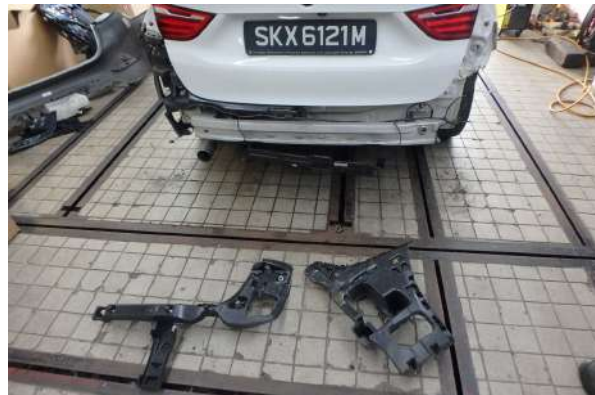
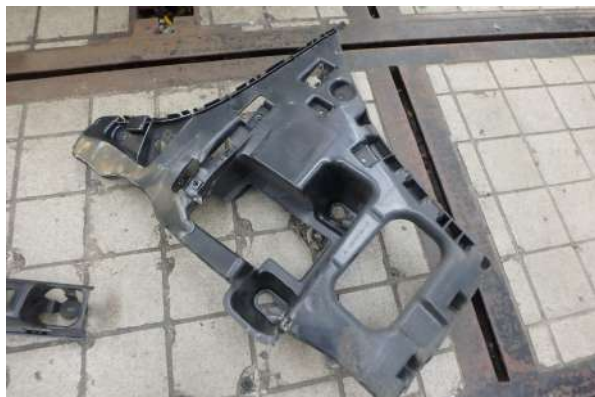
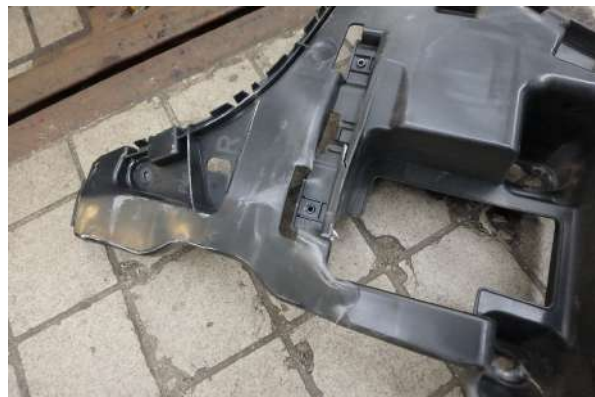
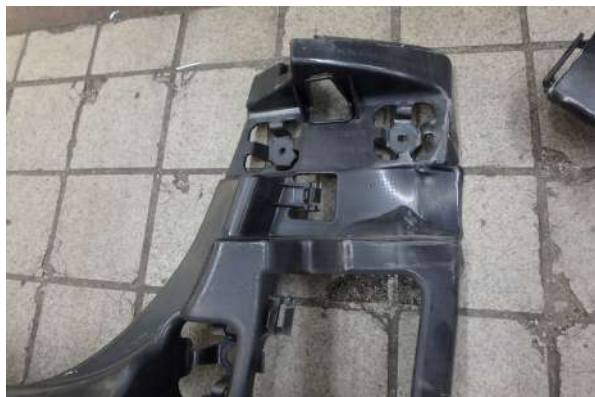
**PHOTOGRAPHS FOR VEHICLE NO. SKX 6121M**

**RE-INSPECTION**

| Qty | Description of Parts | Condition | Estimate By Workshop (\$) | Our Adjusted (\$) |
|---|---|---|---|---|
| | TO REMOVE REAR DAMAGED PARTS ,TO JACK OUT REAR END PANEL AND REAR FLOOR PANEL AND CUT OUT BODY PANEL,TO REWELD ,RESHAPE AND REPAIR REAR END PANEL,REAR FLOOR PANEL,RH REAR FENDER PANEL,TO STRAIGHTEN OUT REAR CHASSIS MEMBER ,TO REPLACE DAMAGED PARTS AND ADJUST REAR BODY AND TAILGATE ALIGNMENT. | | 680.00 | 600.00 |

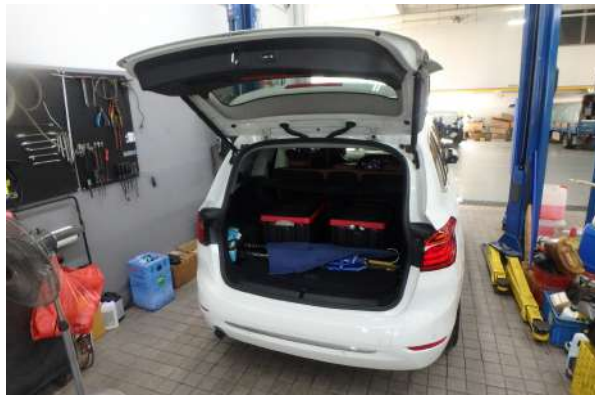
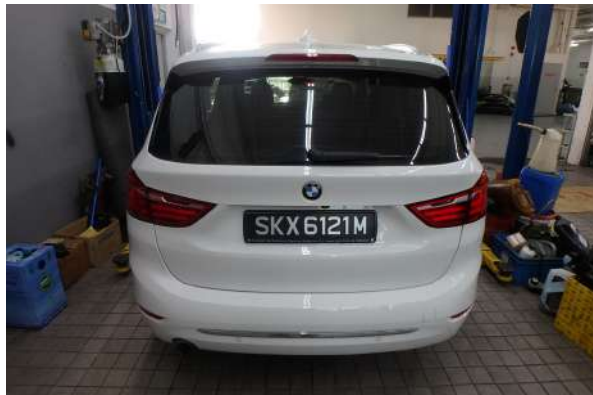
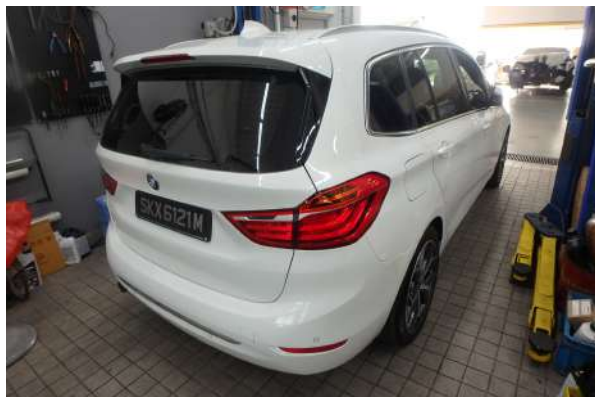
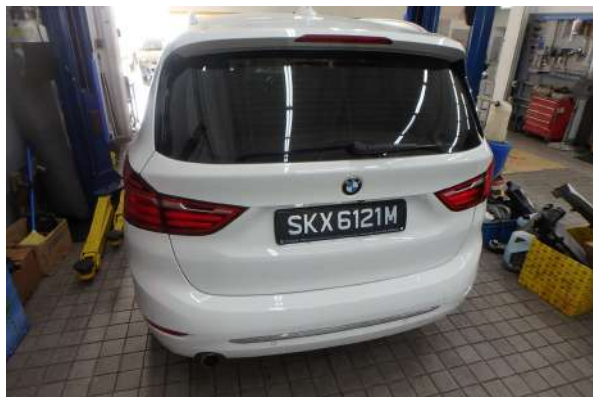
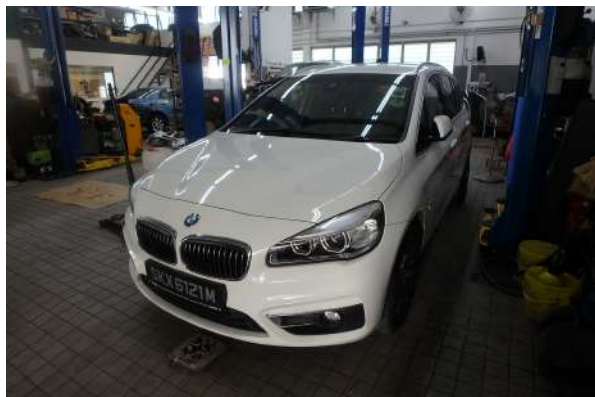
PHOTOGRAPHS FOR VEHICLE NO. SKX 6121M

RE-INSPECTION
