TAX INVOICE

PROFESSIONAL SERVICE FEE

ADJUSTMENT ON REPAIR COST FOR VEHICLE NO. SMX 6857A

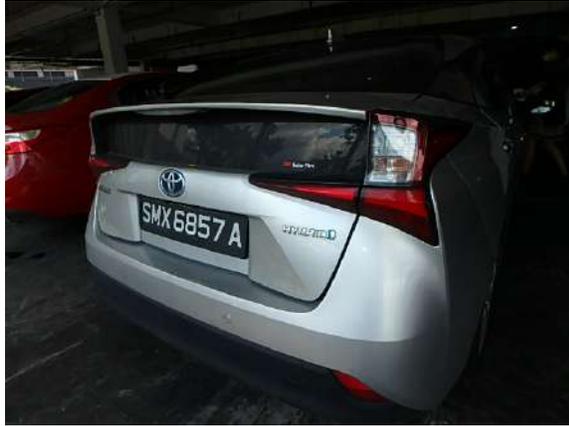
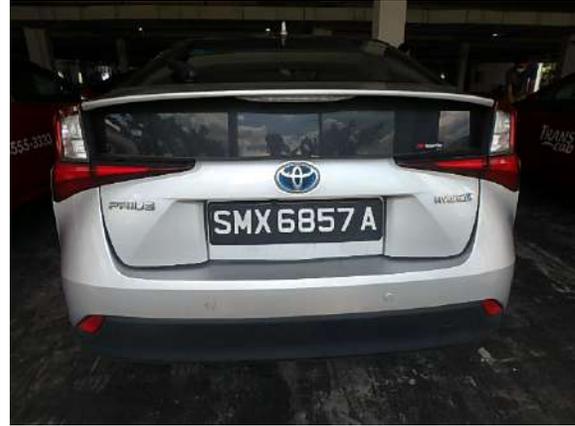
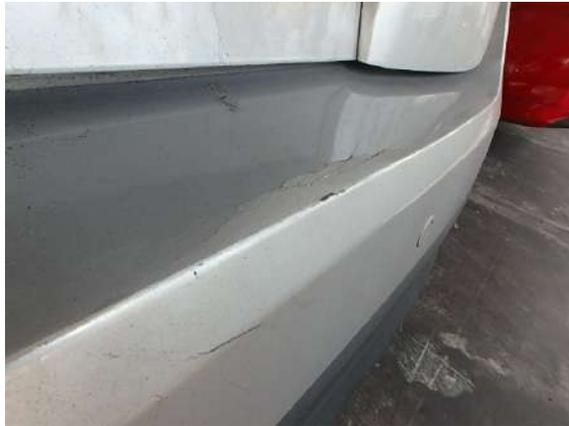
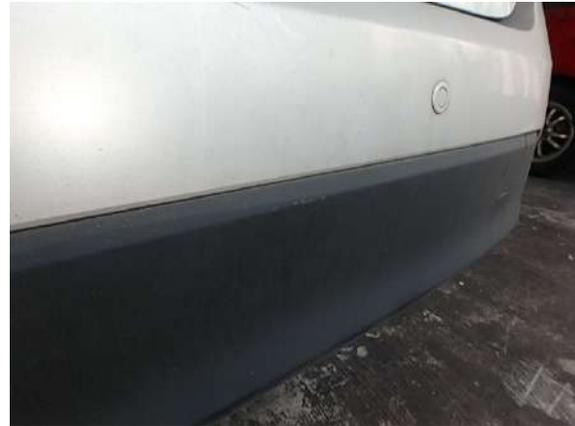
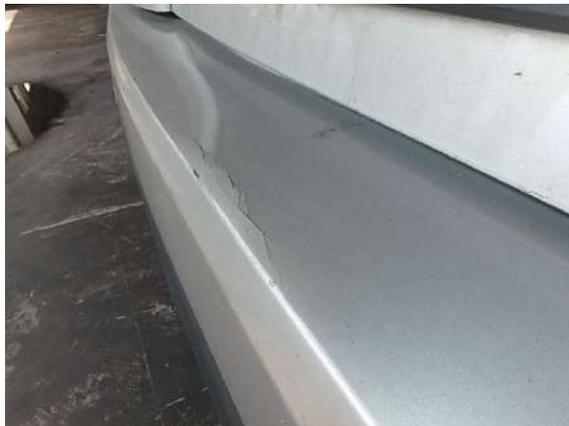
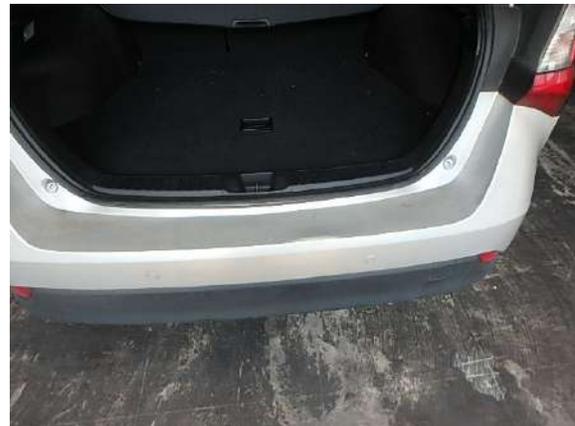
PHOTOGRAPHS FOR VEHICLE NO. SMX 6857A

4. Description of Damages			
THE VEHICLE SUSTAINED DAMAGES AT THE REAR & FRONT PORTION. DAMAGES SEE DETAILS.			
5. General Information			
Accident Date	03/11/2021	Inspection Date	22/11/2021
Survey held at	TRANS-CAB AUTO SERVICES PTE LTD NO.2 ANG MO KIO ST 63 SINGAPORE 569111		
5a. Remarks			
A)THE INSPECTION WAS CONDUCTED ON A"WITHOUT PREJUDICE" BASIS. B)IN ACCORDANCE TO YOUR INSTRUCTIONS, WE HAVE NOT AUTHORISED REPAIRS.			
5b. Estimate Days of Repair			
ESTIMATED NORMAL PERIOD FOR REPAIR:		4 Working Days

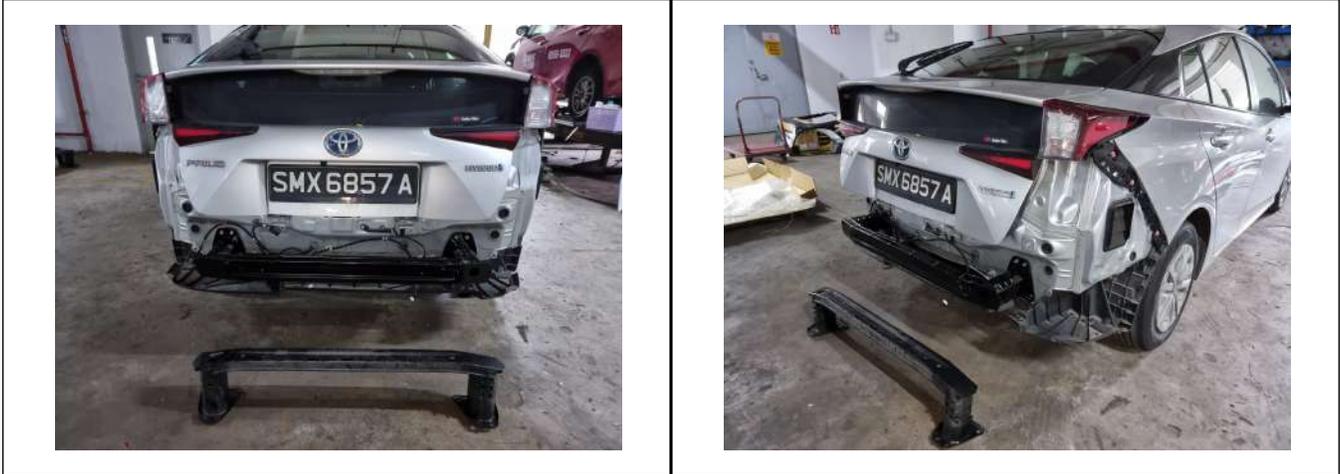
RE-INSPECTION

PHOTOGRAPHS FOR VEHICLE NO. SMX 6857A

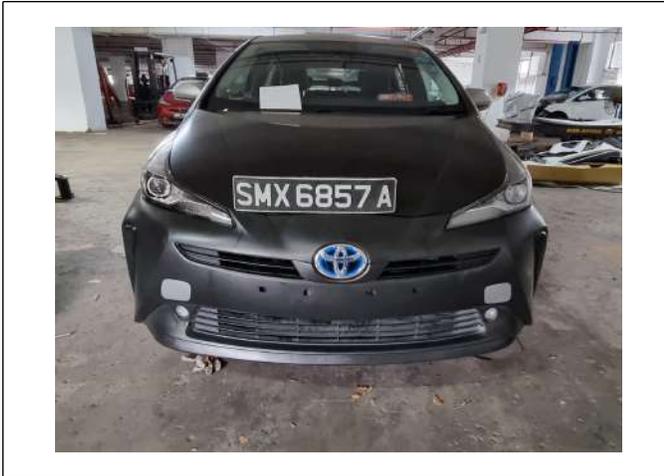
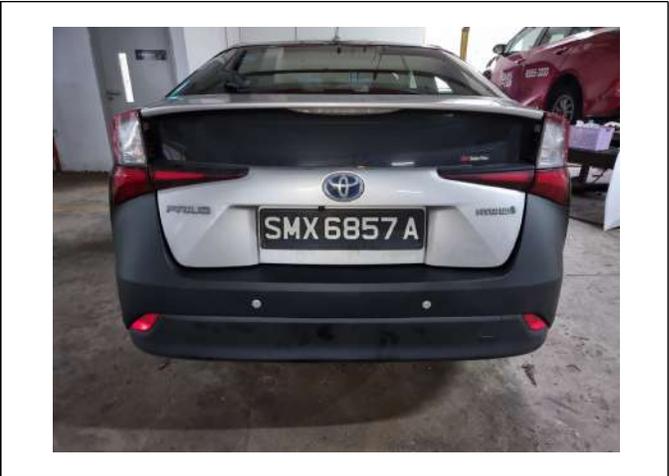
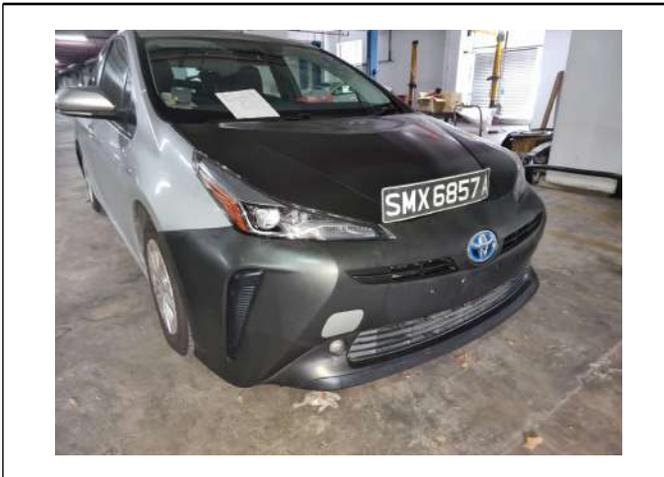
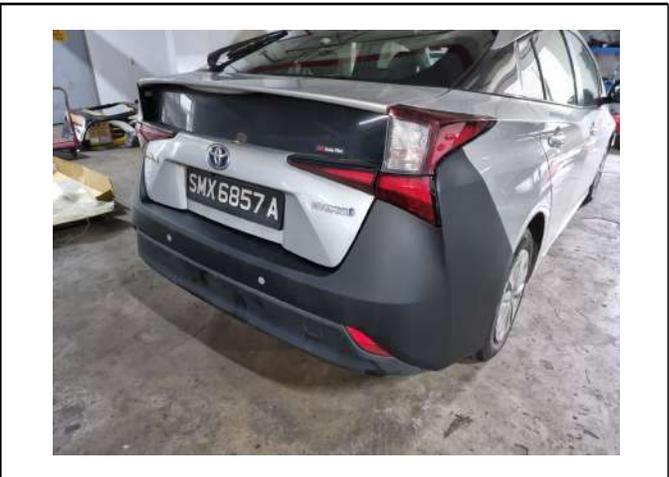
RE-INSPECTION

PHOTOGRAPHS FOR VEHICLE NO. SMX 6857A
