## LKK Auto Consultants Pte Ltd

### ADJUSTMENT ON REPAIR COST FOR VEHICLE NO. GBB 656Z

PHOTOGRAPHS FOR VEHICLE NO. GBB 656Z

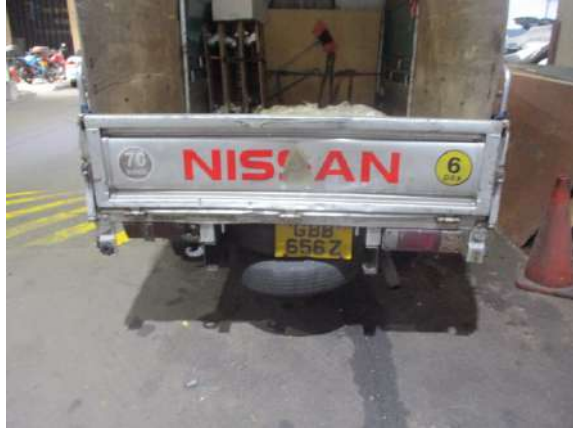
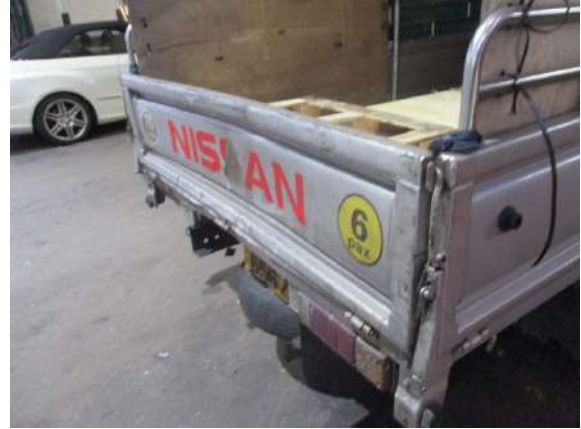
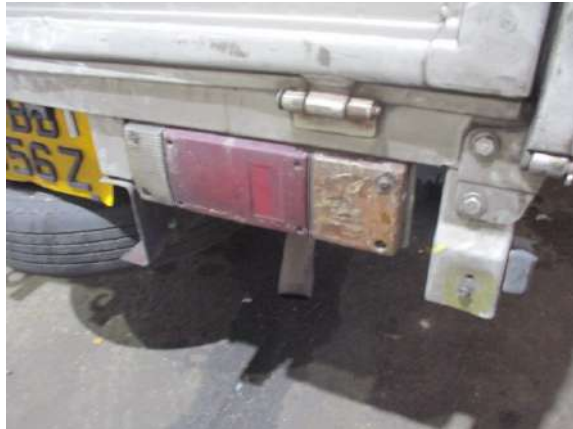
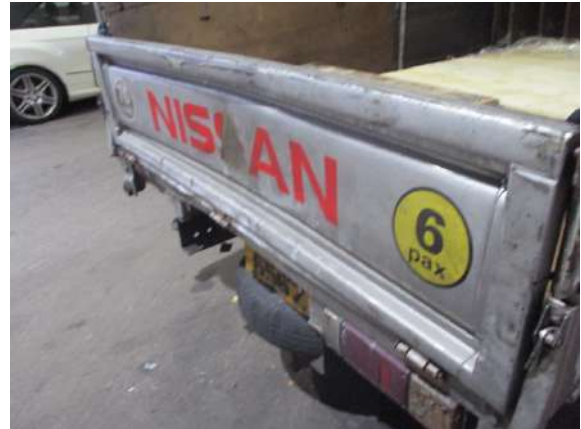
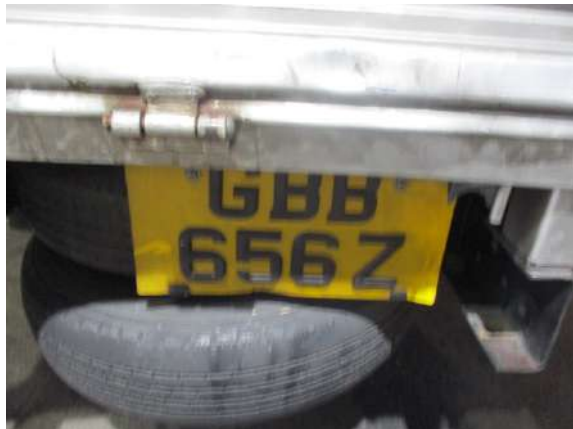
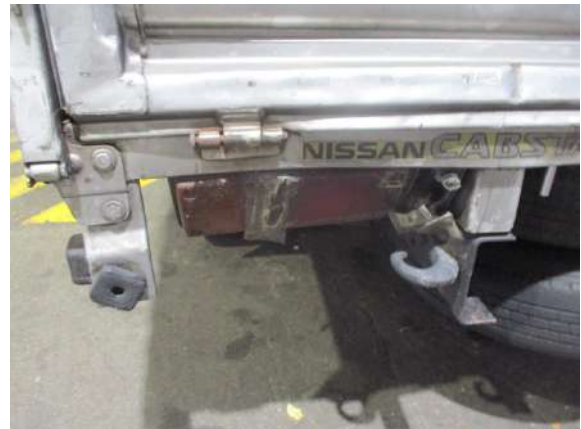
INSPECTION

| Affiliated to Federation Internationale Des Experts En Automobile | | | | |
|---|---|---|---|---|
| | THE VEHICLE SUSTAINED DAMAGES AT THE FRONT AND REAR PORTION.<br><br>DAMAGES SEE DETAILS. | | | |
