Vehicle No. SJH 3433D

## ADJUSTMENT ON REPAIR COST FOR VEHICLE NO. SJH 3433D

### PHOTOGRAPHS FOR VEHICLE NO. SJH 3433D

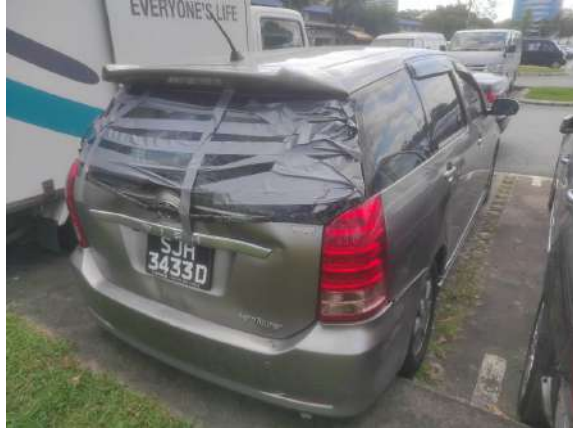
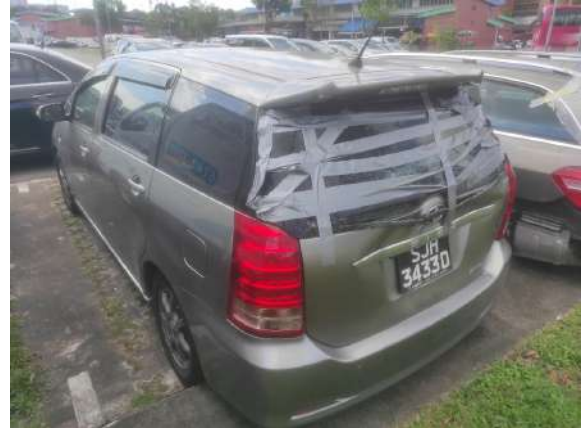
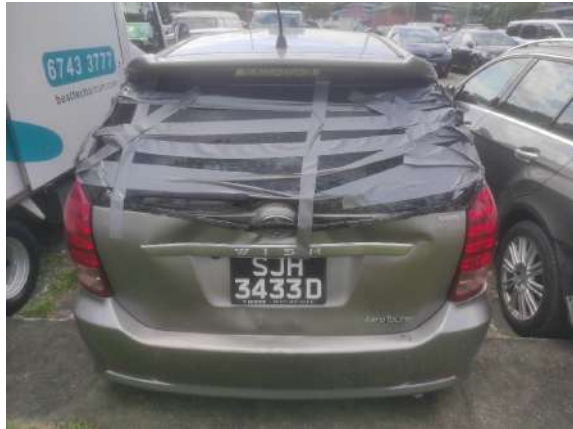
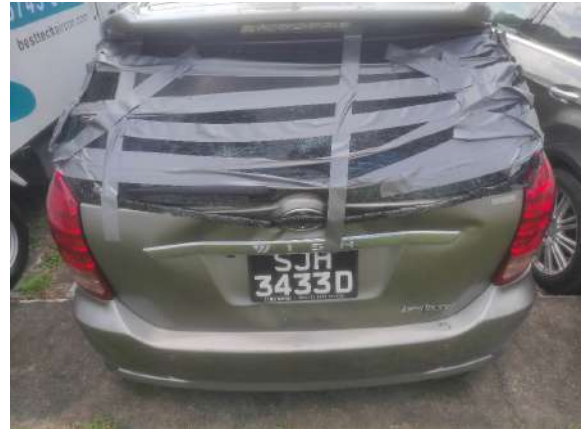
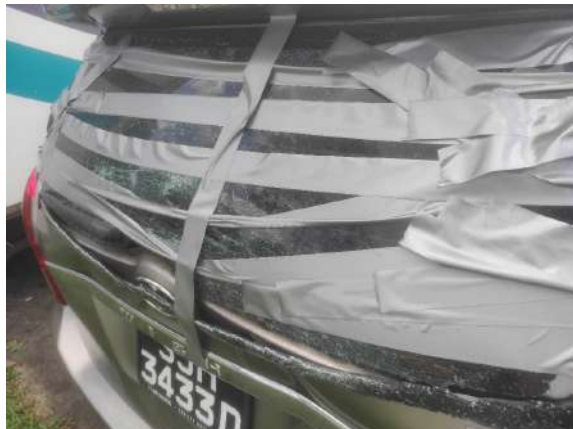
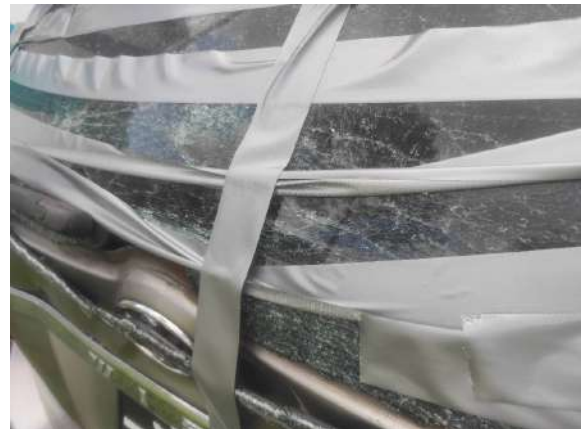
### INSPECTION

| Affiliated to Federation Internationale Des Experts En Automobile | | | | |
|---|---|---|---|---|
| THE VEHICLE SUSTAINED DAMAGES AT THE REAR PORTION.<br><br>DAMAGES SEE DETAILS. | | | | |
