## LKK Auto Consultants Pte Ltd

## ADJUSTMENT ON REPAIR COST FOR VEHICLE NO. SMN 7067J

PHOTOGRAPHS FOR VEHICLE NO. SMN 7067J

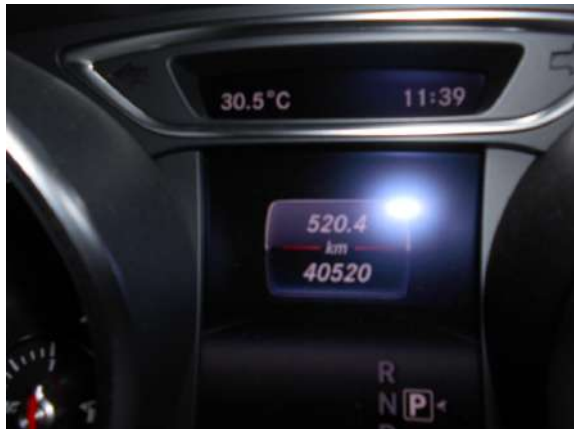
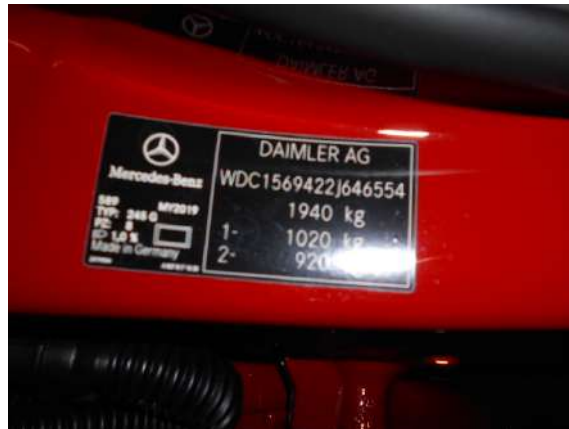
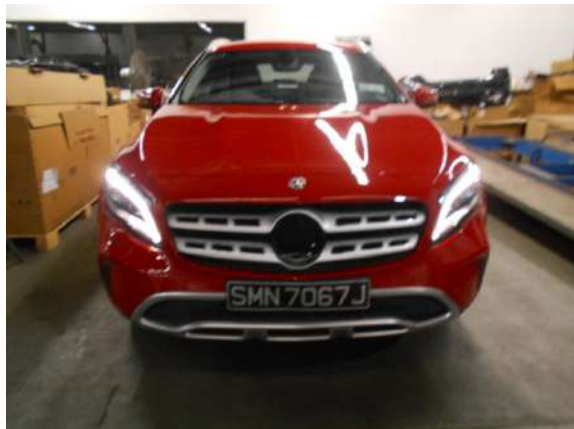
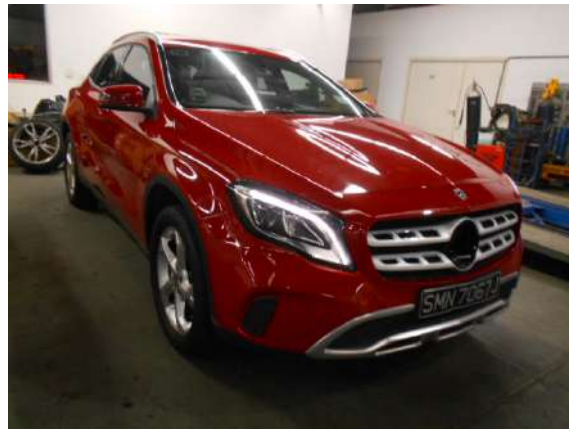
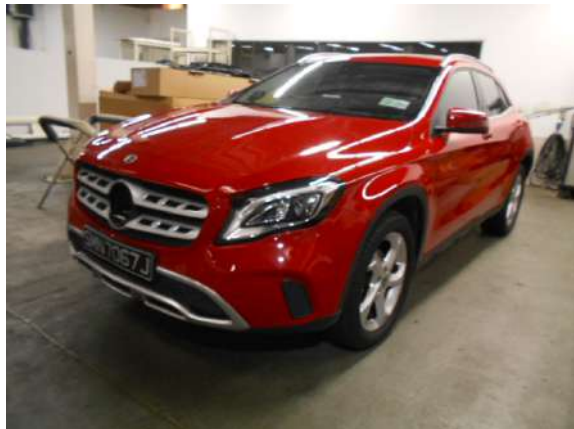
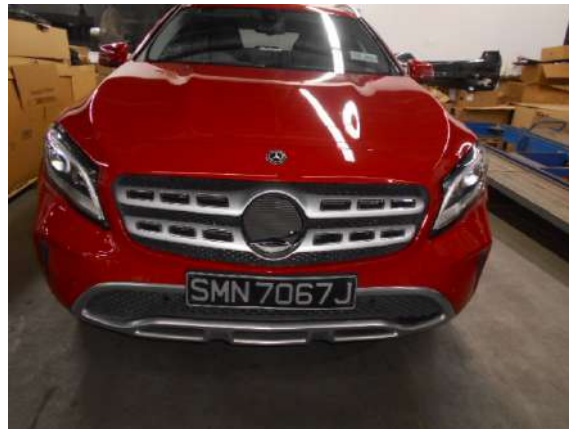
INSPECTION

| Affiliated to Federation Internationale Des Experts En Automobile | | | | |
|---|---|---|---|---|
| | THE VEHICLE SUSTAINED DAMAGES AT THE FRONT AND REAR PORTION.<br>DAMAGES SEE DETAILS. | | | |
