## LKK Auto Consultants Pte Ltd

## ADJUSTMENT ON REPAIR COST FOR VEHICLE NO. YQ 3208M

### PHOTOGRAPHS FOR VEHICLE NO. YQ 3208M

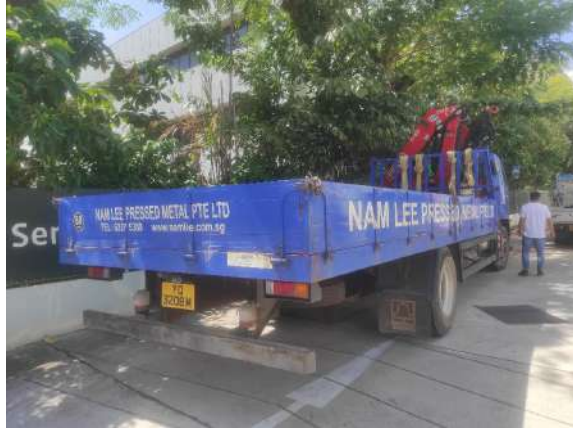
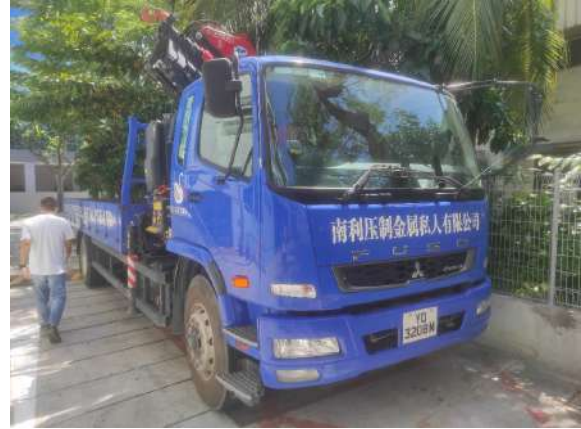
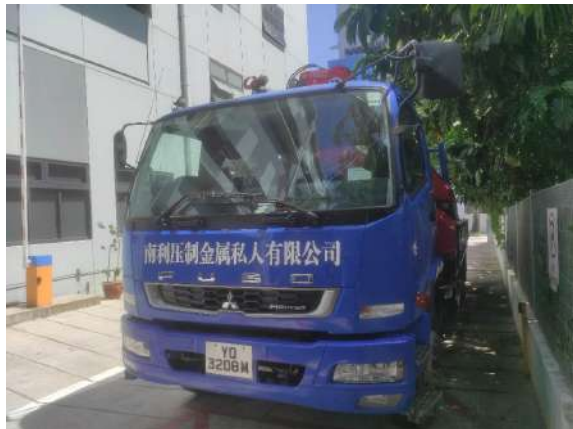
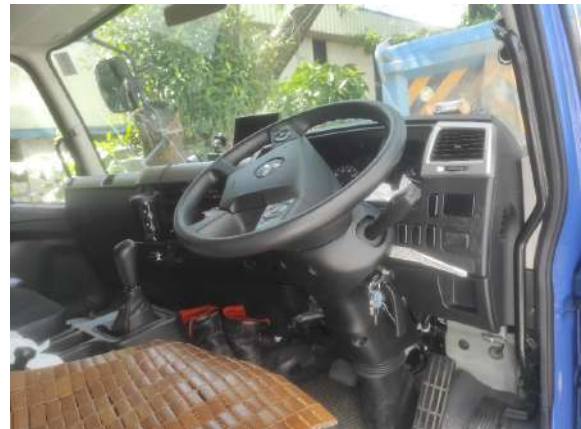
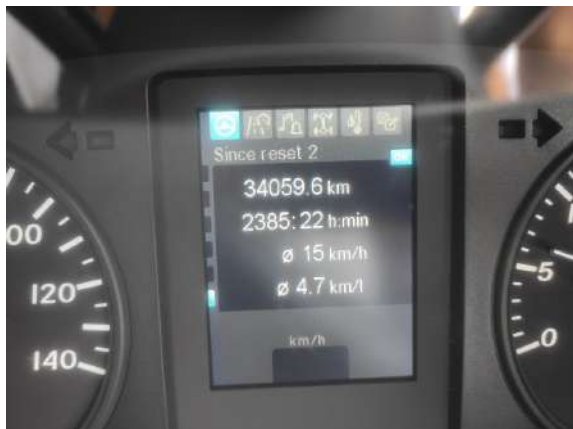
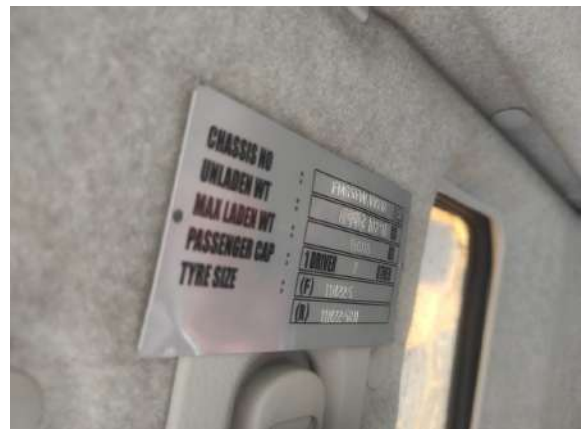
### INSPECTION

| Affiliated to Federation Internationale Des Experts En Automobile | | | | |
|---|---|---|---|--|
| THE VEHICLE SUSTAINED DAMAGES AT THE FRONT PORTION.<br>DAMAGES SEE DETAILS. | | | | |
