LKK Auto Consultants Pte Ltd

TAX INVOICE

ADJUSTMENT ON REPAIR COST FOR VEHICLE NO. GBF 8498P

PHOTOGRAPHS FOR VEHICLE NO. GBF 8498P

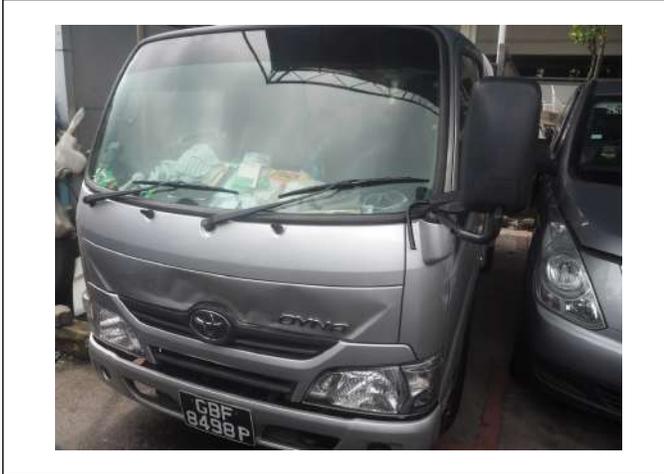
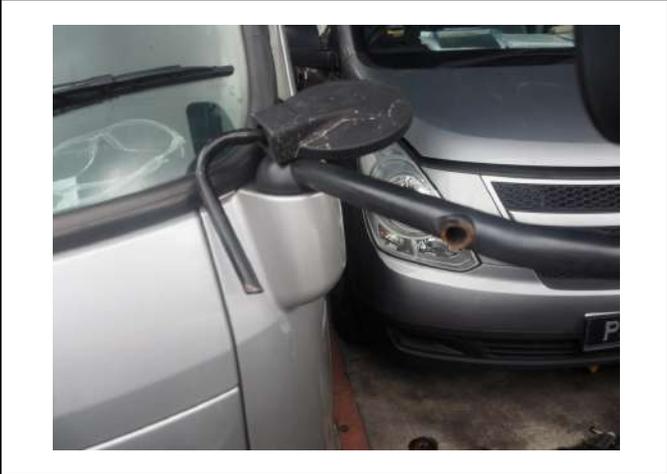
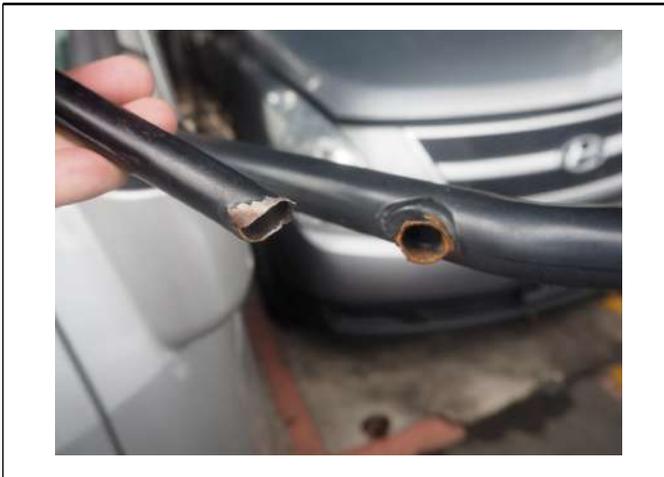
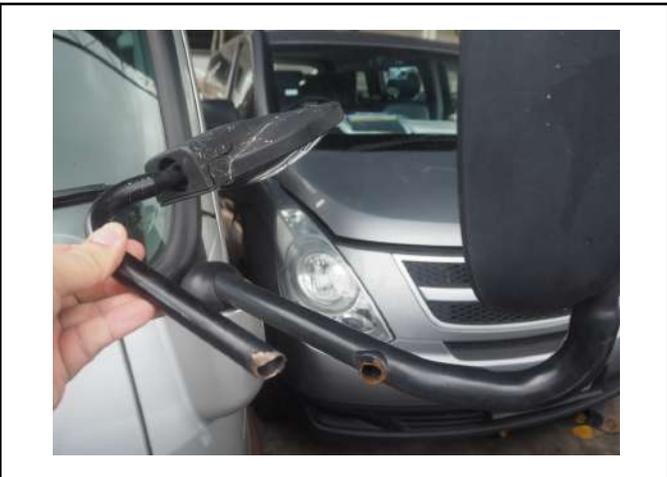
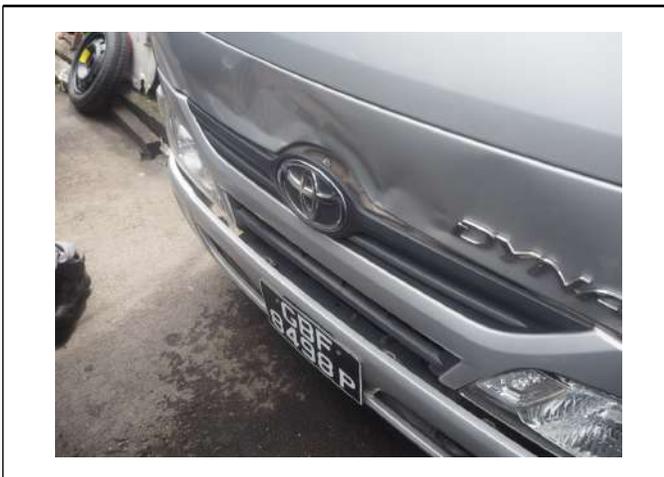
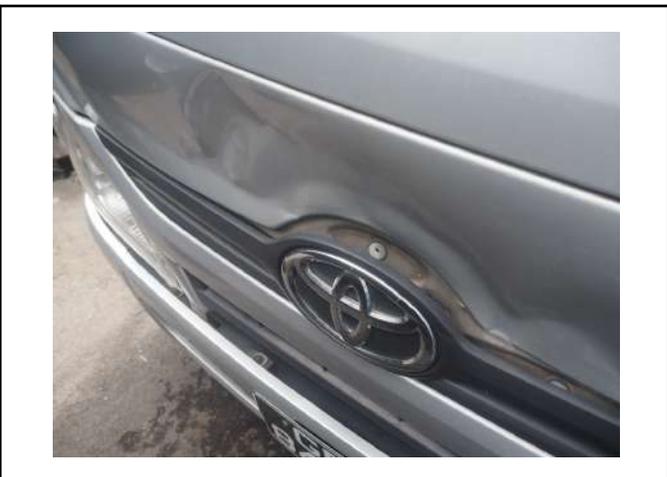
INSPECTION

THE VEHICLE SUSTAINED DAMAGES AT THE FRONT PORTION.
DAMAGES SEE DETAILS.

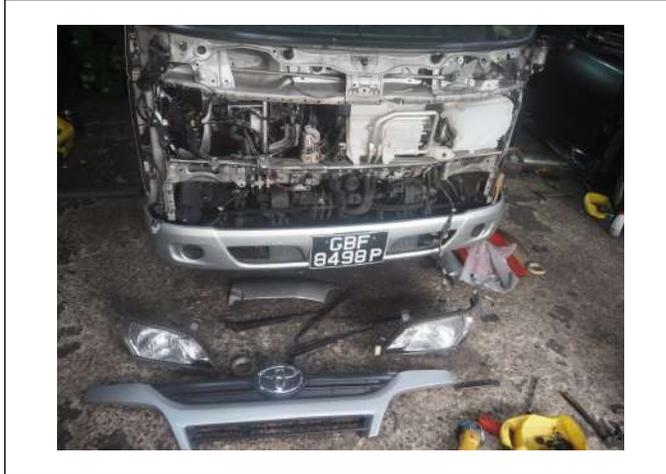
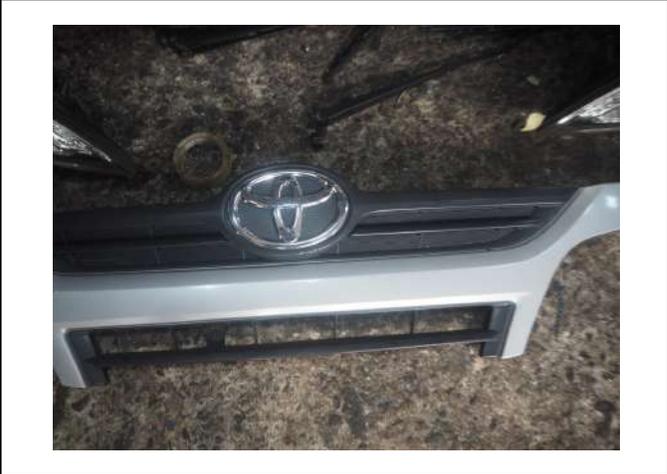
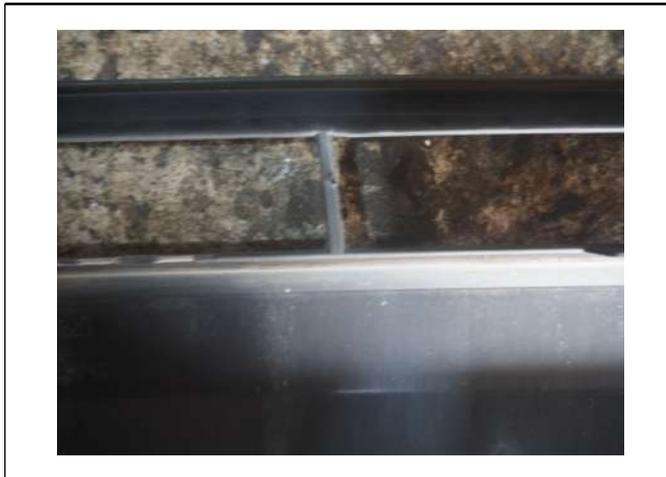
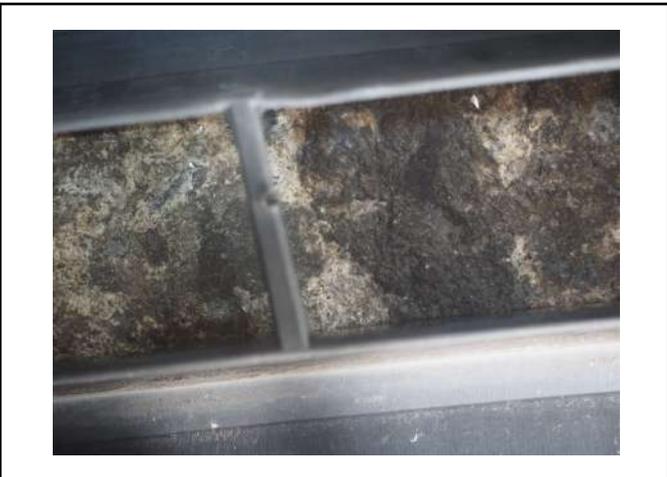
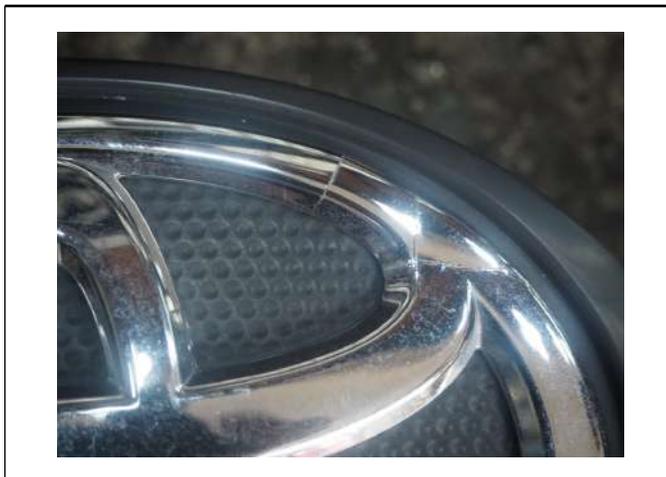
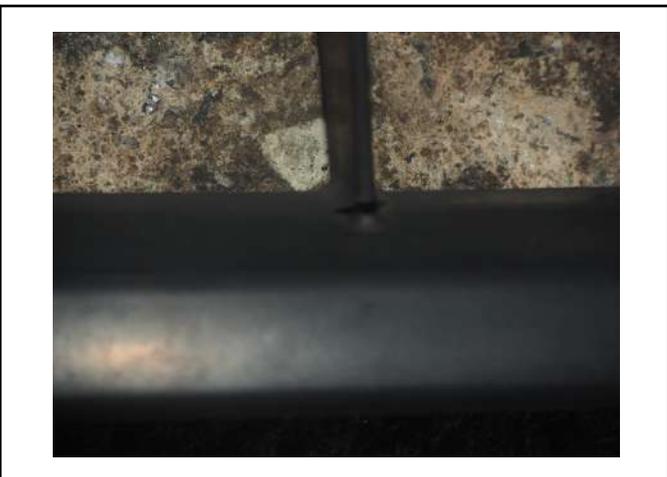
RE-INSPECTION

PHOTOGRAPHS FOR VEHICLE NO. GBF 8498P
