## LKK Auto Consultants Pte Ltd

Vehicle No. SJB 9330J  
Insured Veh. SGW 1383J  
Claim No. SNM21D207394/C02  
Policy No. DMPCSNW00246322100  
Accident Date 18/12/2021  
Inspection Date 20/12/2021

## ADJUSTMENT ON REPAIR COST FOR VEHICLE NO. SJB 9330J

### PHOTOGRAPHS FOR VEHICLE NO. SJB 9330J

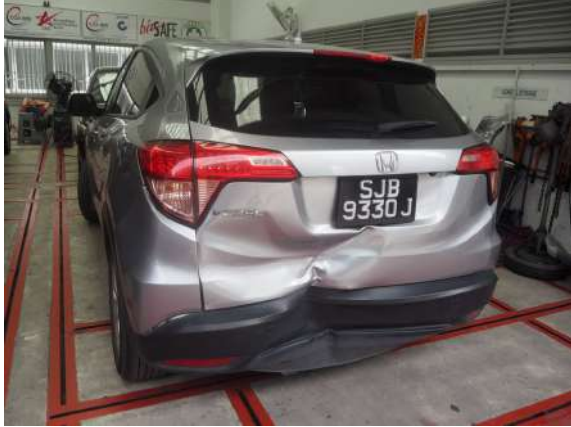
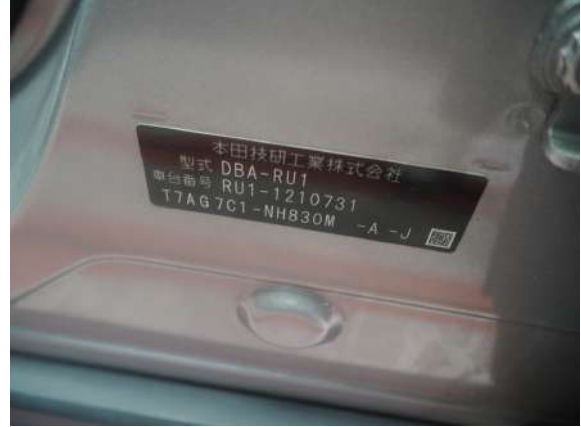
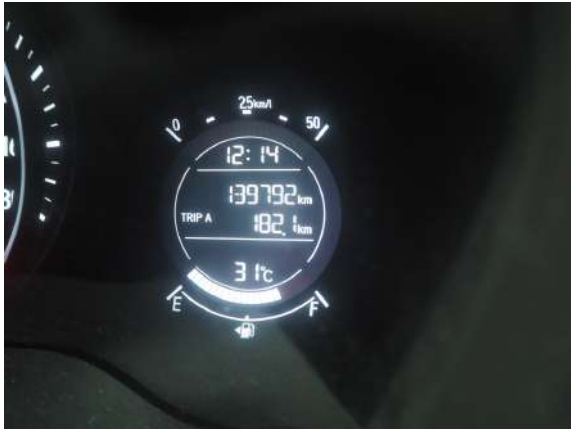
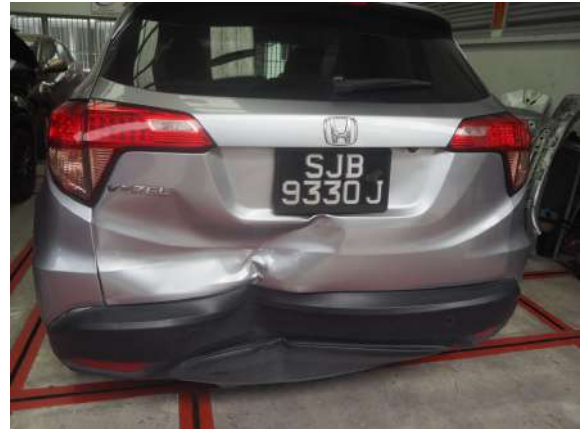
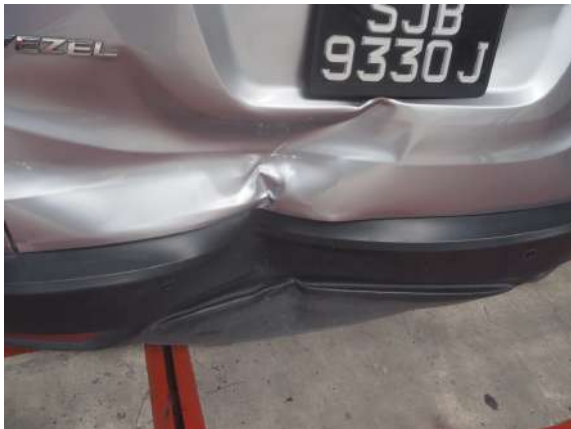
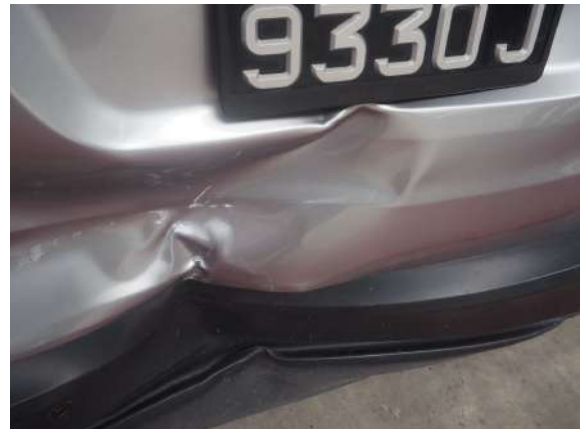
### INSPECTION

| Affiliated to Federation Internationale Des Experts En Automobile | | | | |
|---|---|---|---|--|
| THE VEHICLE SUSTAINED DAMAGES AT THE REAR PORTION.<br><br>DAMAGES SEE DETAILS. | | | | |
