Vehicle No. SHD 3519K  
Insured Veh. GY 353S  
Claim No. SNM21D207440/C02  
Policy No. DMCVSNW0013442105  
Accident Date 19/12/2021  
Inspection Date 22/12/2021

## ADJUSTMENT ON REPAIR COST FOR VEHICLE NO. SHD 3519K

### PHOTOGRAPHS FOR VEHICLE NO. SHD 3519K

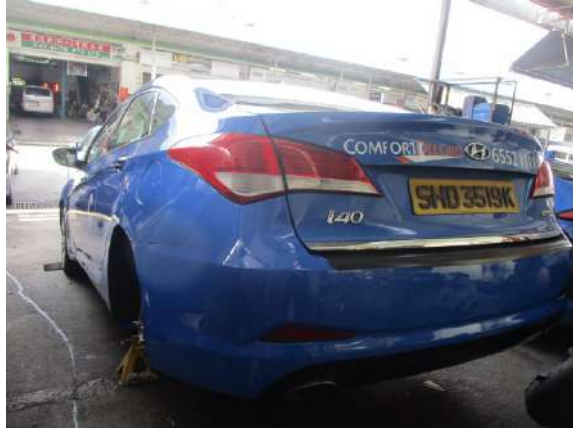
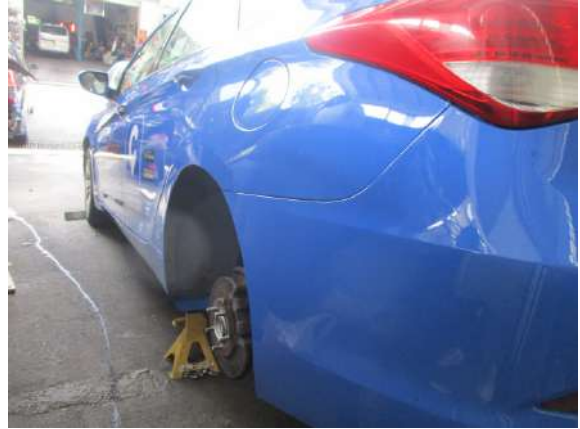
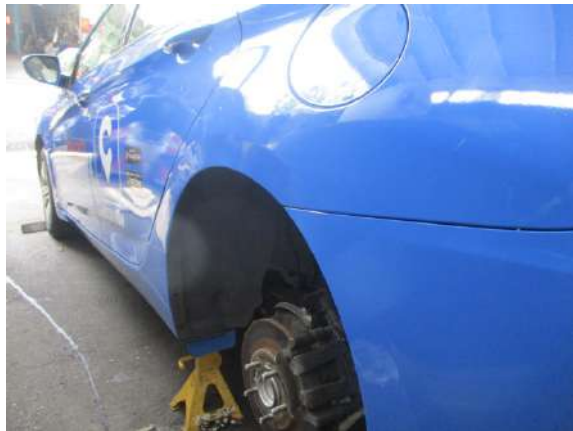
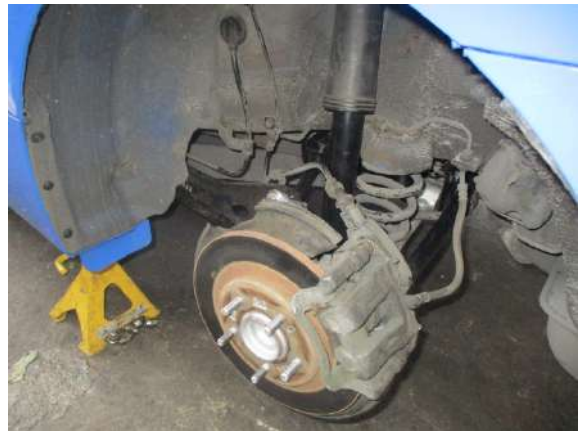
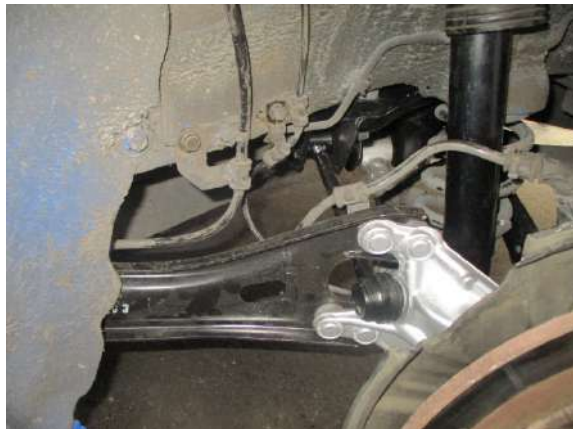
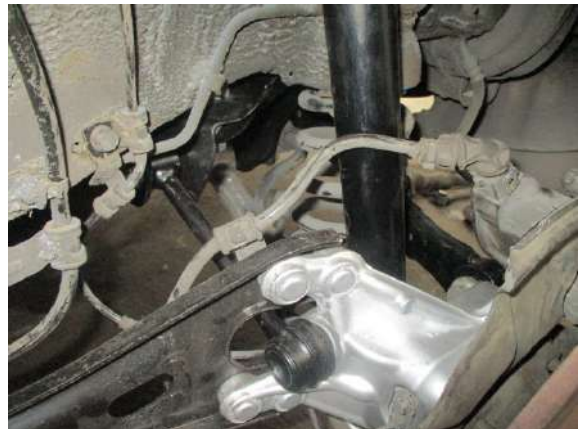
**PHOTOGRAPHS FOR VEHICLE NO. SHD 3519K**

**RE-INSPECTION**

| Affiliated to Federation Internationale Des Experts En Automobile | | | | |
|---|---|---|---|--|
| THE VEHICLE SUSTAINED DAMAGES AT THE N/S BODY.<br><br>DAMAGES SEE DETAILS. | | | | |
