## LKK Auto Consultants Pte Ltd

## ADJUSTMENT ON REPAIR COST FOR VEHICLE NO. SMN 3804A

### PHOTOGRAPHS FOR VEHICLE NO. SMN 3804A

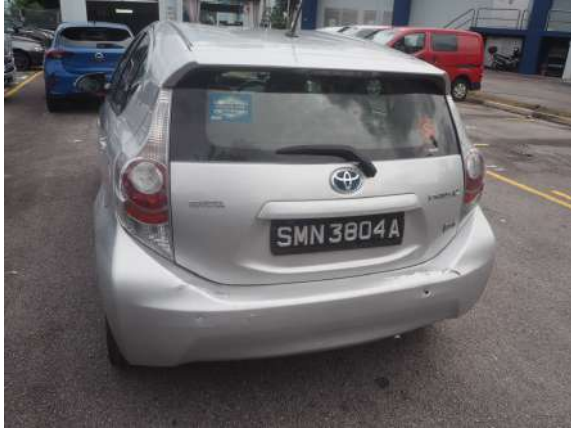
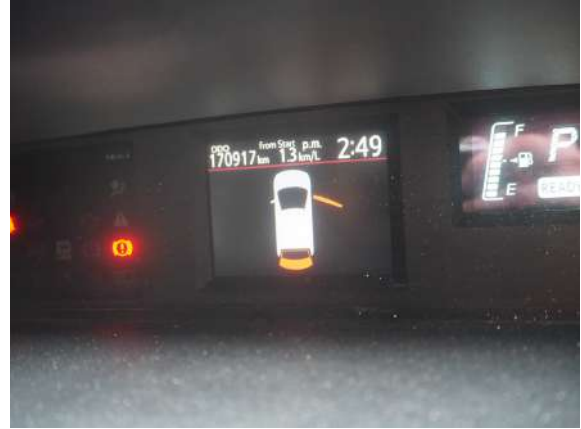
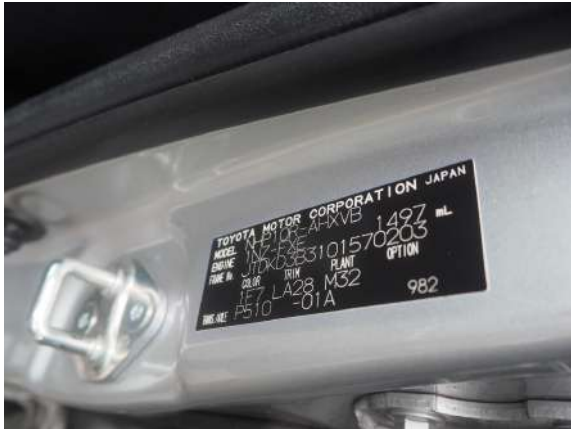
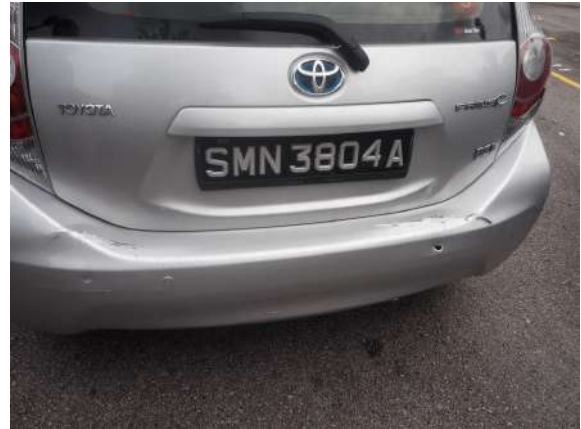
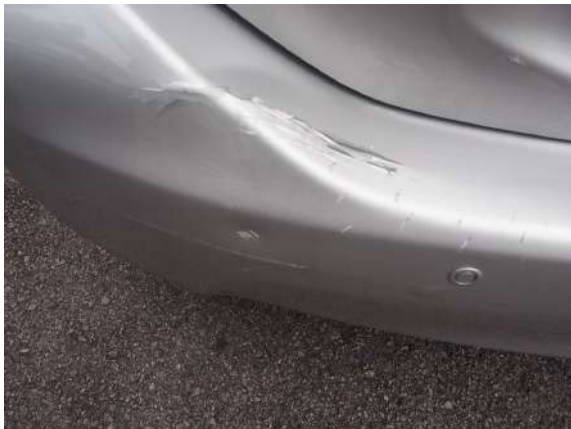
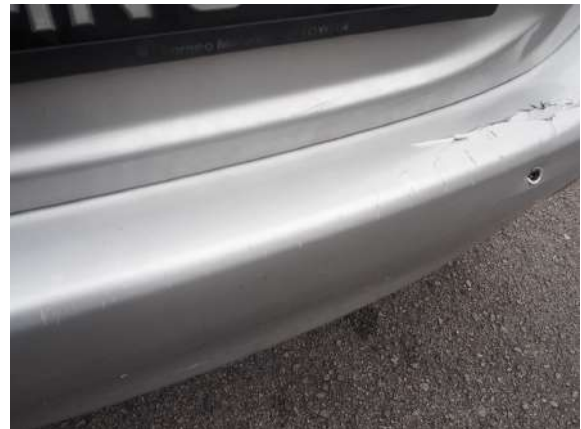
### INSPECTION

| Affiliated to Federation Internationale Des Experts En Automobile | | | | |
|---|---|---|---|--|
| THE VEHICLE SUSTAINED DAMAGES AT THE FRONT AND REAR PORTION.<br>DAMAGES SEE DETAILS. | | | | |

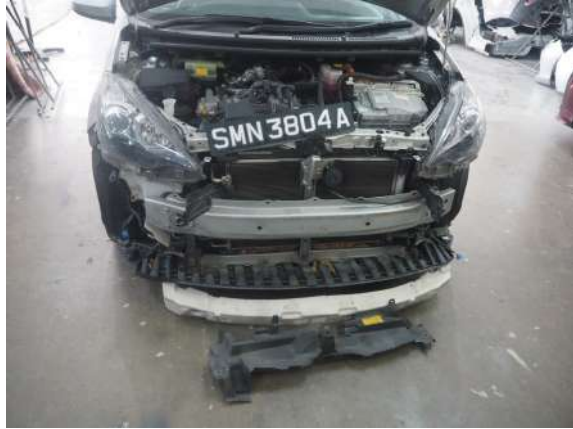
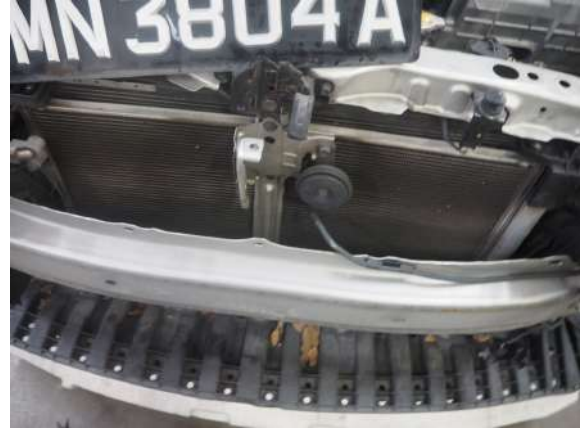
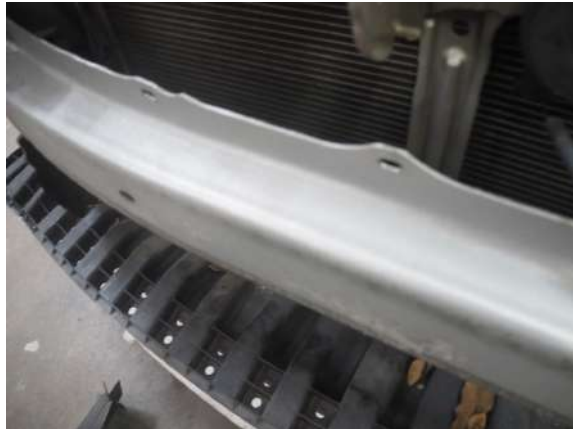
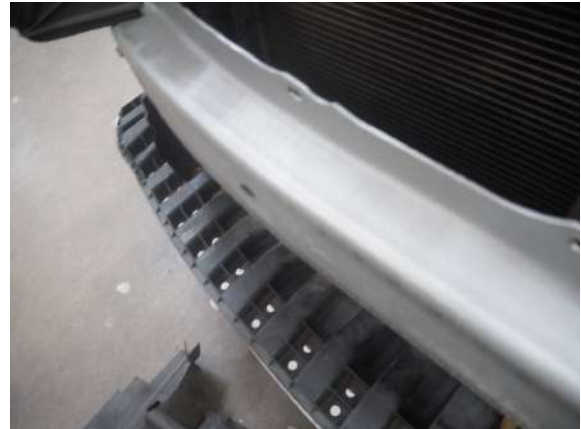
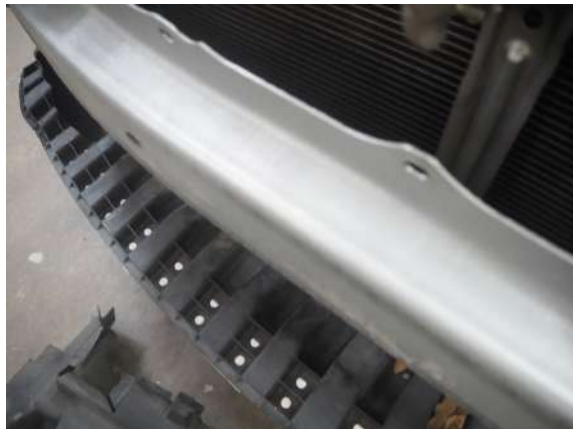
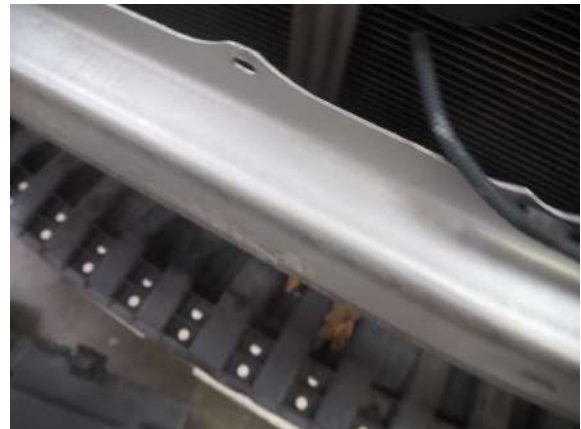
**PHOTOGRAPHS FOR VEHICLE NO. SMN 3804A**

**RE-INSPECTION**
