## LKK Auto Consultants Pte Ltd

### PROFESSIONAL SERVICE FEE

Vehicle No. SMA 4621Y

### ADJUSTMENT ON REPAIR COST FOR VEHICLE NO. SMA 4621Y

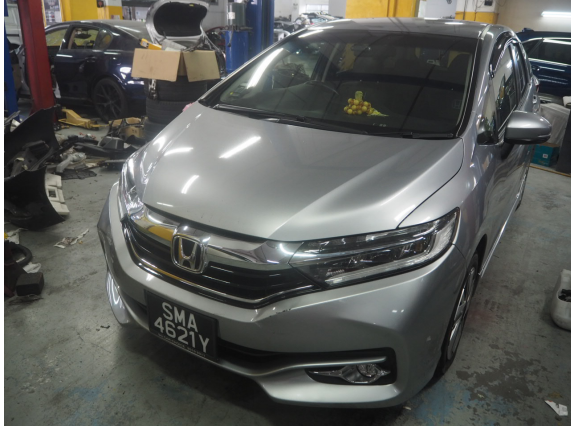
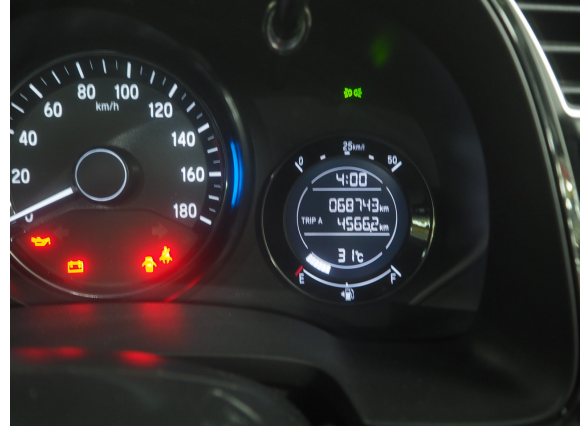
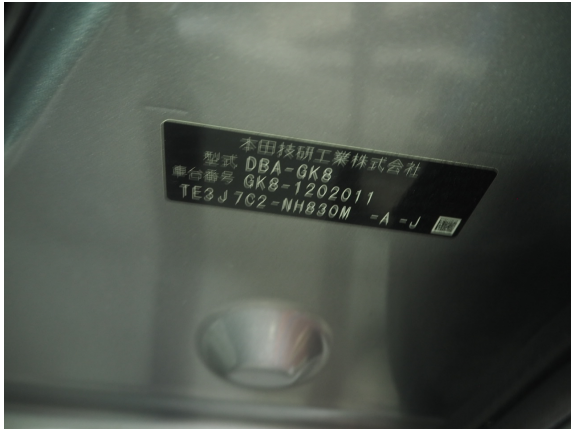
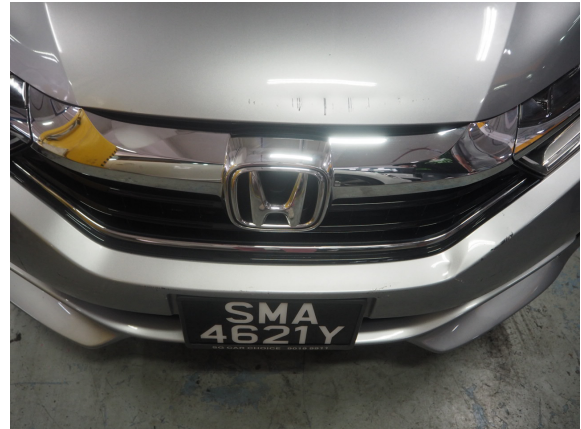
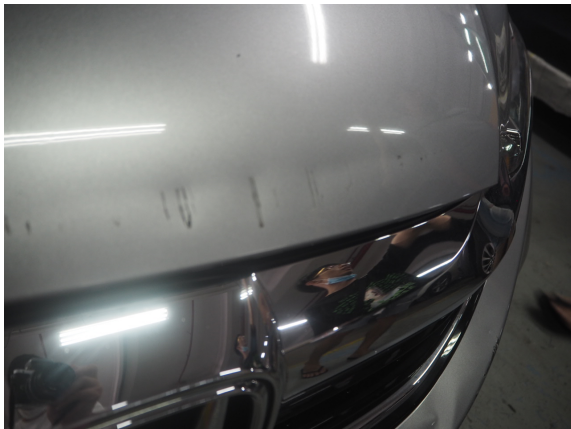
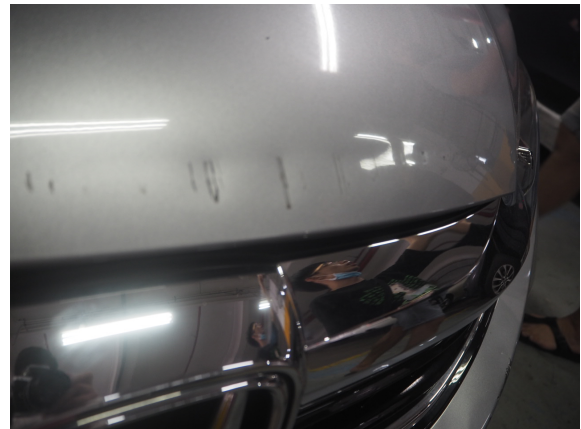
### INSPECTION

### PHOTOGRAPHS FOR VEHICLE NO. SMA 4621Y

| Affiliated to Federation Internationale Des Experts En Automobile | | | | |
|---|---|---|---|---|
| | THE VEHICLE SUSTAINED DAMAGES AT THE FRONT PORTION.<br><br>DAMAGES SEE DETAILS. | | | |

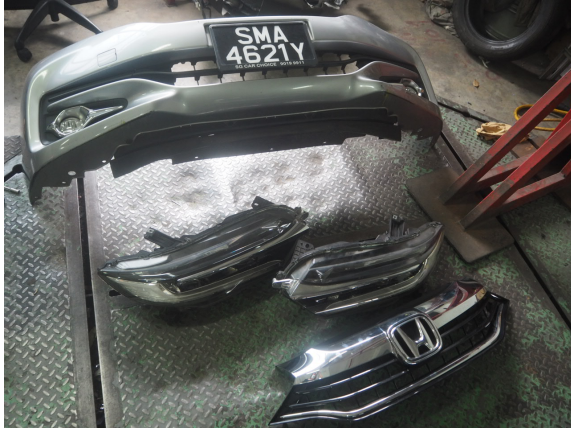
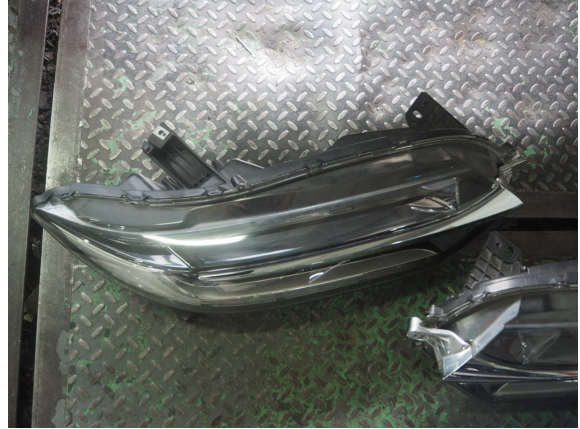
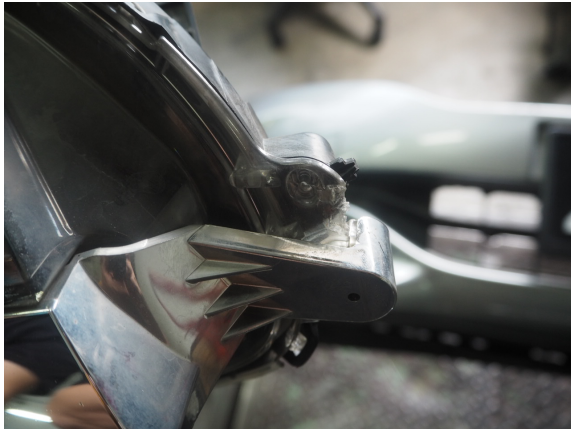
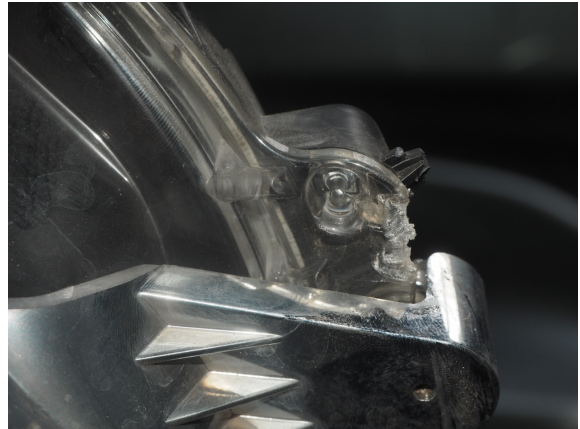
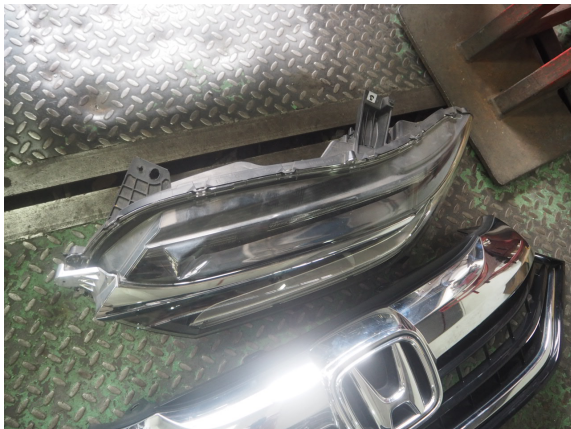
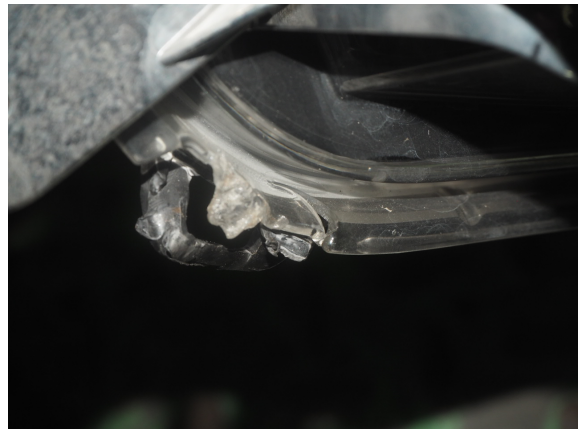
RE-INSPECTION

PHOTOGRAPHS FOR VEHICLE NO. SMA 4621Y
