### ADJUSTMENT ON REPAIR COST FOR VEHICLE NO. SJN 8576K

**PHOTOGRAPHS FOR VEHICLE NO. SJN 8576K**

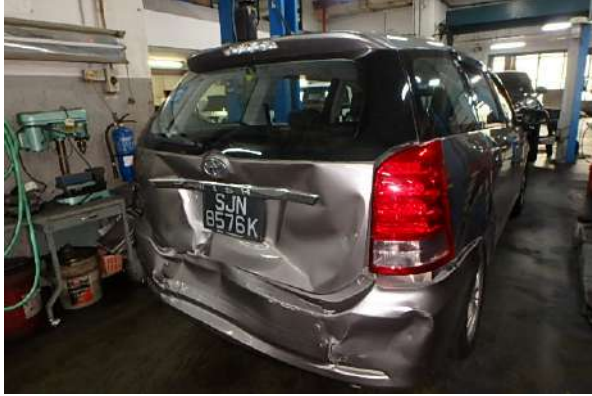
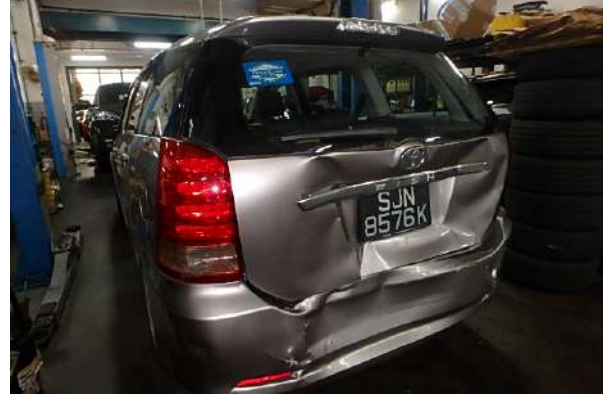
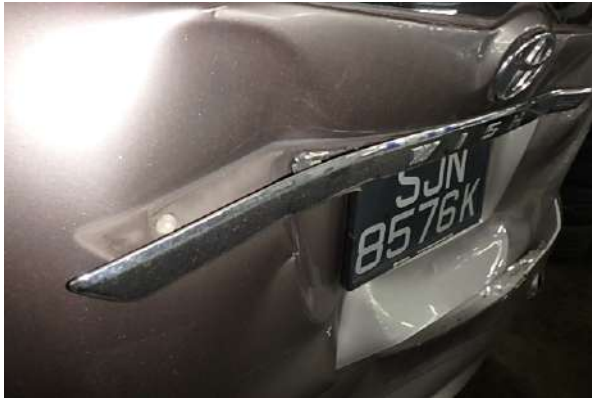
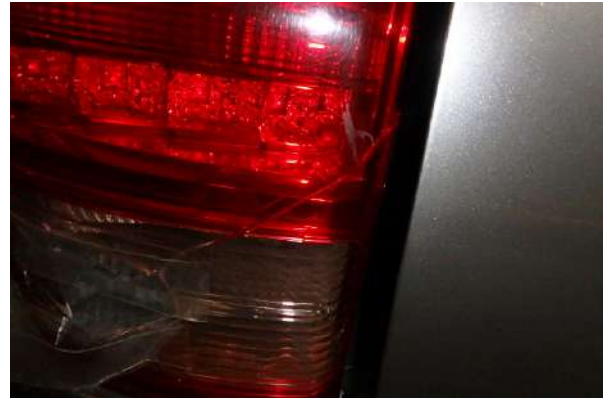
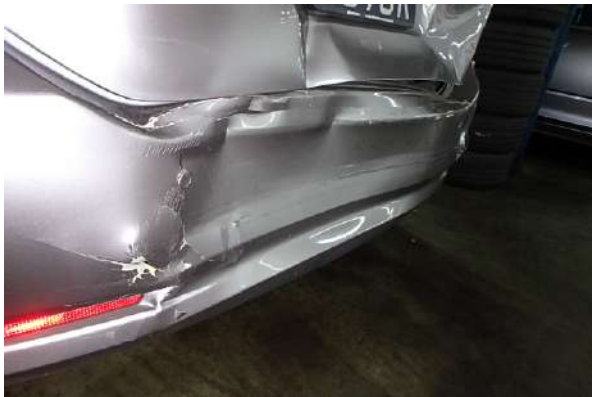
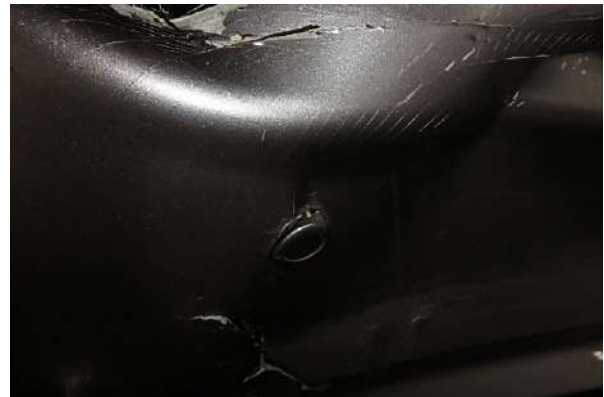
| Affiliated to Federation Internationale Des Experts En Automobile | | | | |
|---|---|---|---|--|
| THE VEHICLE SUSTAINED DAMAGES AT THE REAR AND FRONT PORTION.<br>DAMAGES SEE DETAILS. | | | | |

**INSPECTION**
