LKK Auto Consultants Pte Ltd

Vehicle No. SKN 355Y
Insured Veh. YP 4451A
Claim No. 21/21/22/VC00/025286
Policy No. Z/21/VC00/112234
Accident Date 23/12/2021
Inspection Date 27/12/2021

4. Description of Damages

PHOTOGRAPHS FOR VEHICLE NO. SKN 355Y

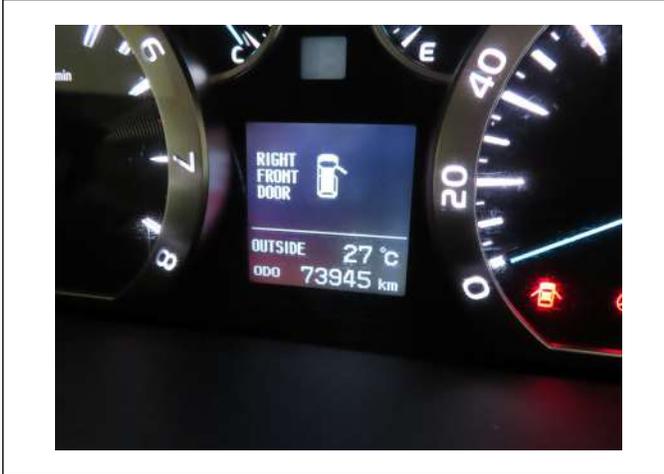
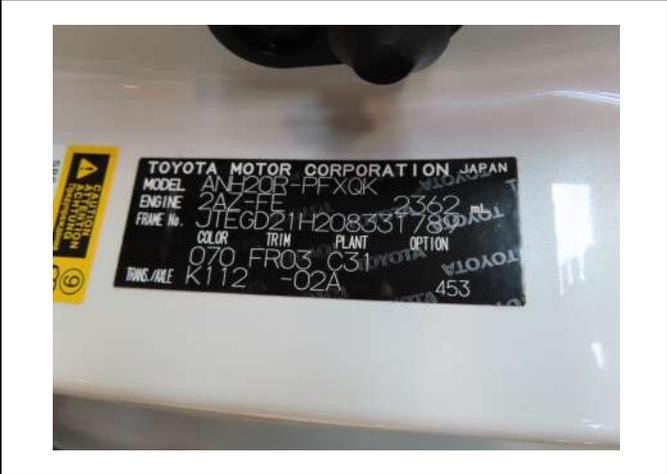
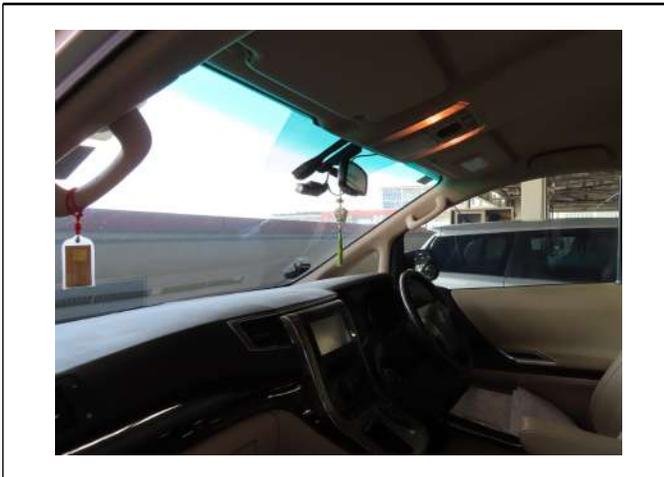
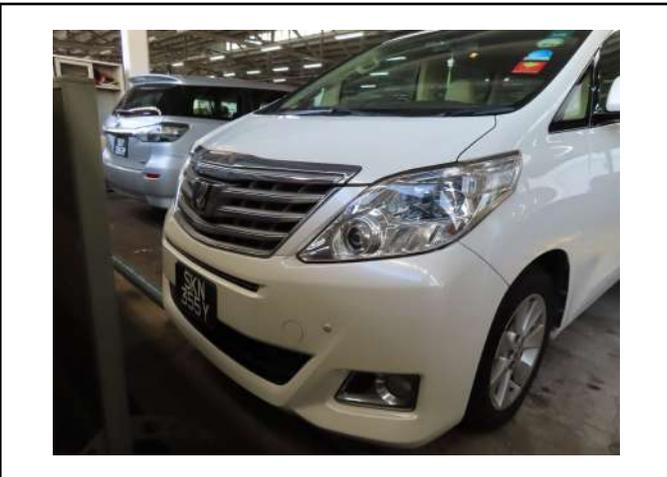
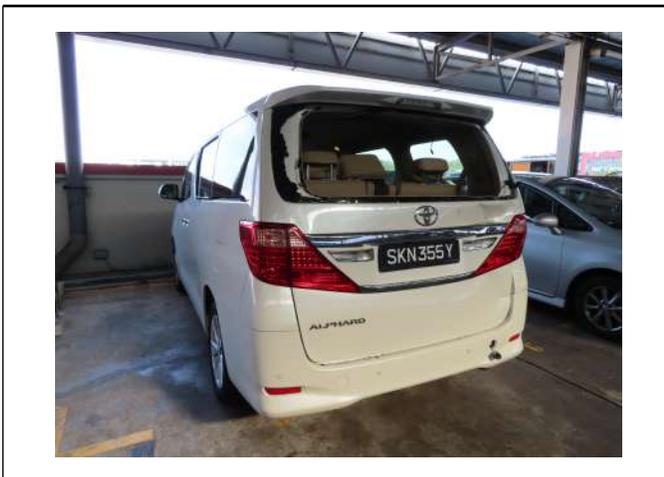
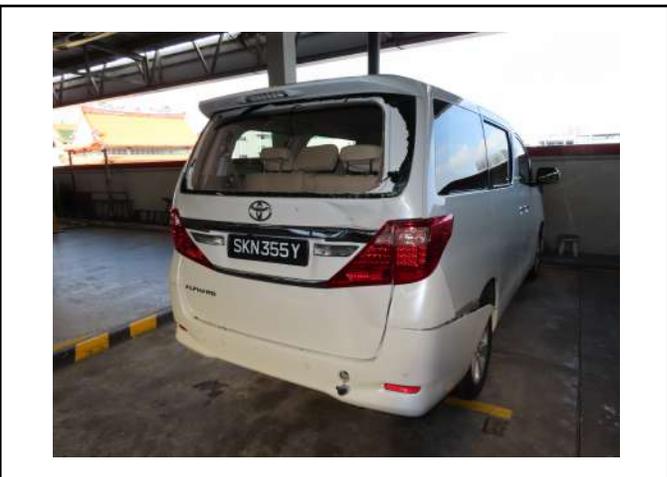
INSPECTION

THE VEHICLE SUSTAINED DAMAGES AT THE REAR PORTION AND REAR WINDSCREEN SHATTERED.
DAMAGES SEE DETAILS.

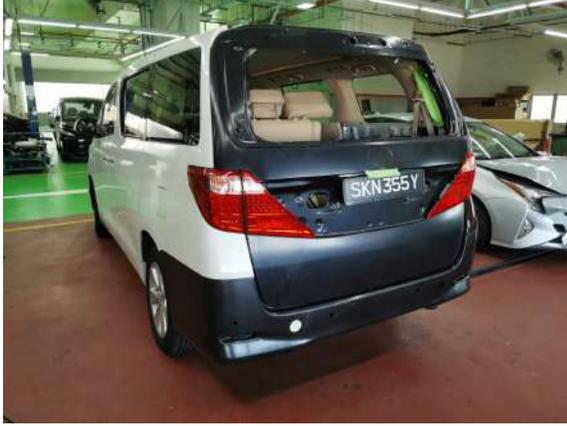
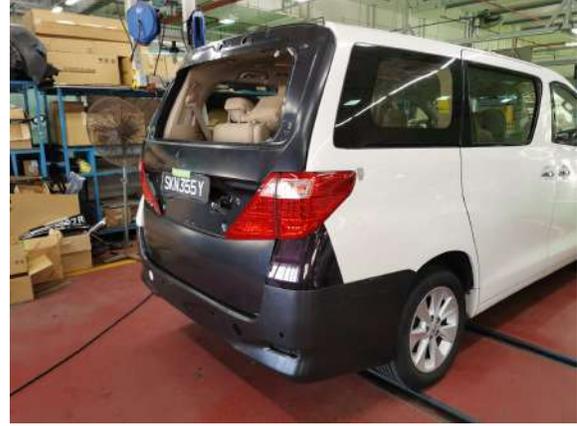
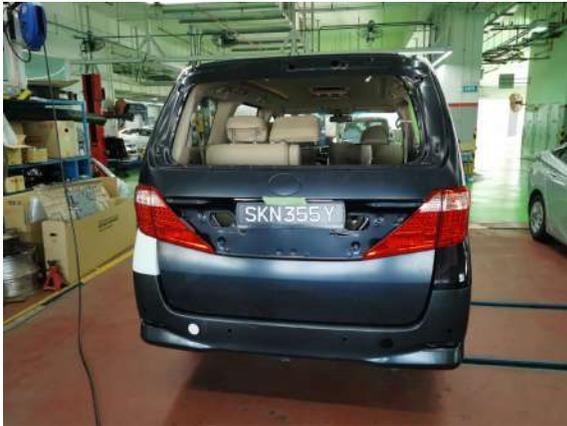
PHOTOGRAPHS FOR VEHICLE NO. SKN 355Y

RE-INSPECTION
