# Tommie Lim Appraisal

## VEHICLE INSPECTION REPORT

Vehicle number	: SJB1953P	Registration date	: 3 Jan 2008
Make	: PORSCHE	Chassis number	: WPOZZZ98Z8U751028
Model	: CAYMAN TIPTRONIC	Engine number	: 65804057
Body colour	: BLACK	Engine capacity	: 2687 CC
Odometer	: 123255 KM	Transmission	: AUTOMATIC

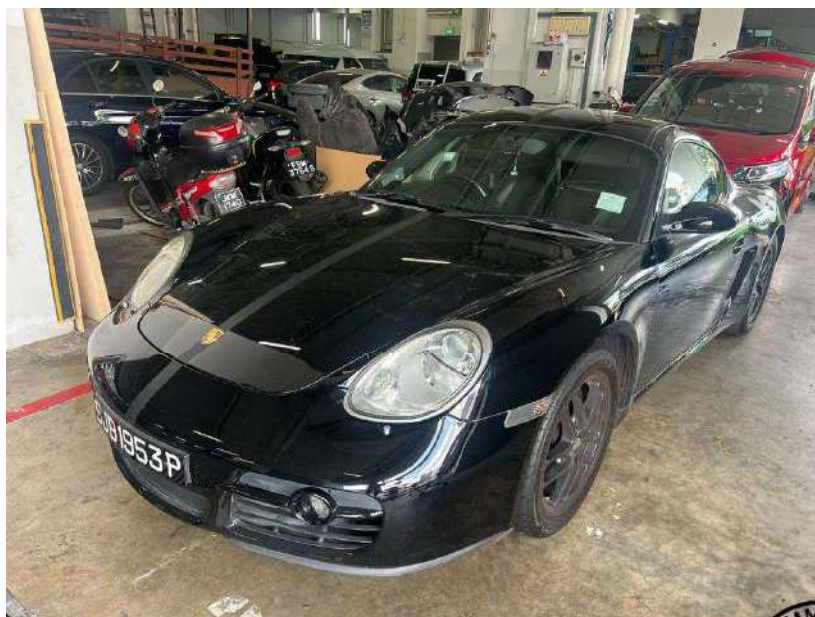
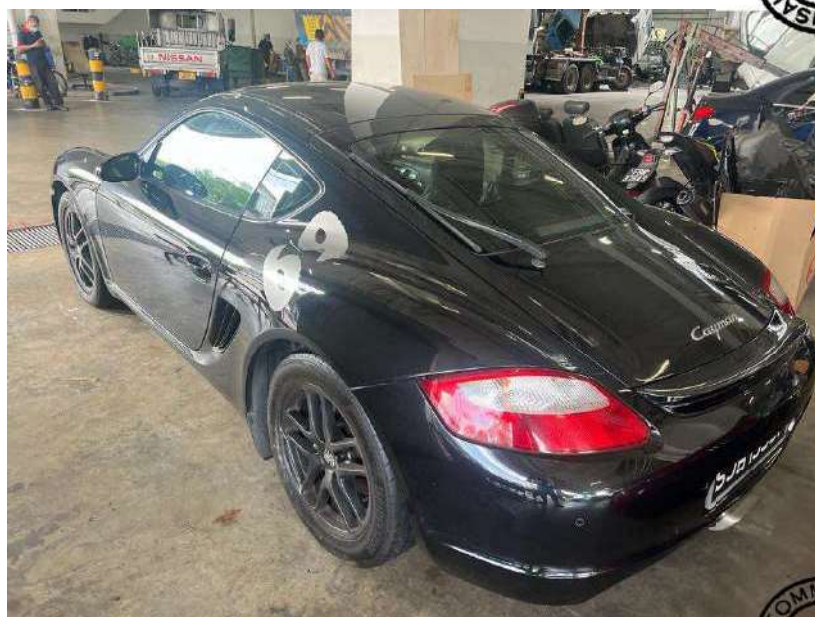
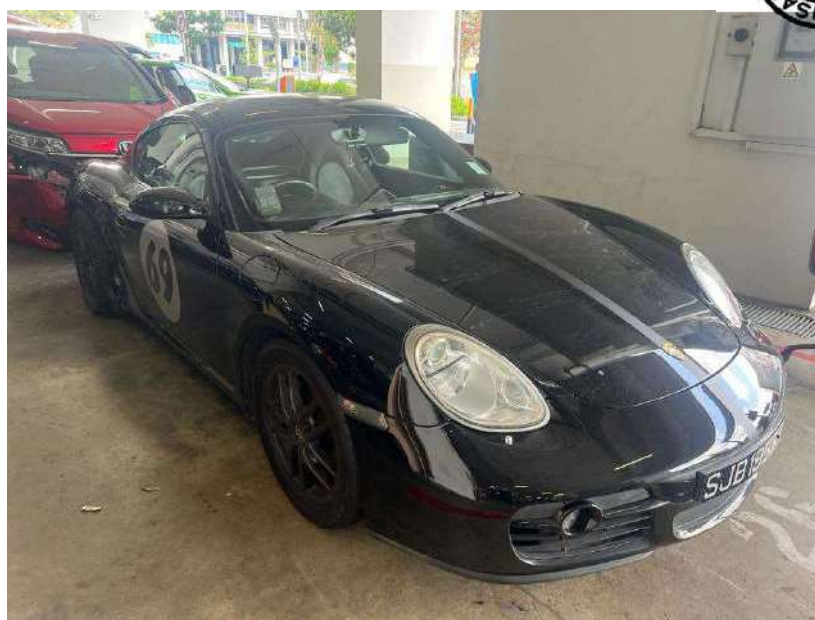
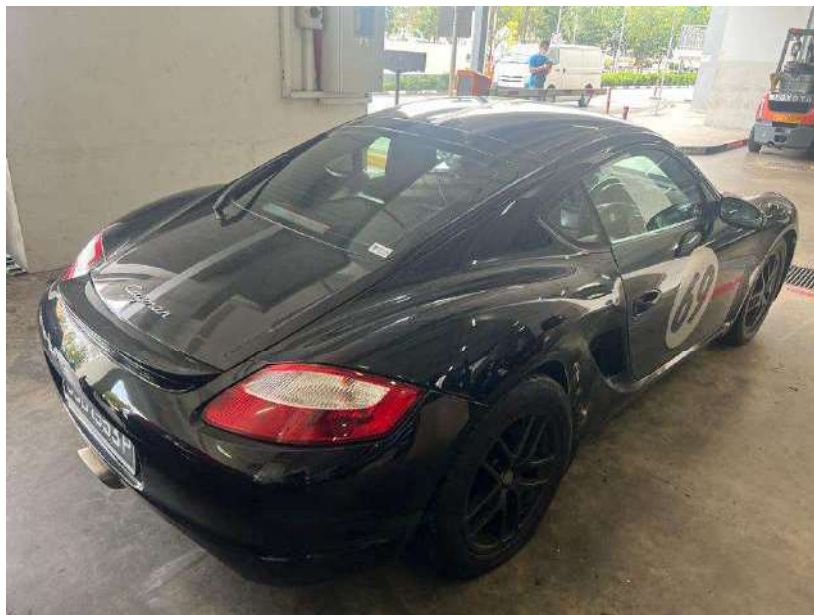
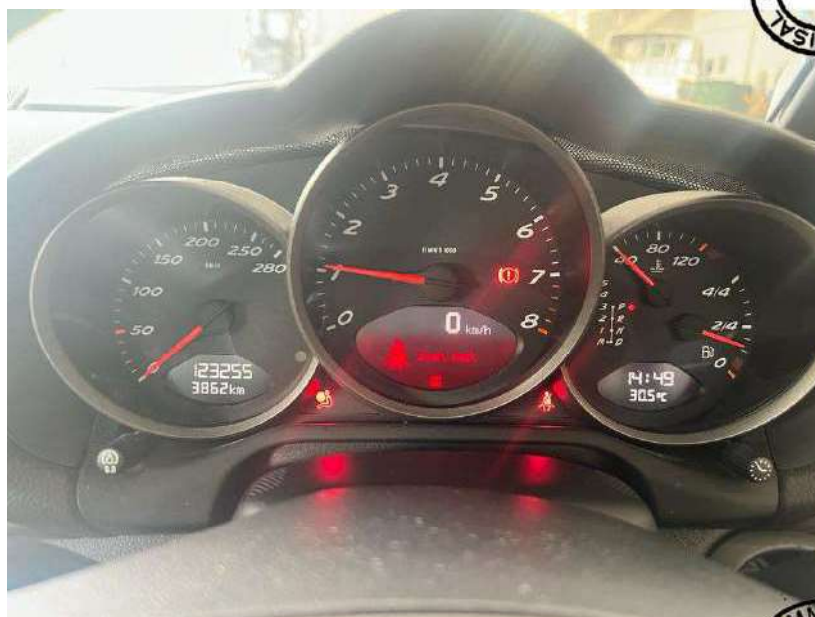
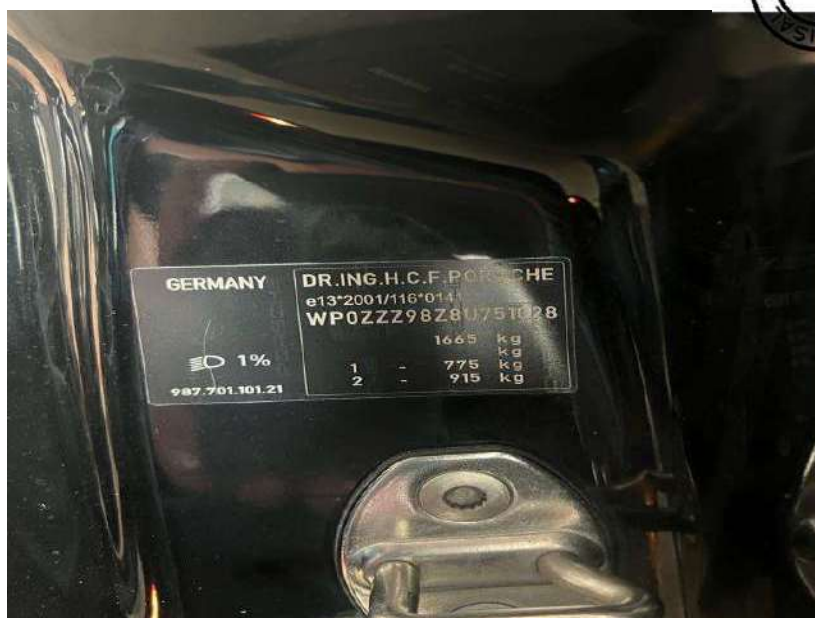
The impact of the collision has damaged/affected the rear bumper, rear o/s fender, front o/s door, front o/s wind mirror, rear o/s rim, rear o/s undercarriage and etc...

Please refer to Annex A and Annex B (Appraisalment Schedule) for a detailed account of the damages and photographs taken.
