PERFECT AUTOMOBILE APPRAISAL SERVICES

THIRD PARTY CLAIM

REGN PLATE	: SGT 6120 J	COLOUR	: Blue
MAKE & MODEL	: Mitsubishi Lancer 1.6A	GEN BODY WORK	: Good
YEAR REGN	: 2007	AUDIO PLAYER	: Yes
ENG CAPACITY	: 1584cc	AIR CONDITIONER	: Yes
ENGINE NO.	: 4G18HY3676	STEERING	: Affected
CHASSIS NO	: JMSTCS3A7U009699	HAND BRAKE	: Serviceable
MILEAGE	: 173491Km	FOOT BRAKE	: Serviceable

GENERAL DESCRIPTION OF DAMAGES :

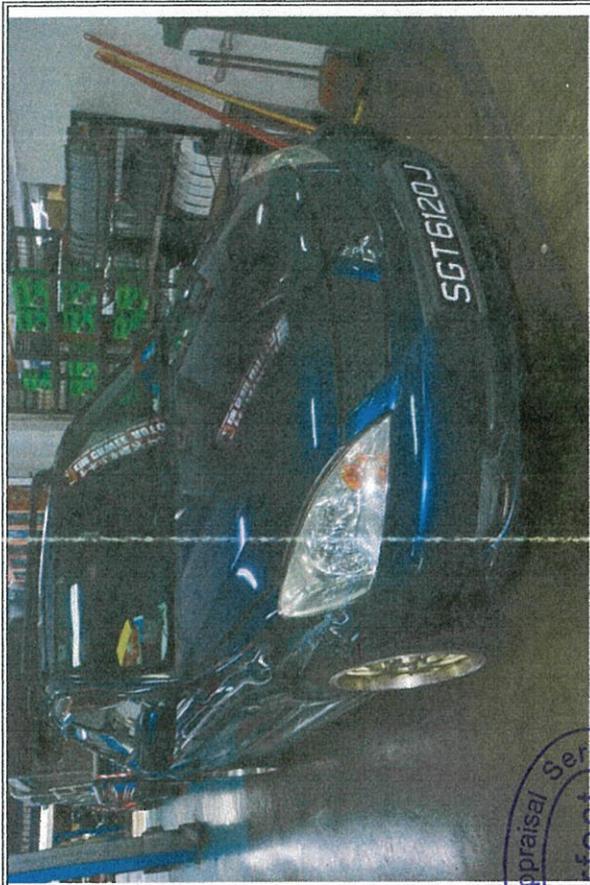
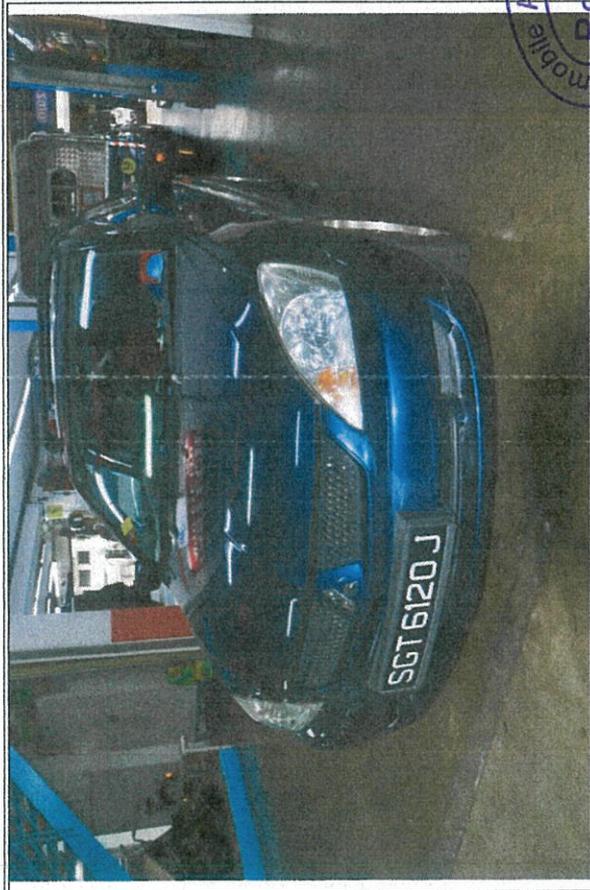
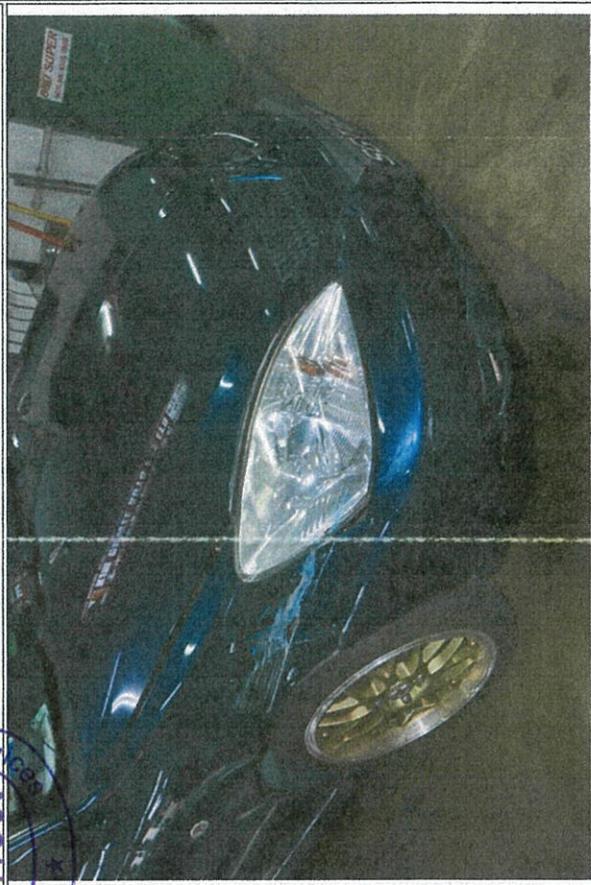
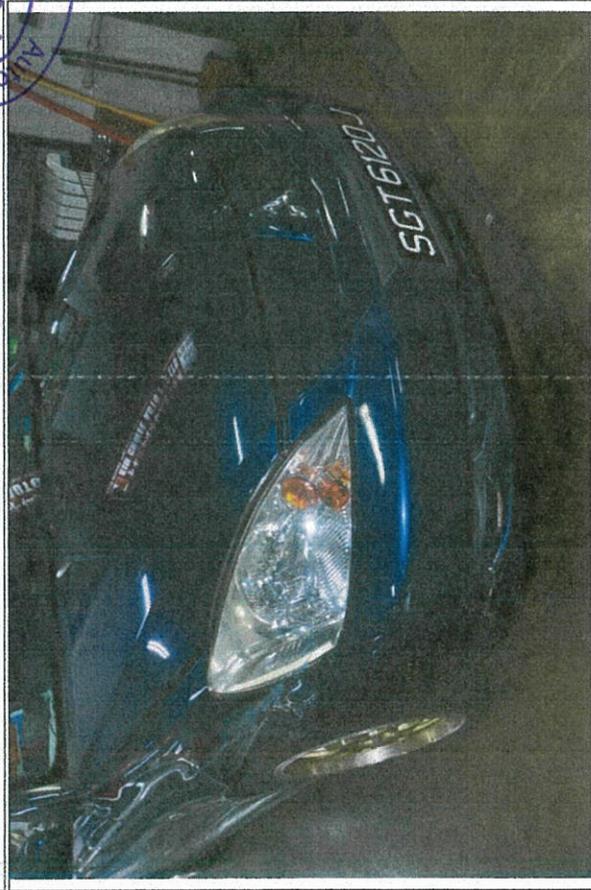
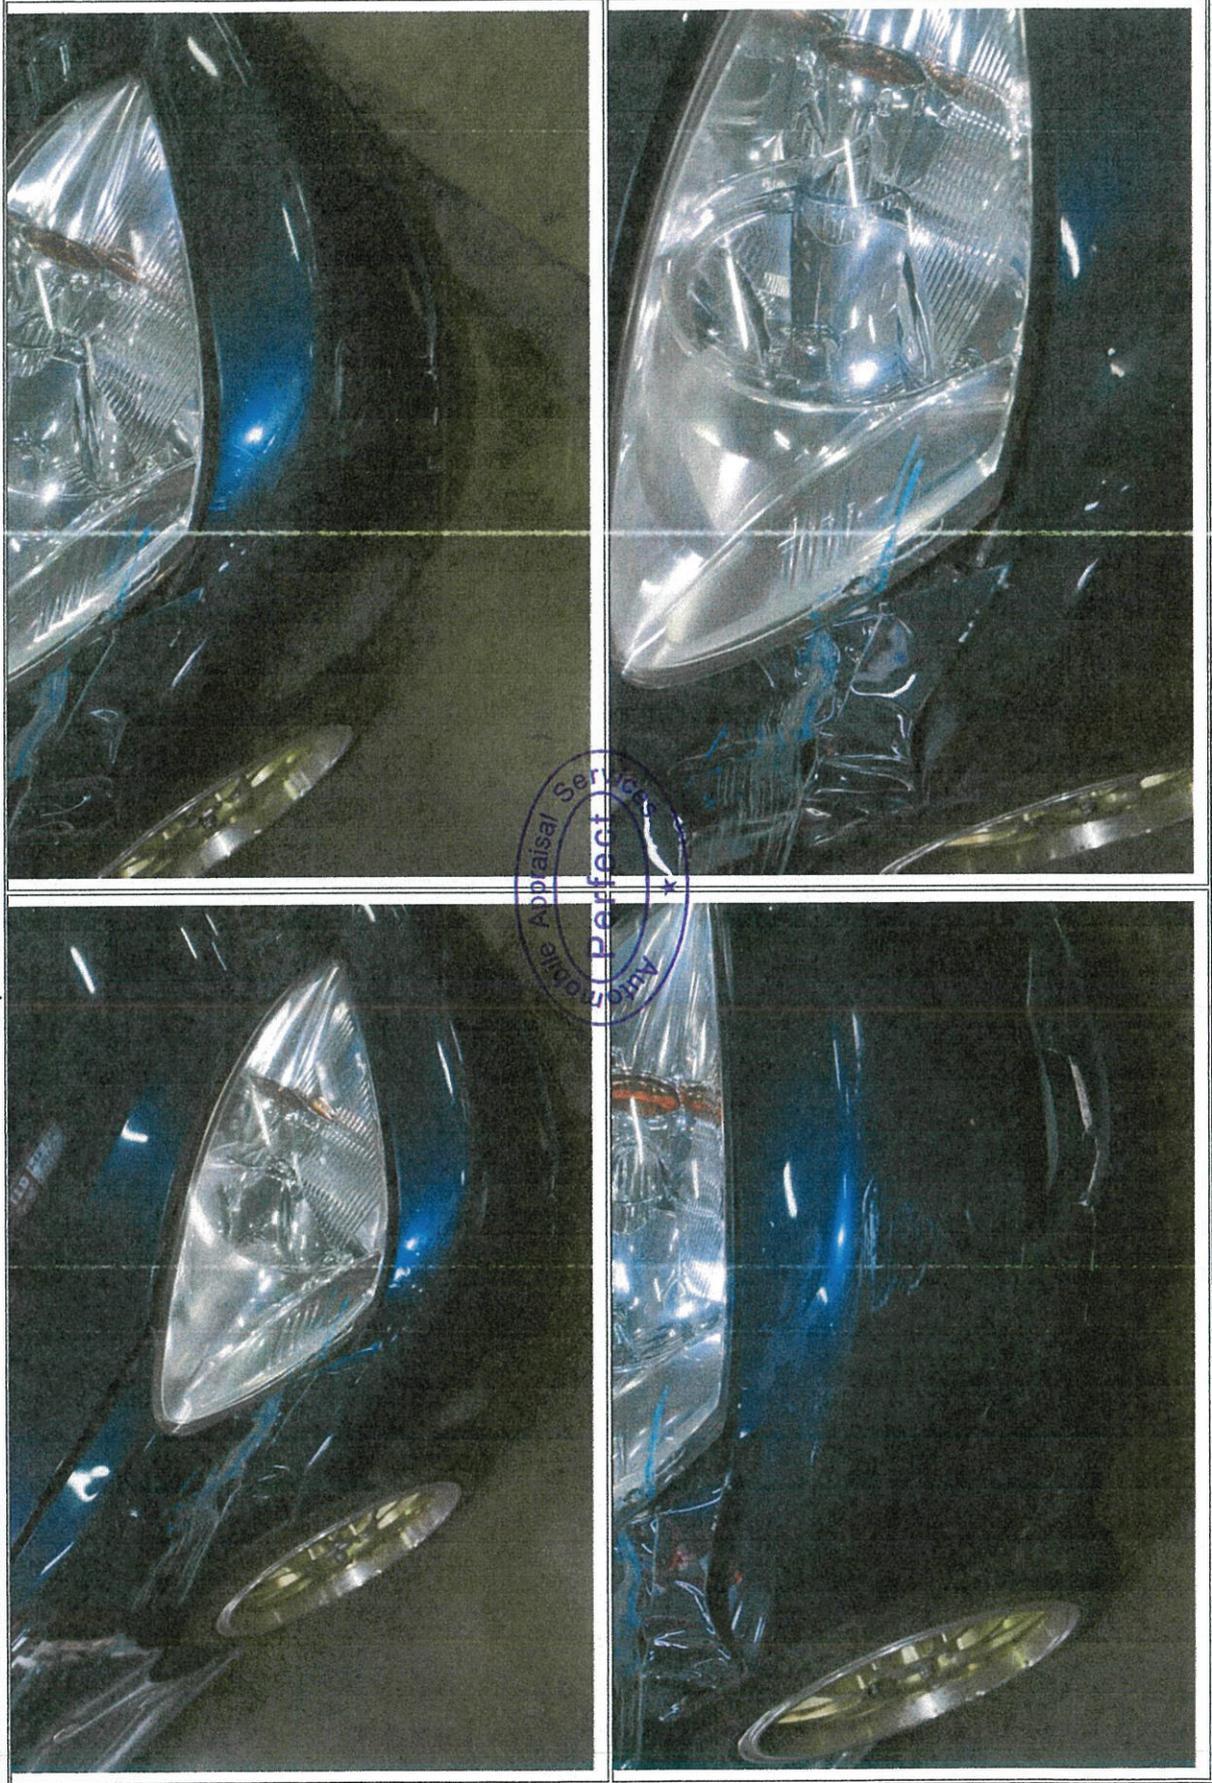
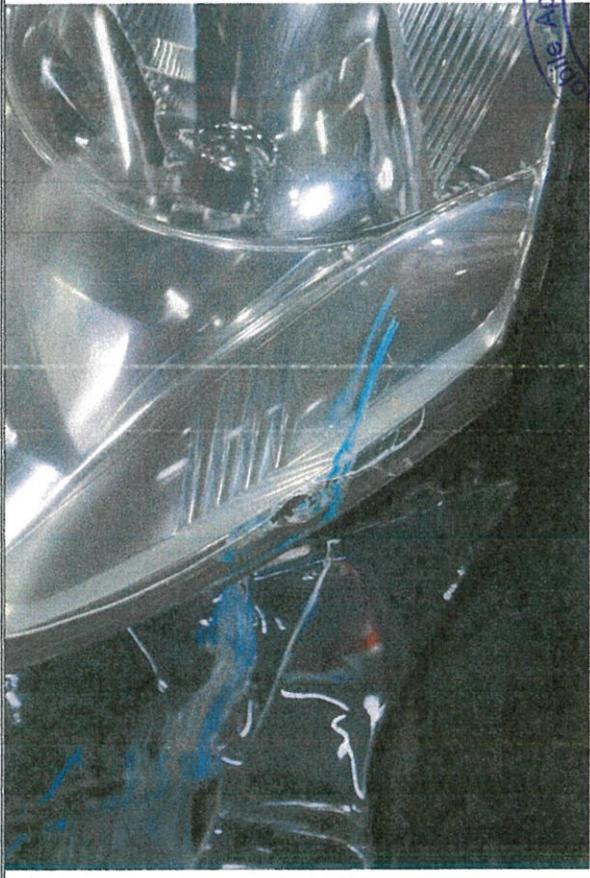
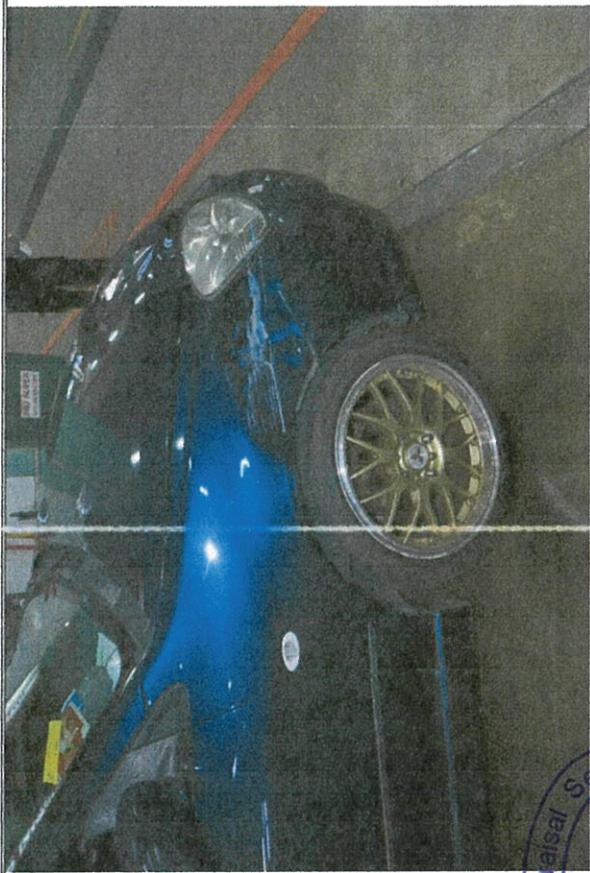
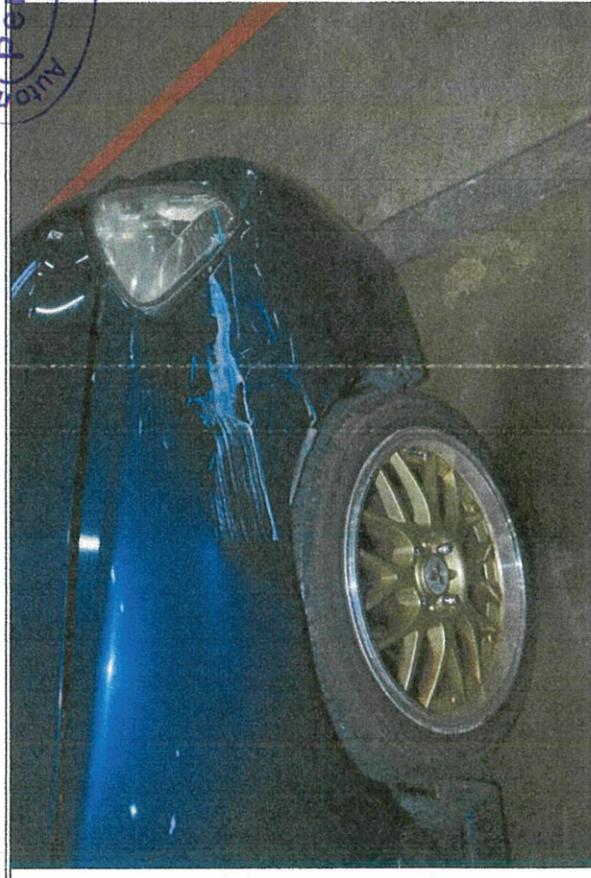
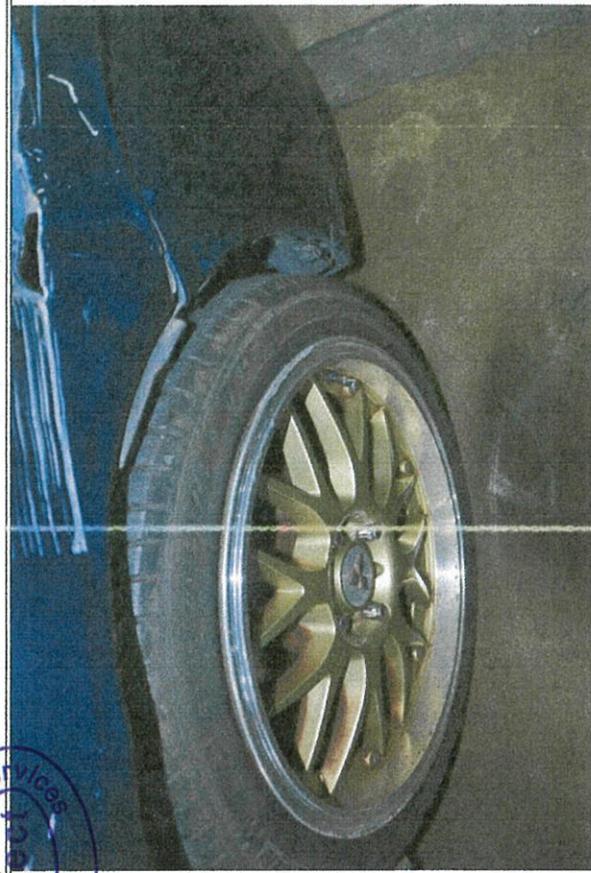
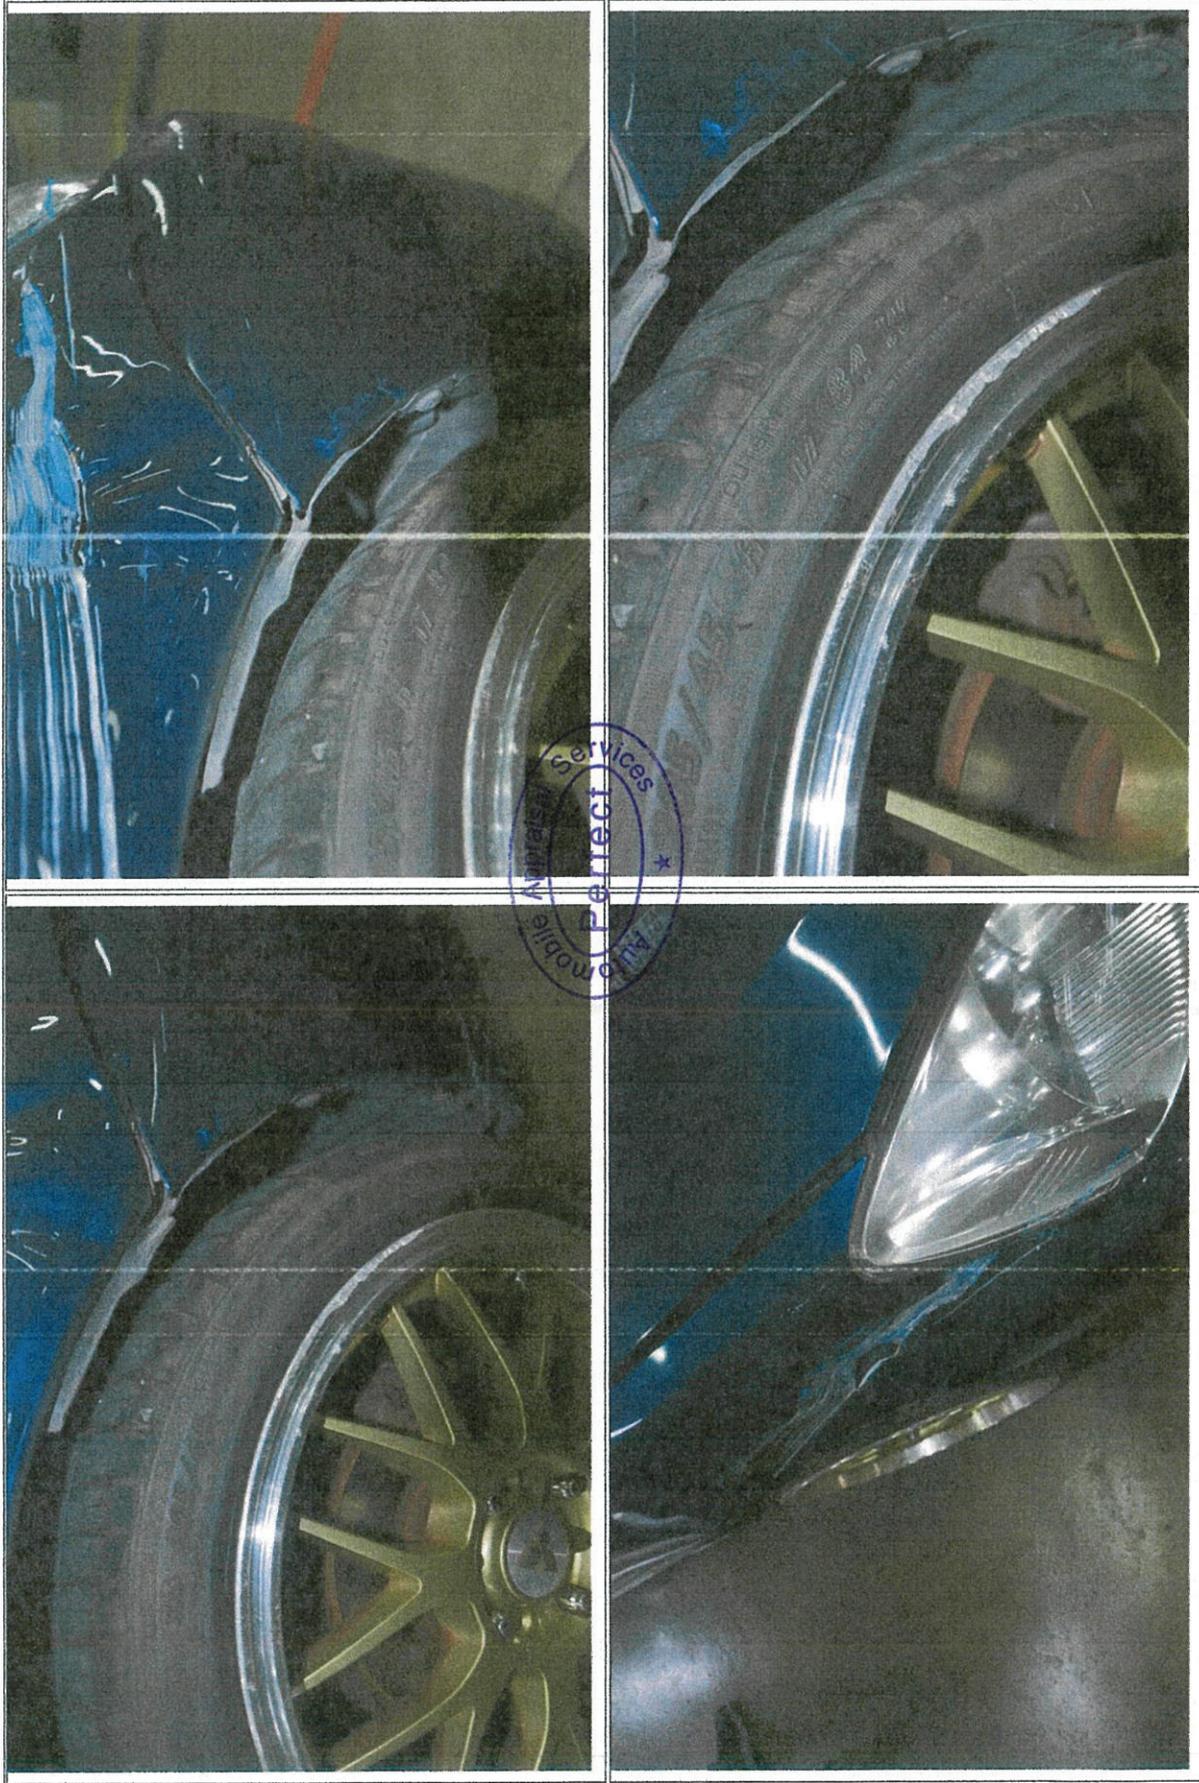
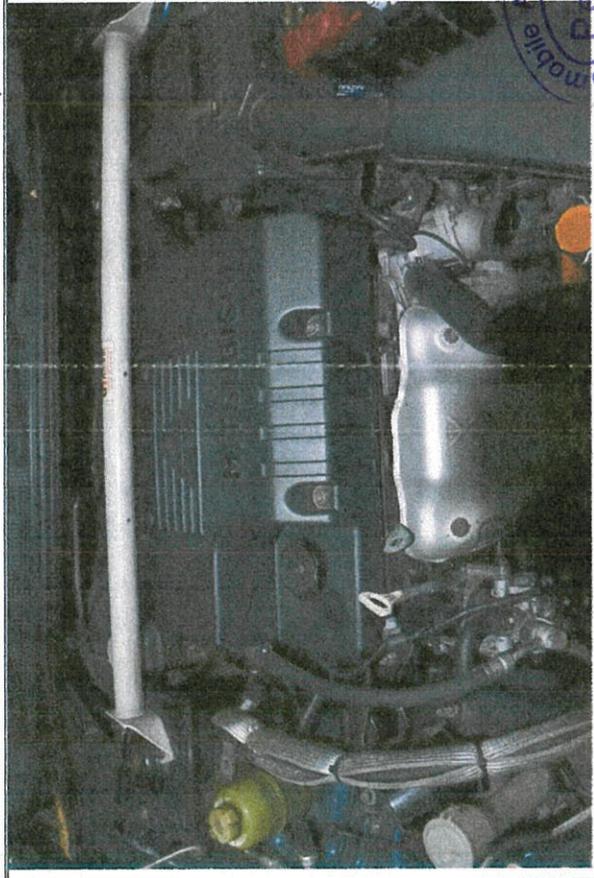
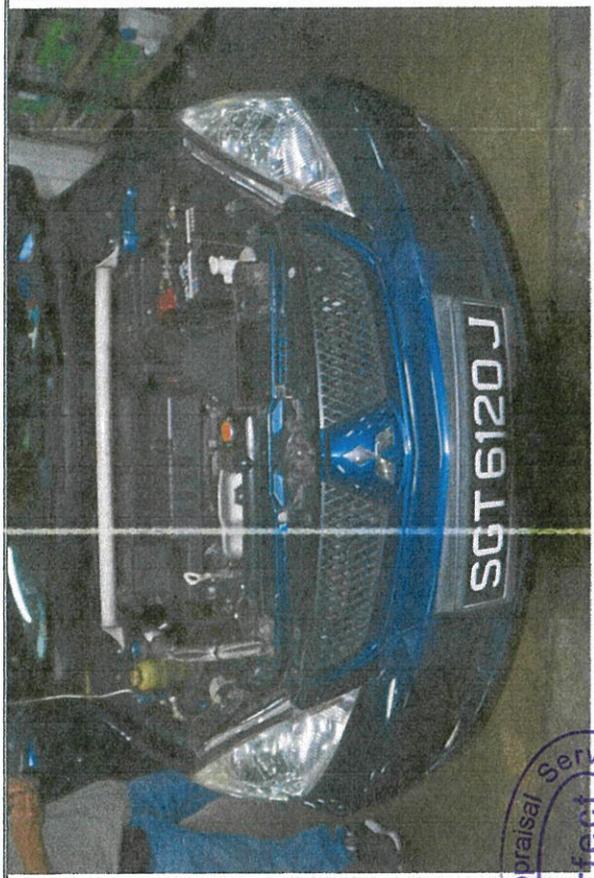
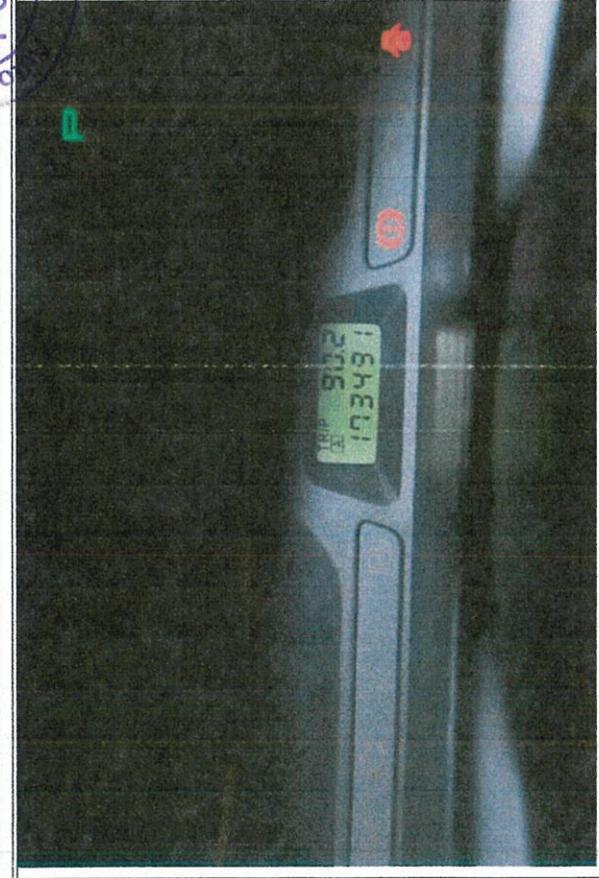
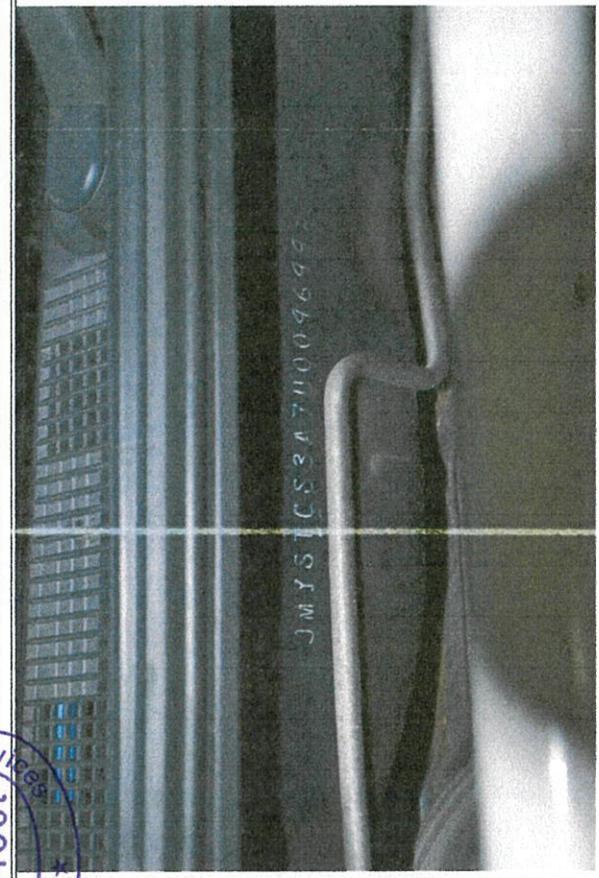
Inspection Photos

At the time of inspection, we noted that this vehicle sustained damages at the front o/s portion.

For more details of the damages, please see schedule and photographs attached.
