## LKK Auto Consultants Pte Ltd

### ADJUSTMENT ON REPAIR COST FOR VEHICLE NO. SME 5332D

PHOTOGRAPHS FOR VEHICLE NO. SME 5332D

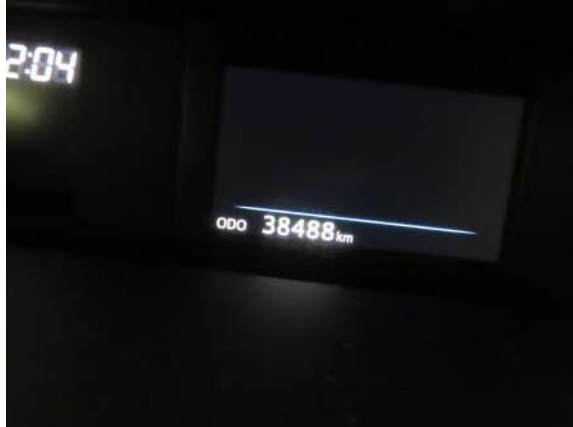
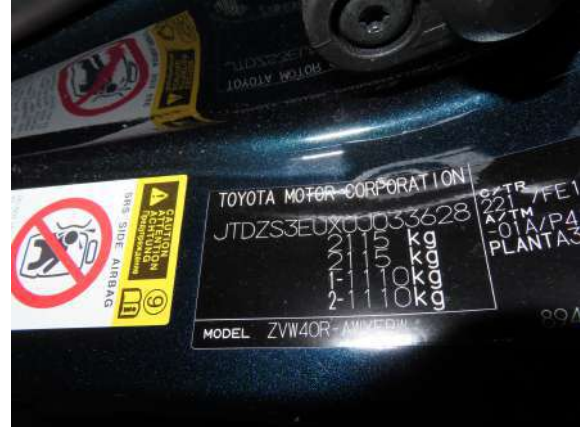
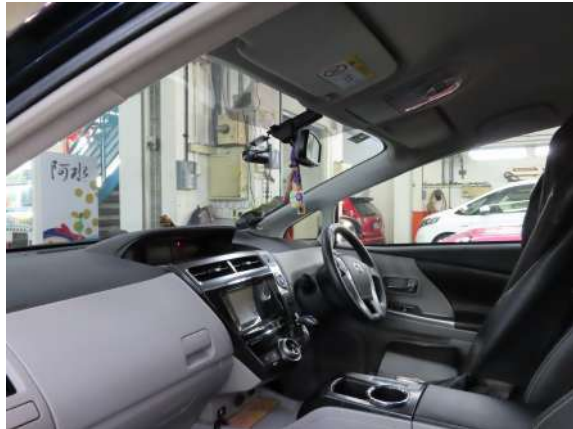
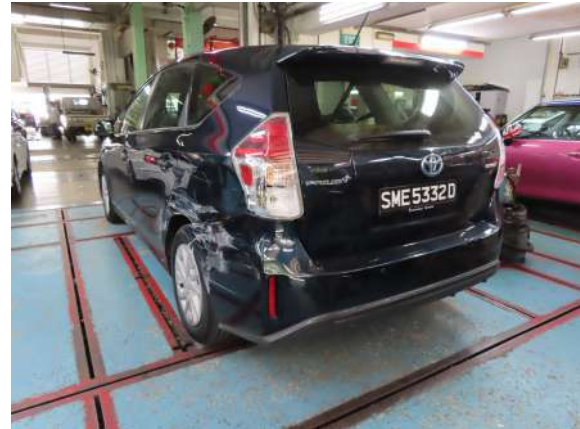
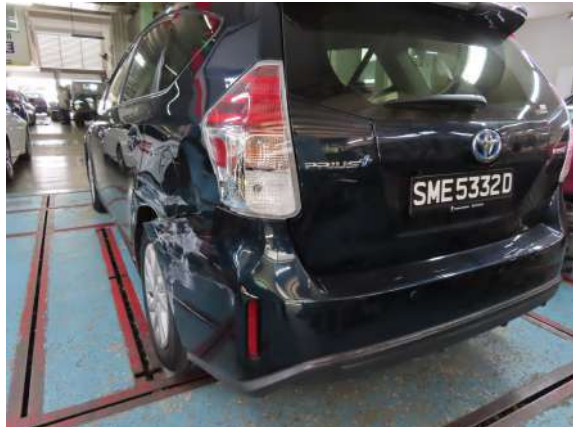
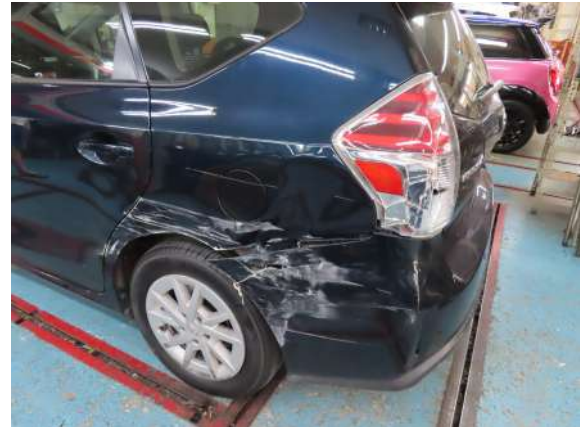
| Affiliated to Federation Internationale Des Experts En Automobile | | | | |
|---|---|---|---|---|
| | THE VEHICLE SUSTAINED DAMAGES AT THE N/S REAR PORTION.THE UNDERCARRIAGE AFFECTED DUE TO COLLISION.<br><br>DAMAGES SEE DETAILS. | | | |

INSPECTION

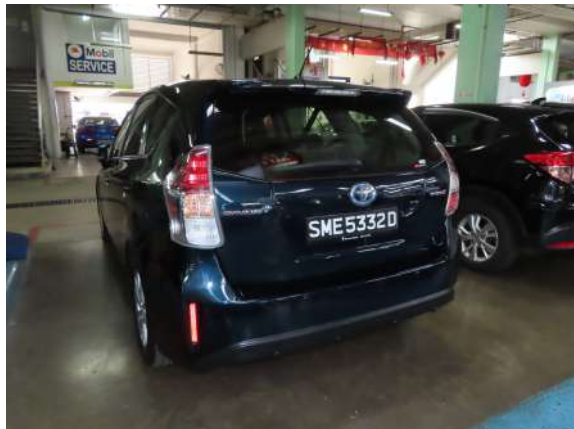
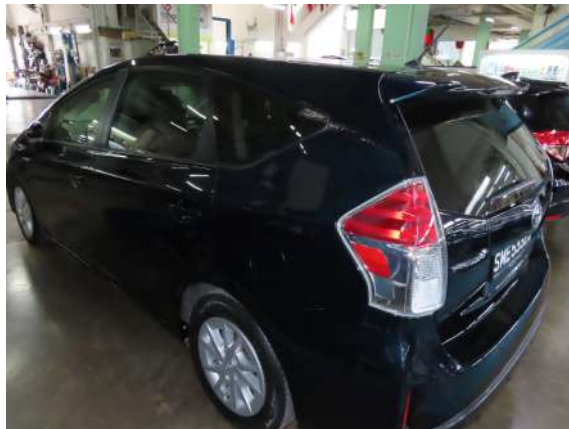
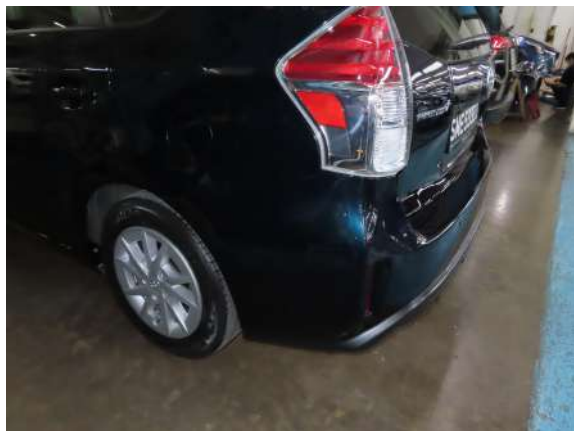
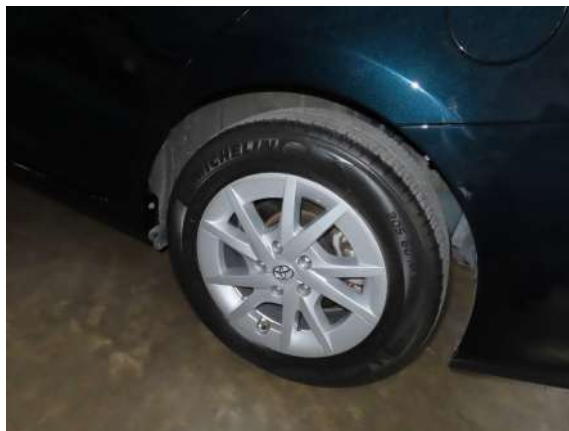
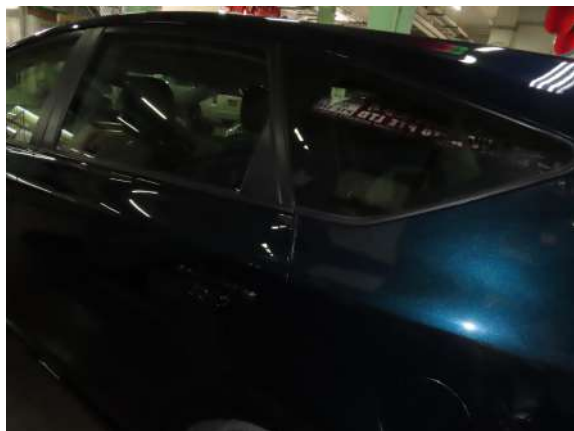
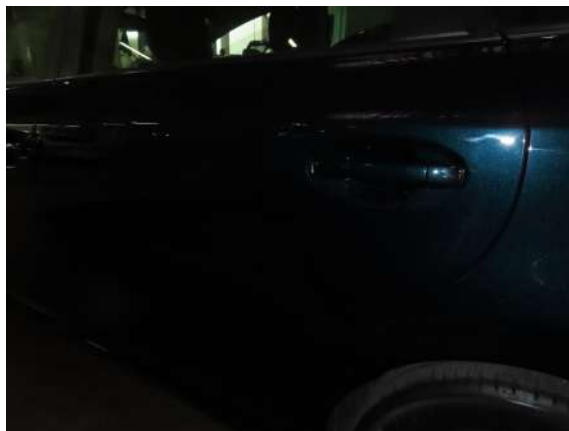
PHOTOGRAPHS FOR VEHICLE NO. SME 5332D

RE-INSPECTION
