Vehicle No. SNB 1965H  
Insured Veh. GBJ 4797G  
Claim No. SNM22D200223/C02  
Policy No. DMCVSNW00041322101  
Accident Date 09/01/2022  
Inspection Date 11/01/2022

### ADJUSTMENT ON REPAIR COST FOR VEHICLE NO. SNB 1965H

### PHOTOGRAPHS FOR VEHICLE NO. SNB 1965H

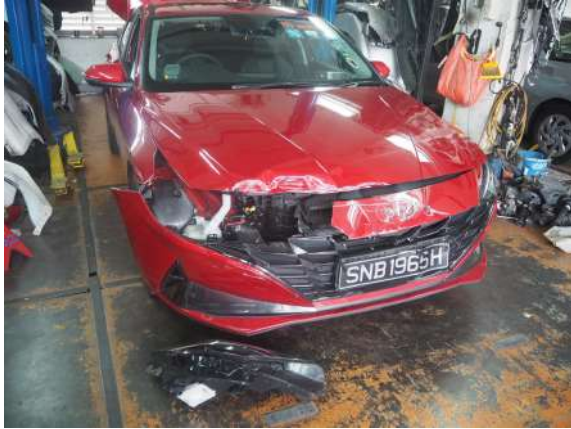
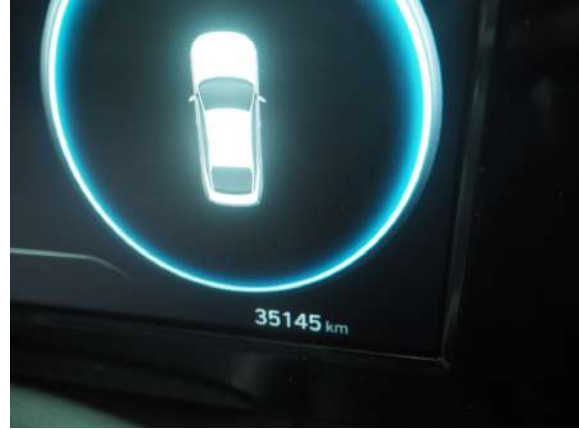
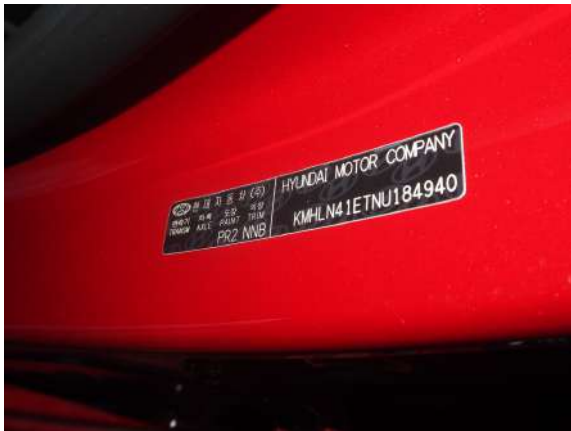
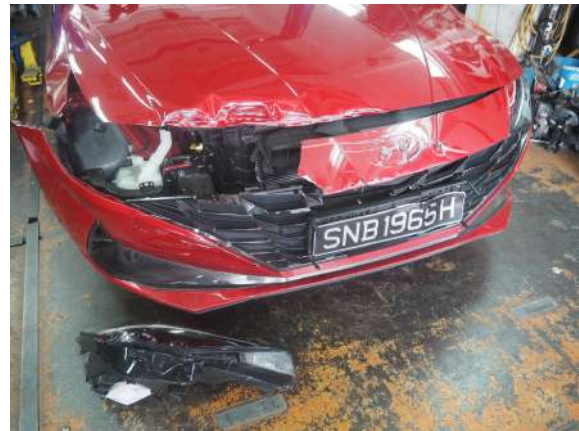
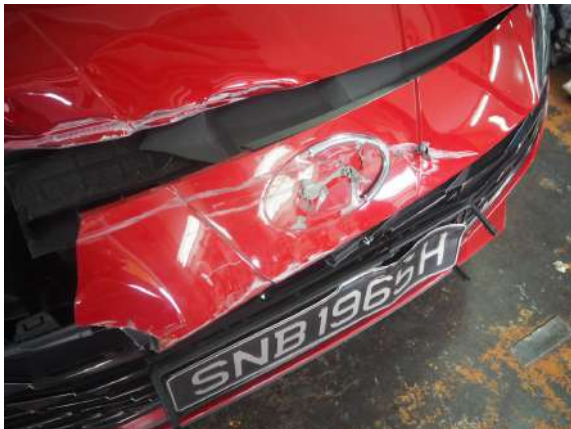
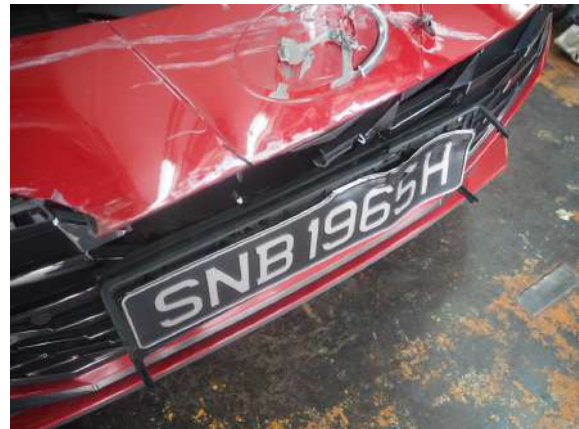
### INSPECTION

| Affiliated to Federation Internationale Des Experts En Automobile | | | | |
|---|---|---|---|--|
| THE VEHICLE SUSTAINED FRONT REAR PORTION.<br>DAMAGES SEE DETAILS. | | | | |
