Vehicle No. SJE 7925R  
Insured Veh. GBK 2864D  
Claim No. 21/22/22/VC05/025343  
Policy No. Z21VC05007165  
Accident Date 06/01/2022  
Inspection Date 14/01/2022

# LKK Auto Consultants Pte Ltd

### ADJUSTMENT ON REPAIR COST FOR VEHICLE NO. SJE 7925R

### PHOTOGRAPHS FOR VEHICLE NO. SJE 7925R

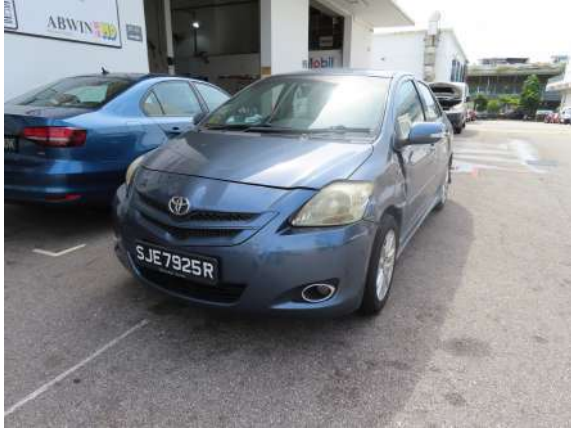
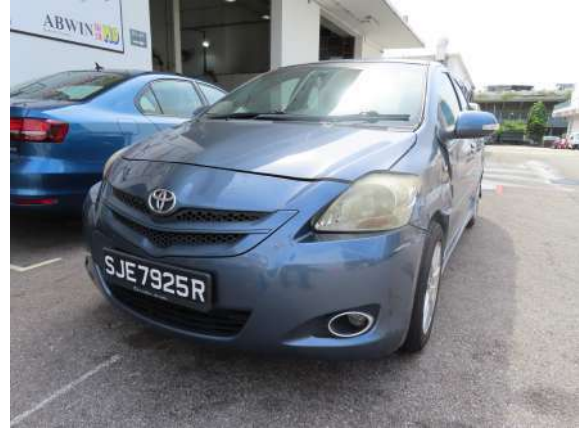
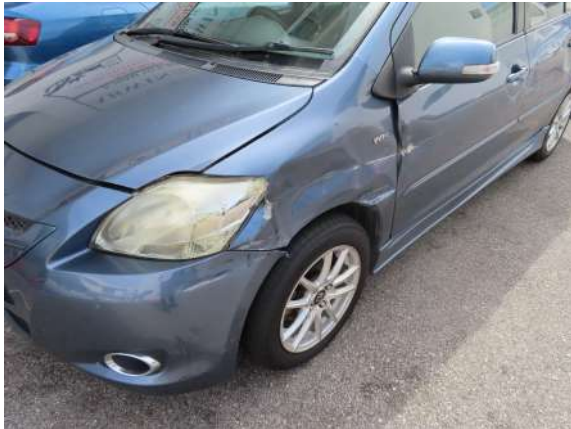
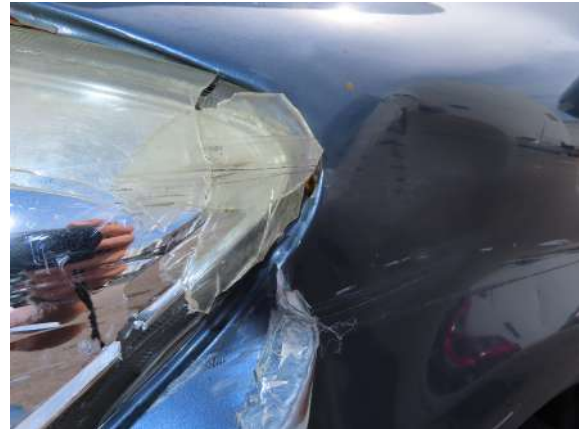
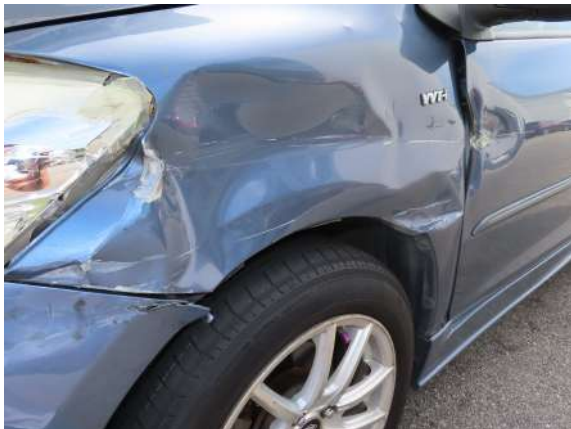
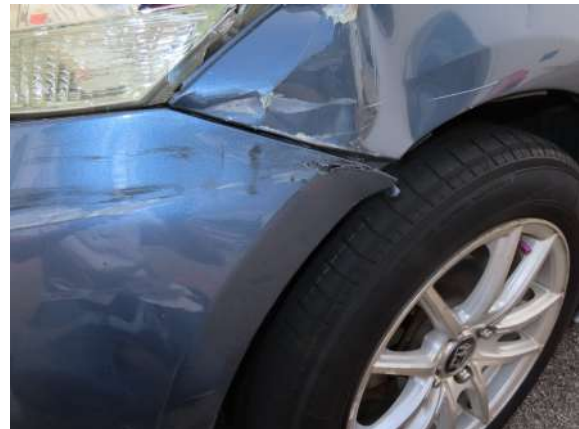
### INSPECTION

| Affiliated to Federation Internationale Des Experts En Automobile | | | | |
|---|---|---|---|--|
| THE VEHICLE SUSTAINED DAMAGES AT THE N/S FRONT PORTION,N/S BODY AND O/S RIM.<br>DAMAGES SEE DETAILS. | | | | |
