## **ACCIDENT DAMAGED VEHICLE INSPECTION REPORT (WITHOUT PREJUDICE)**

Registration Number	: SGP 4442 P	Mileage	: 80,825 km
Make & Model	: Honda HRV 1.5 DX CVT	Chassis Number	: JHMRU1810GX200398
Date of Registration	: 24 October 2016	Engine Number	: L15B4530397
Colour	: Blue	Engine Capacity	: 1,496 cc

### REPAIR DETAILS (SGP 4442 P)

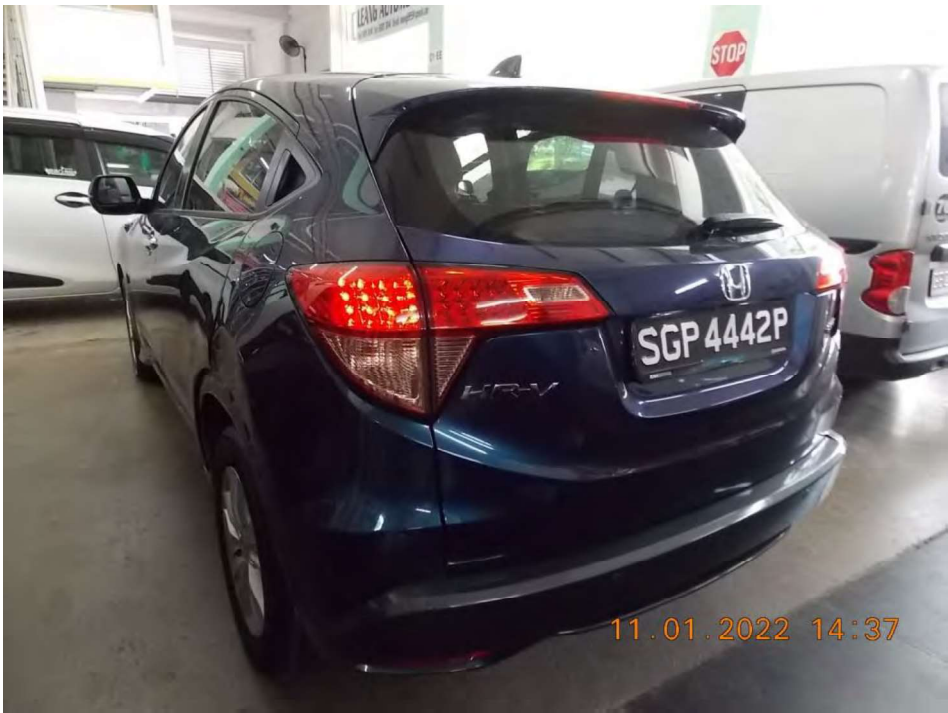
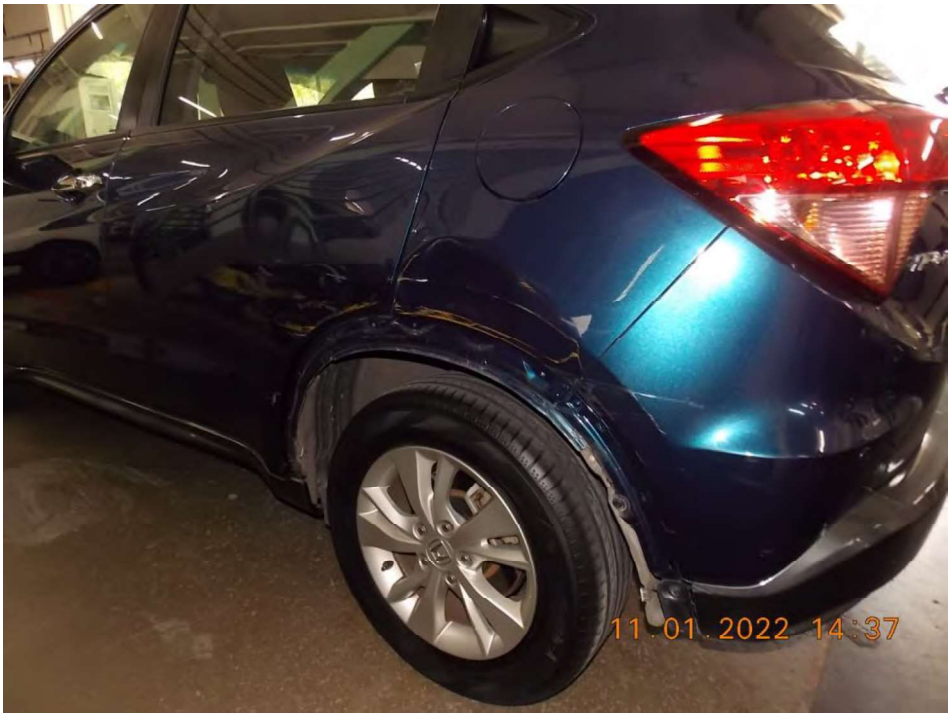
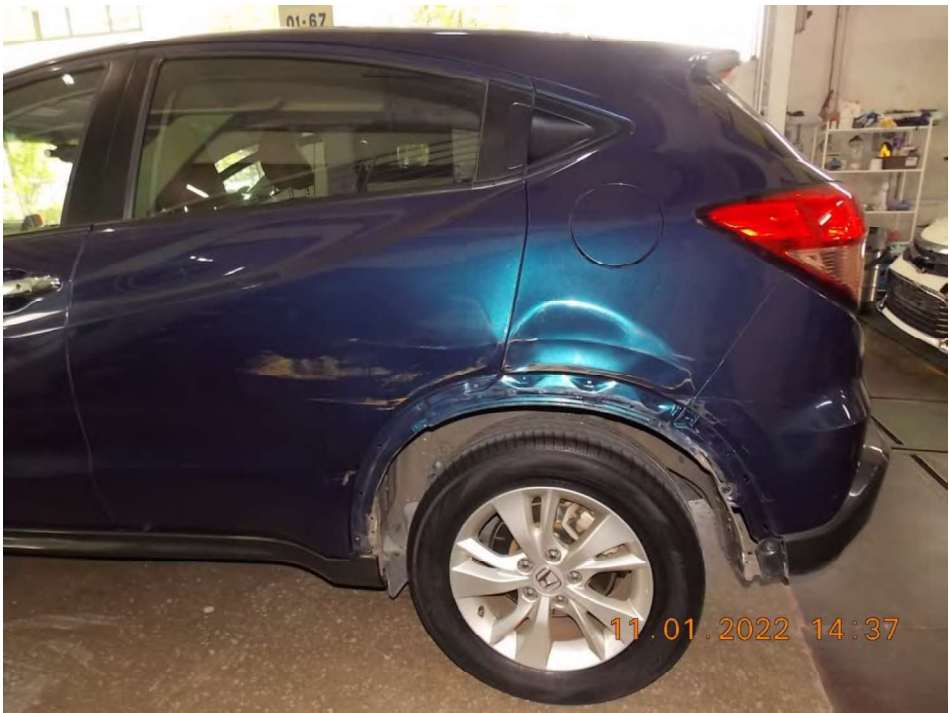
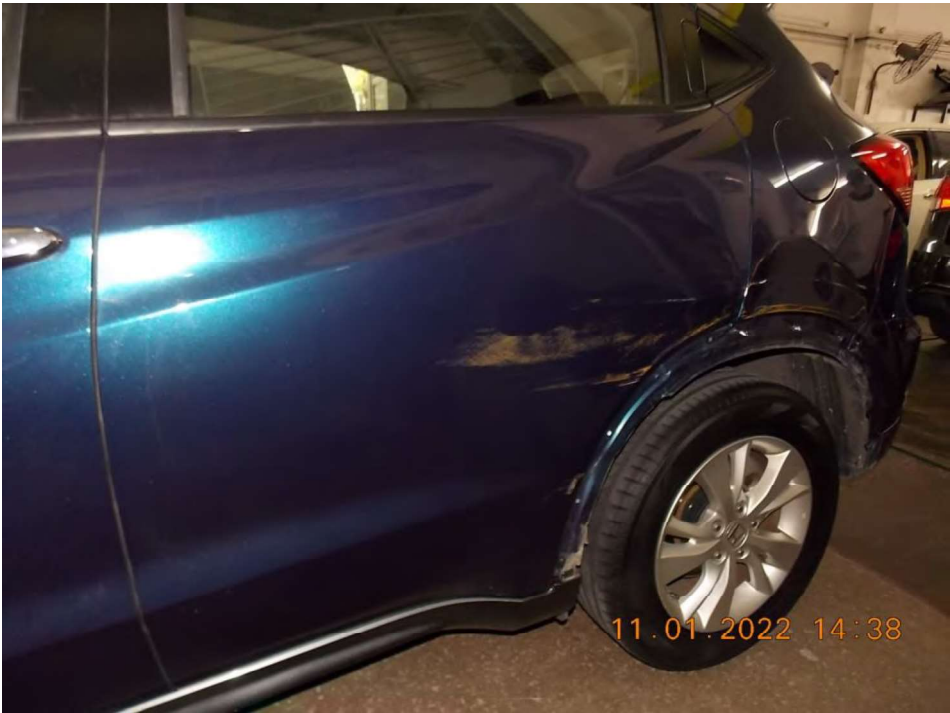
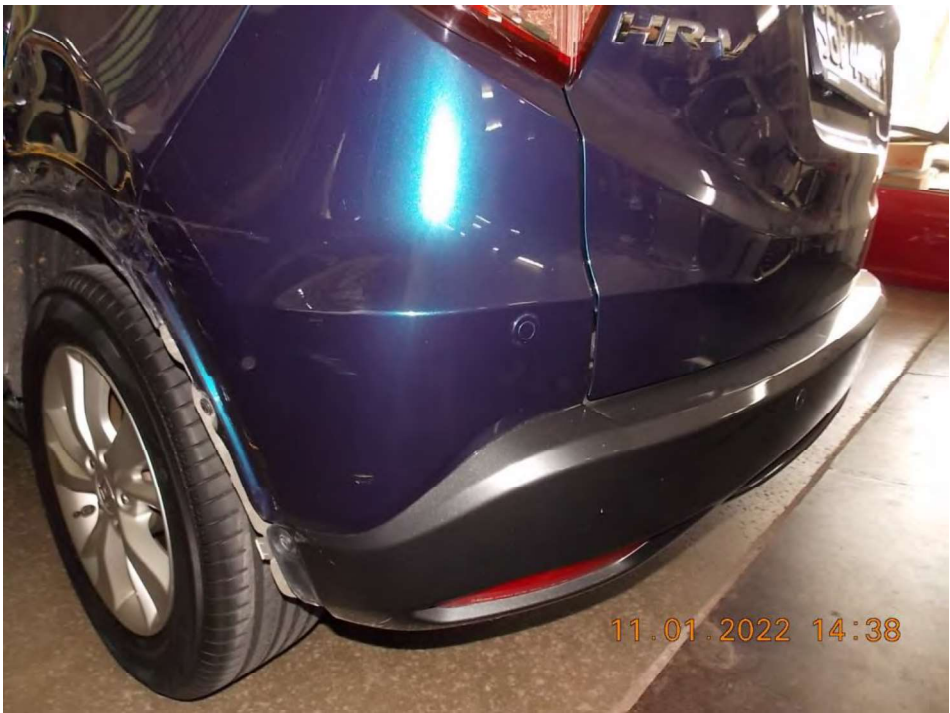
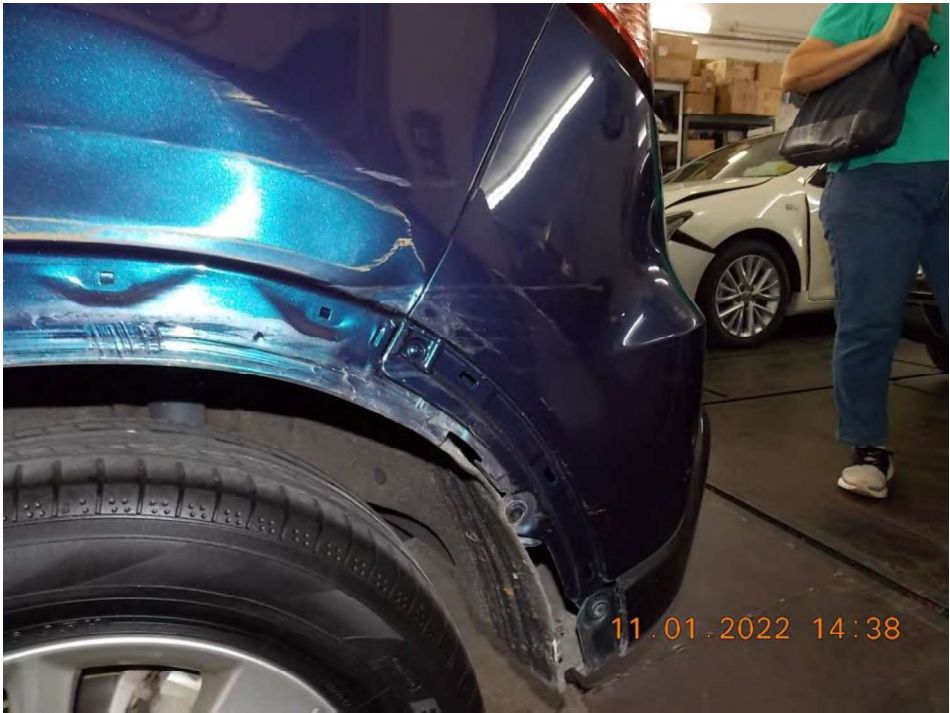
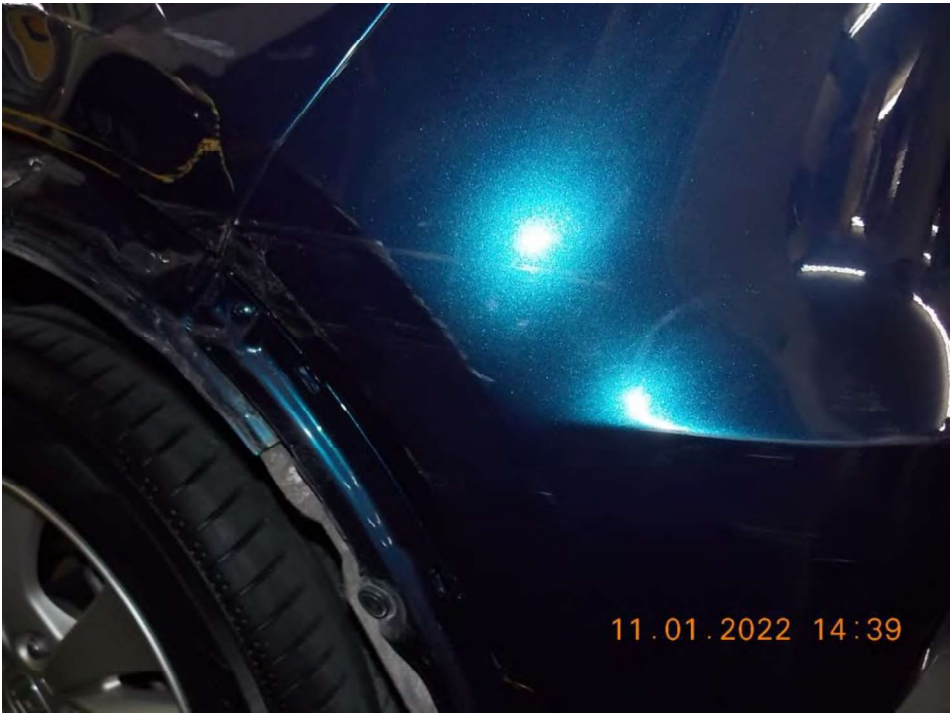
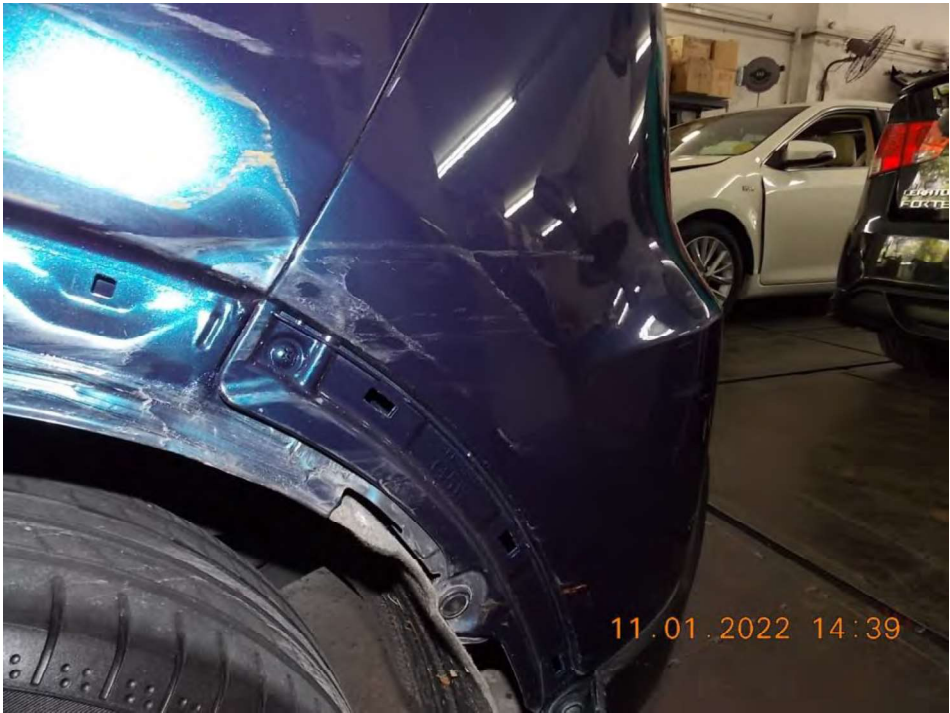
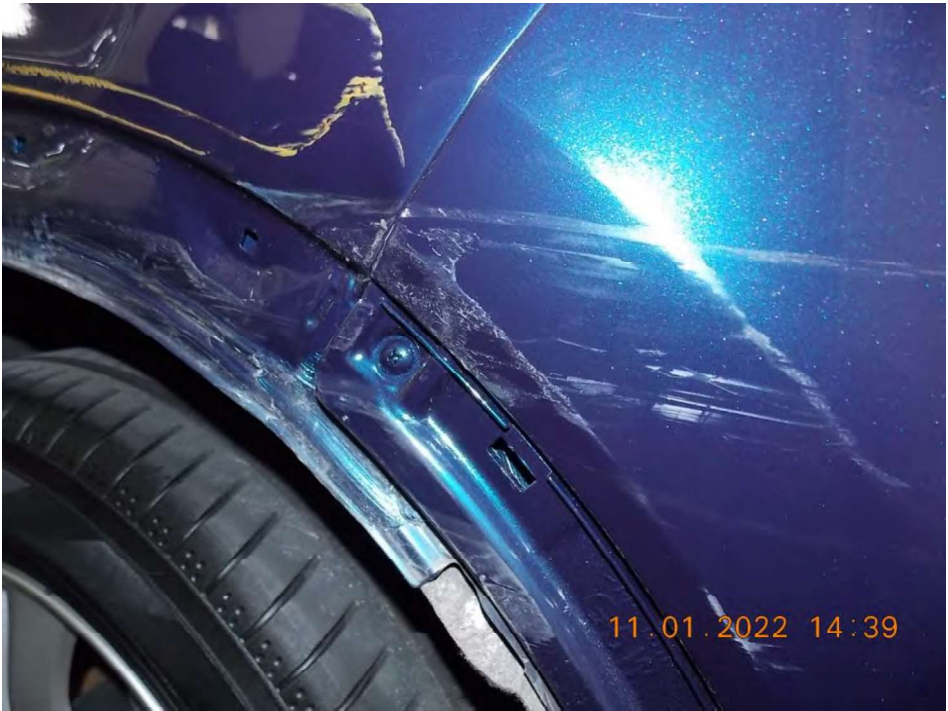
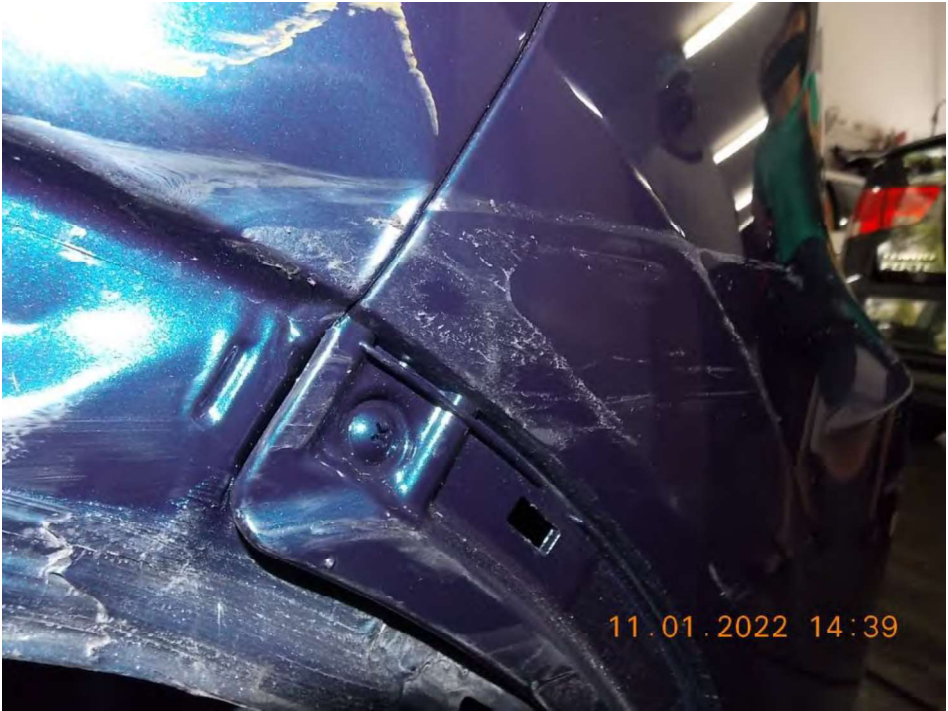
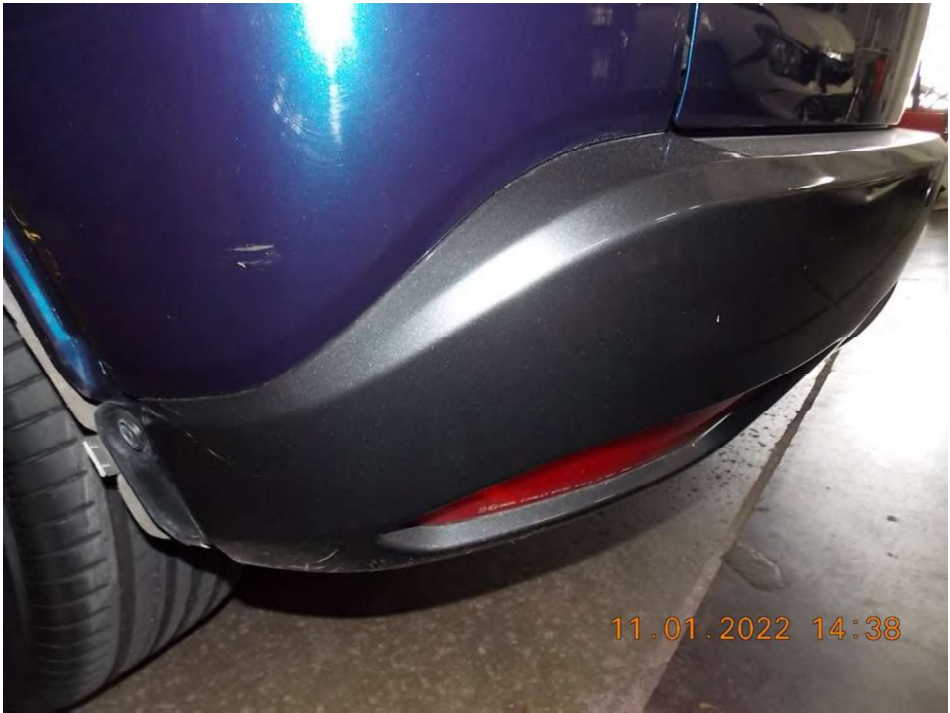
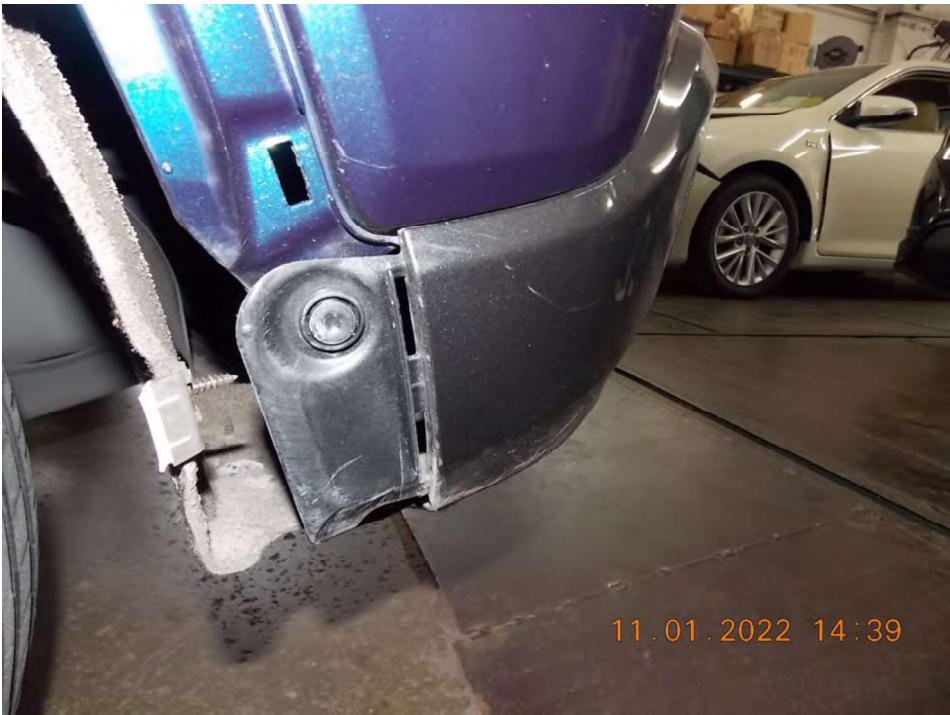
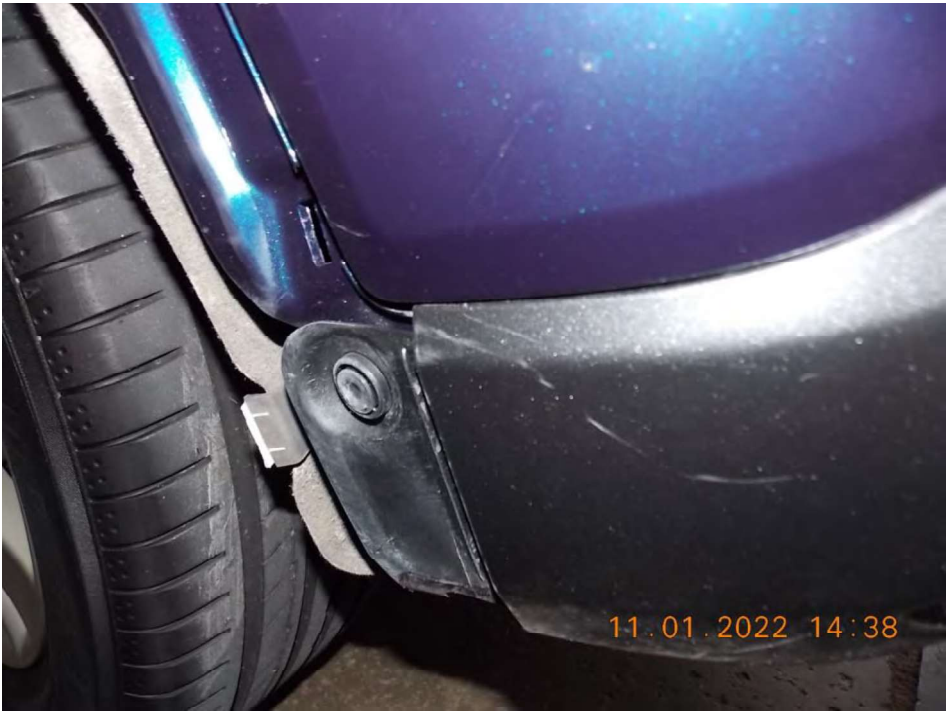
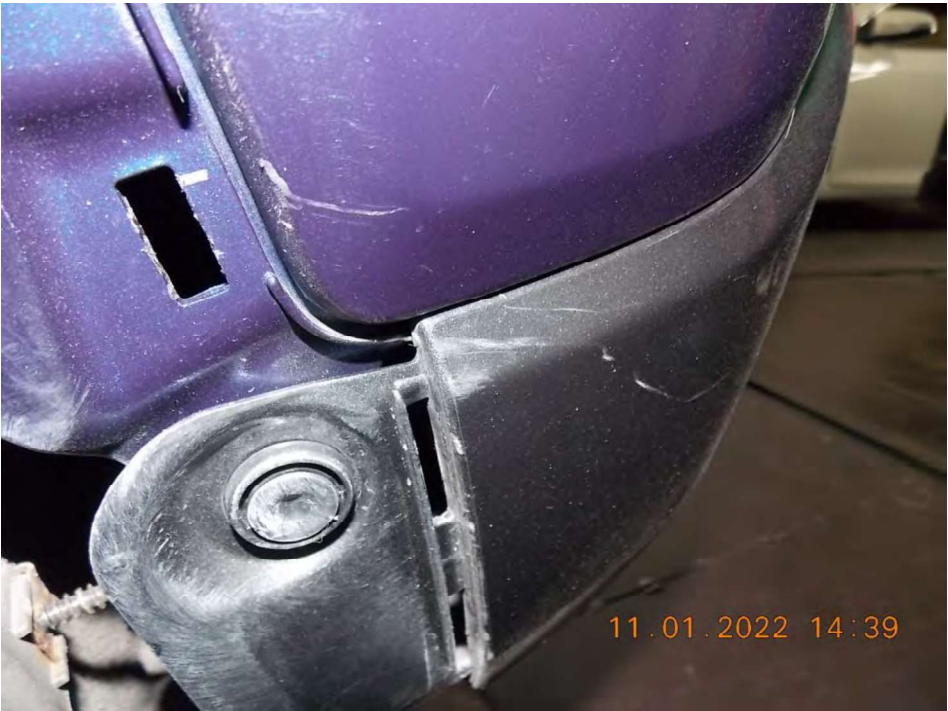
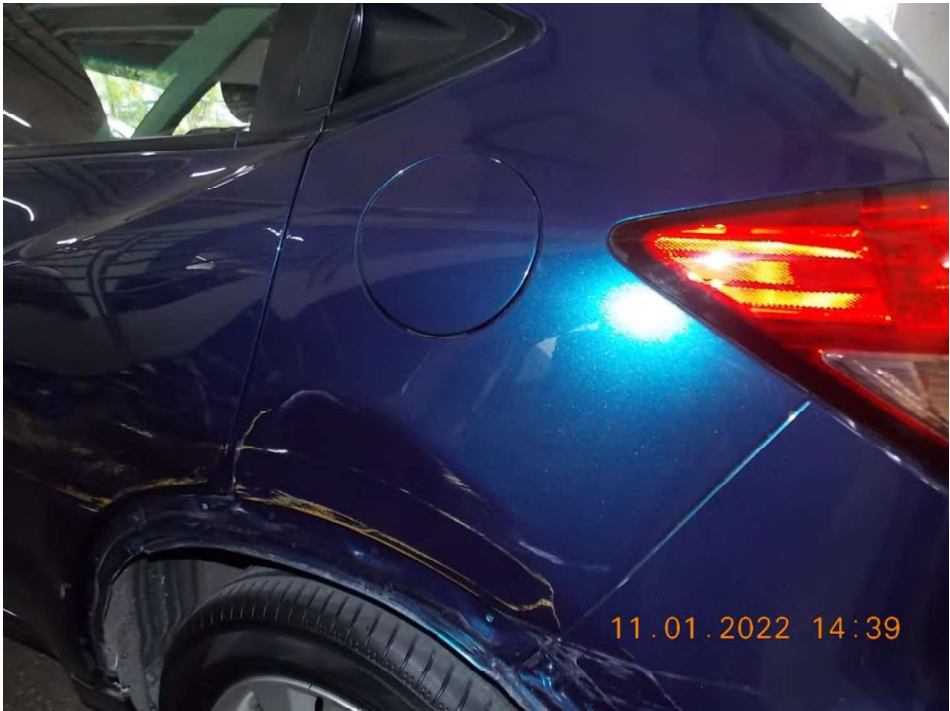
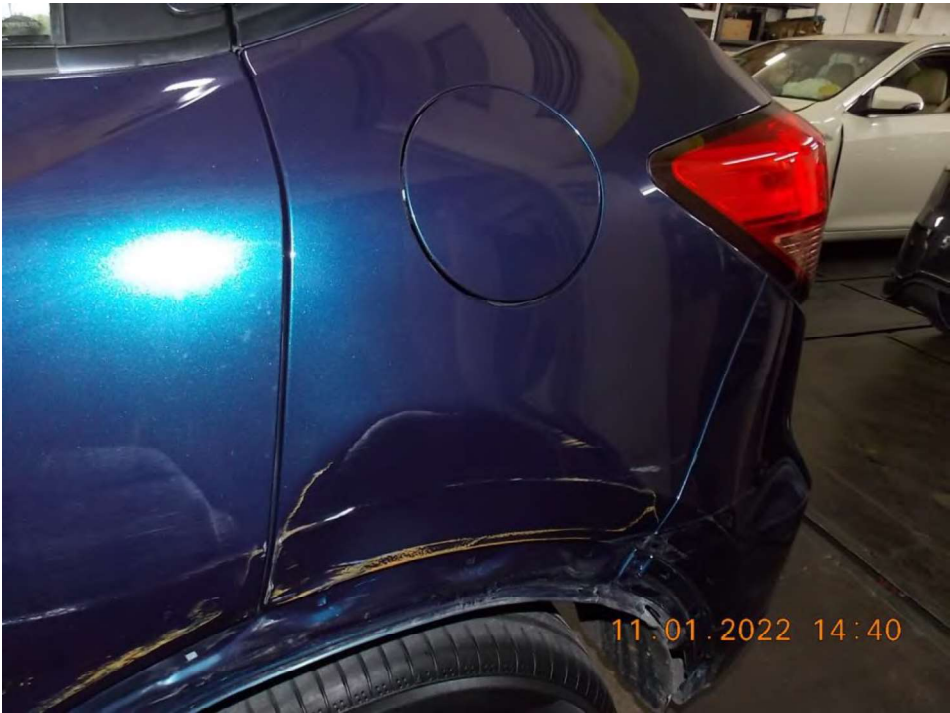
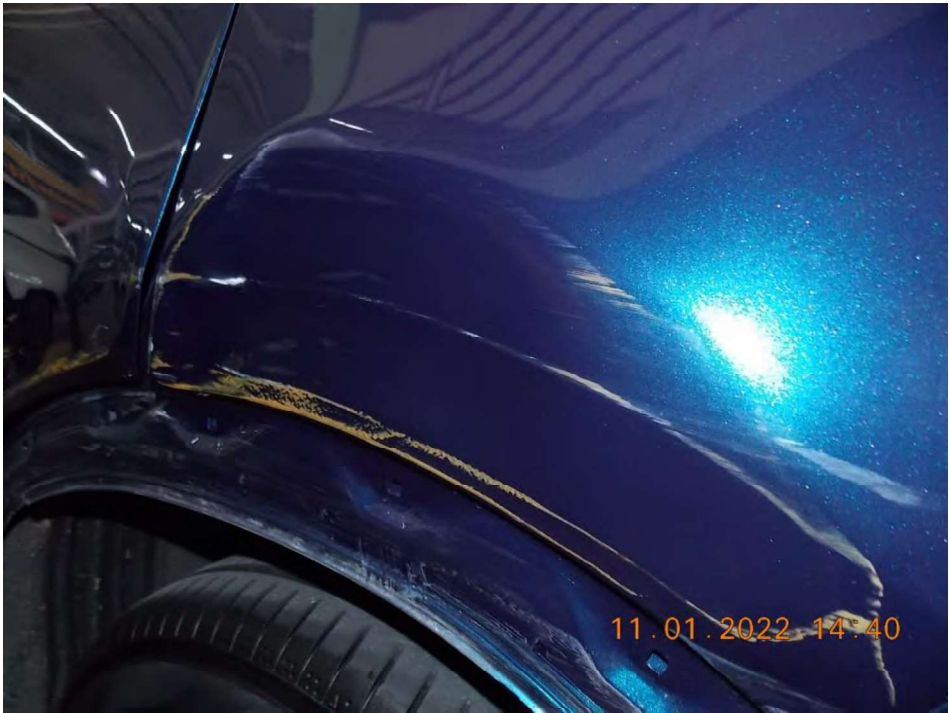
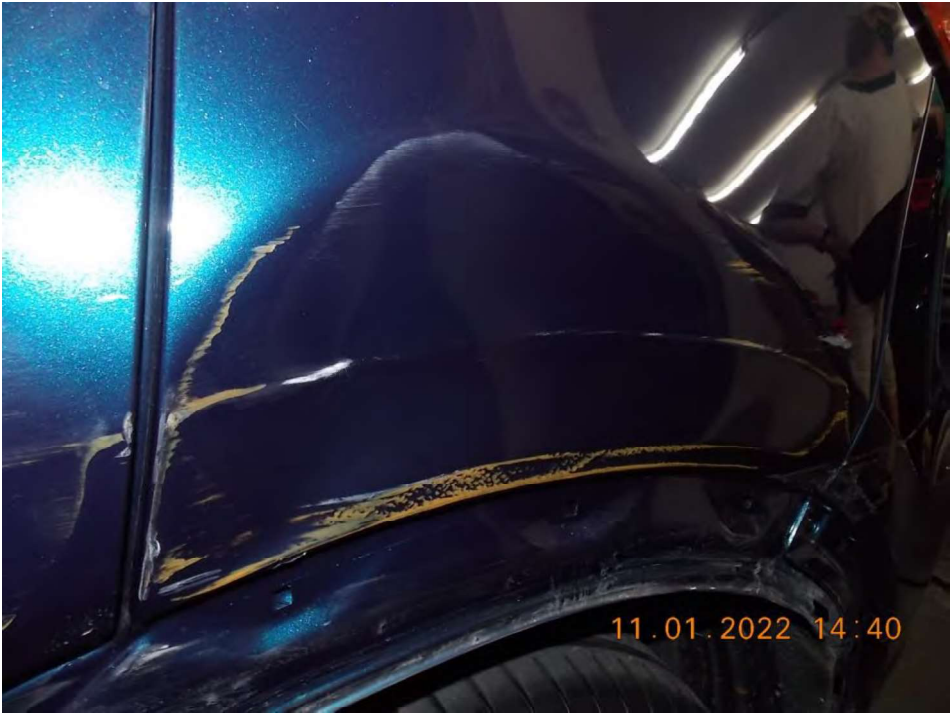
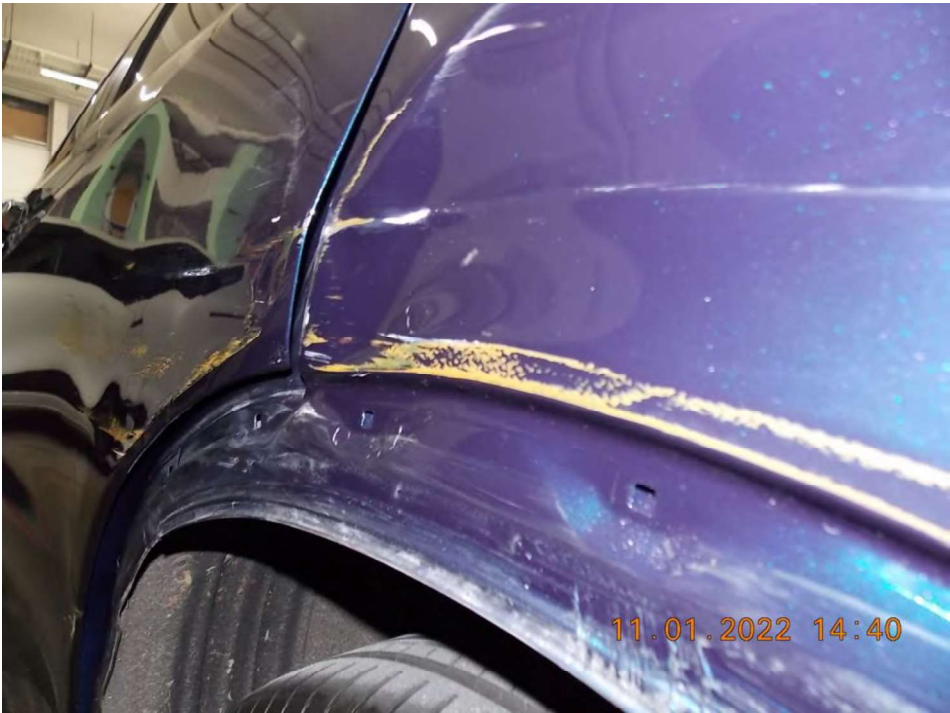
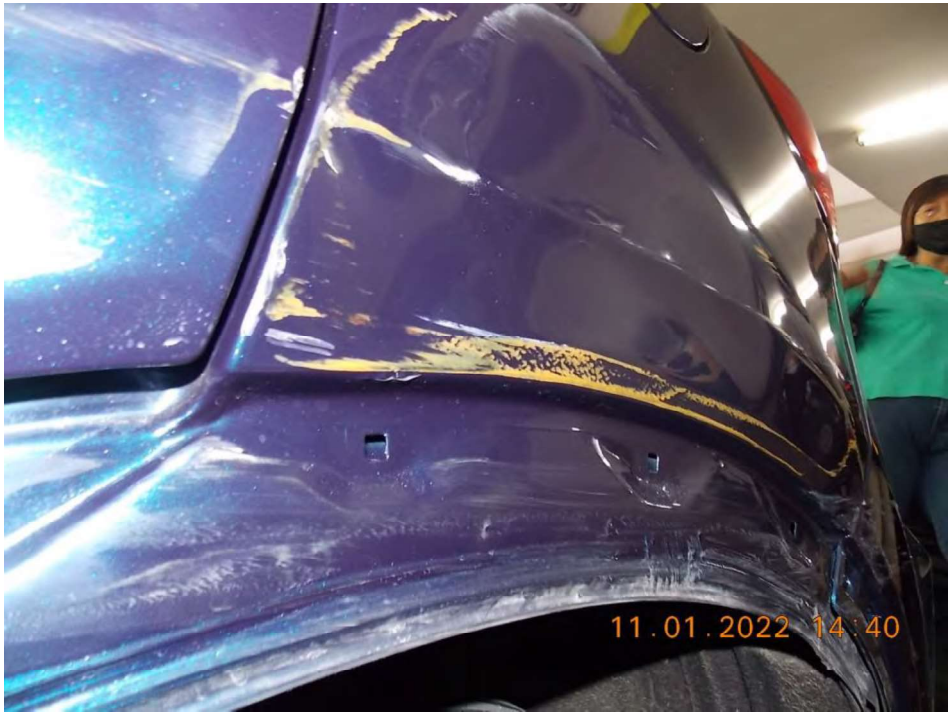
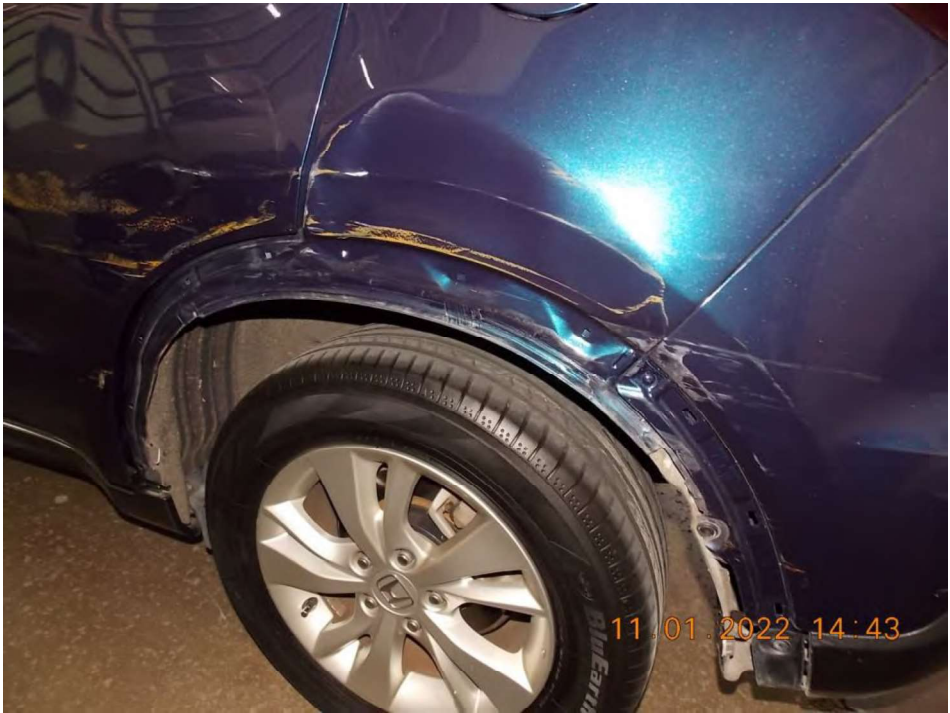
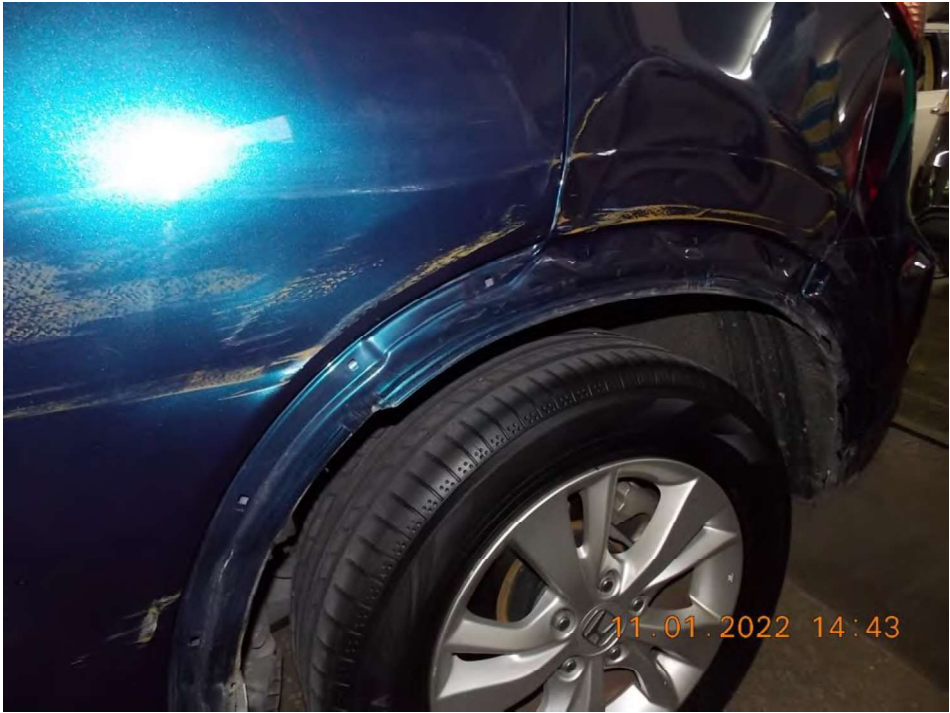
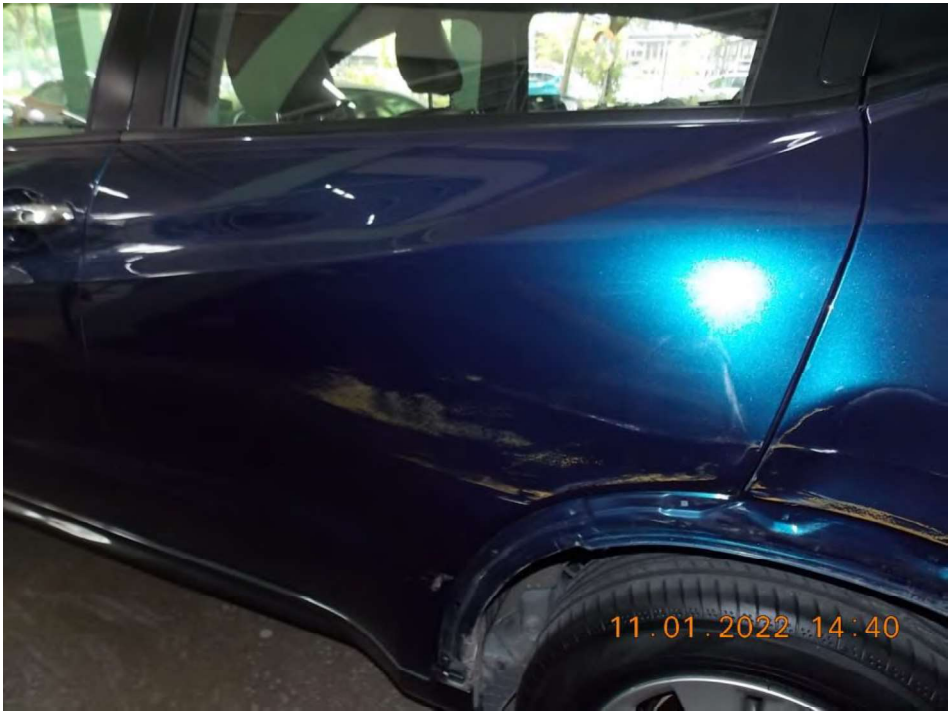
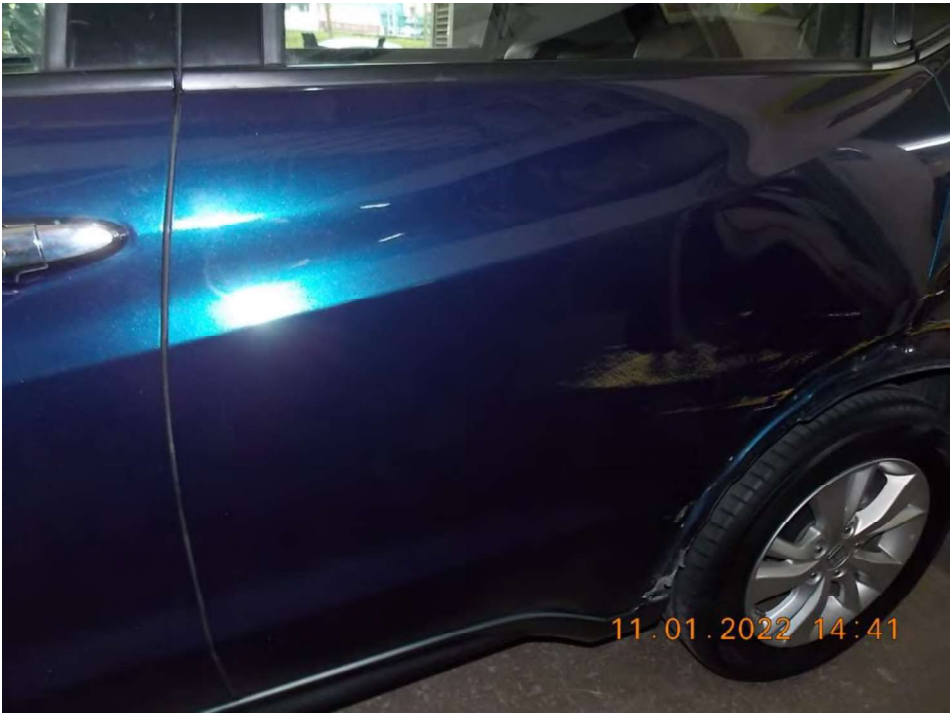
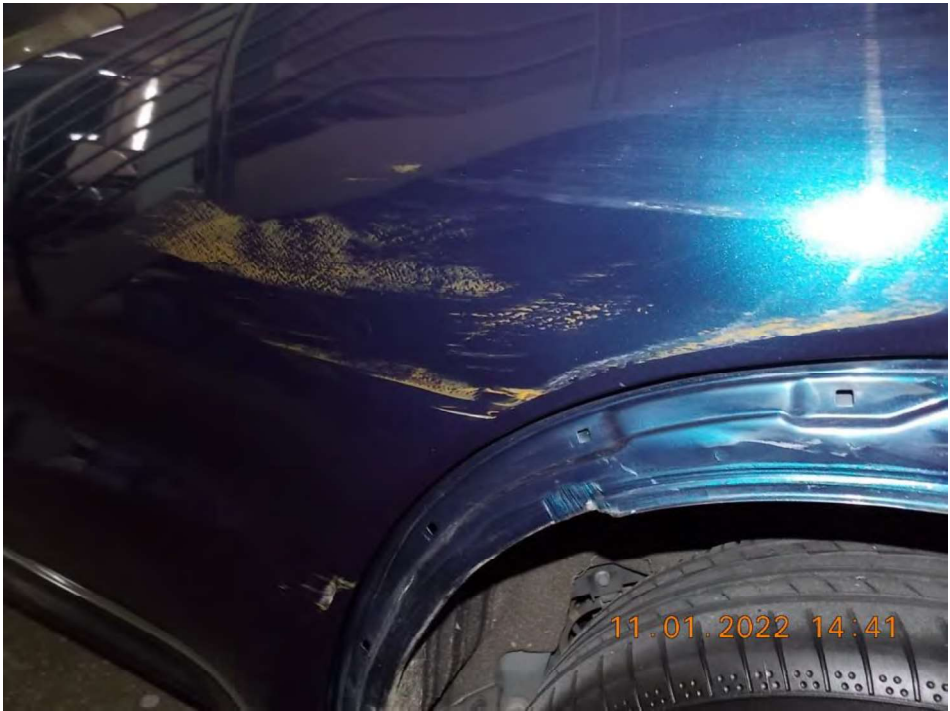
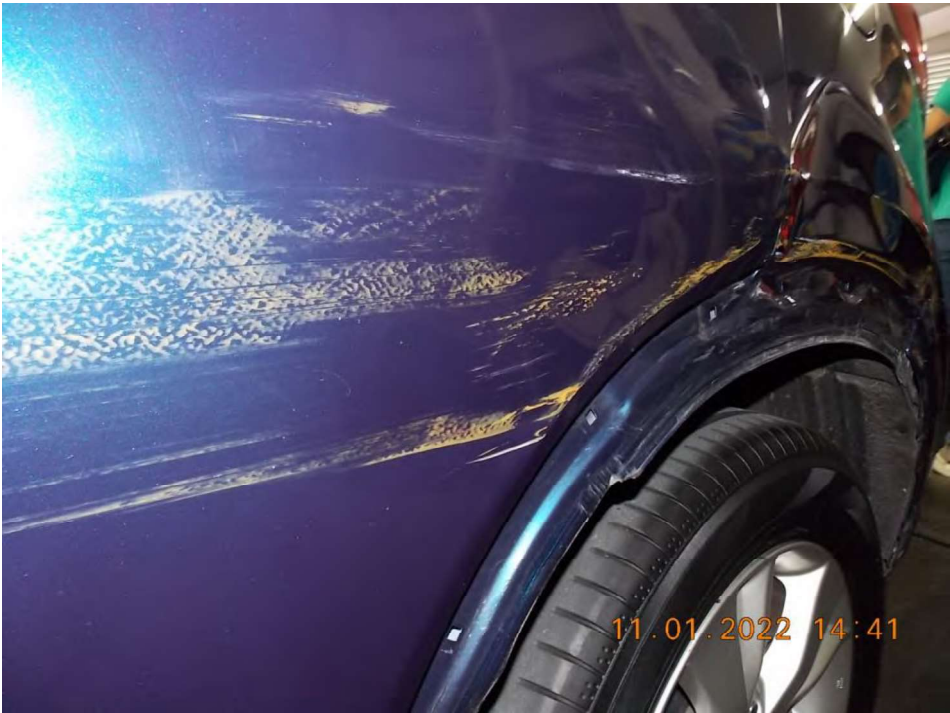
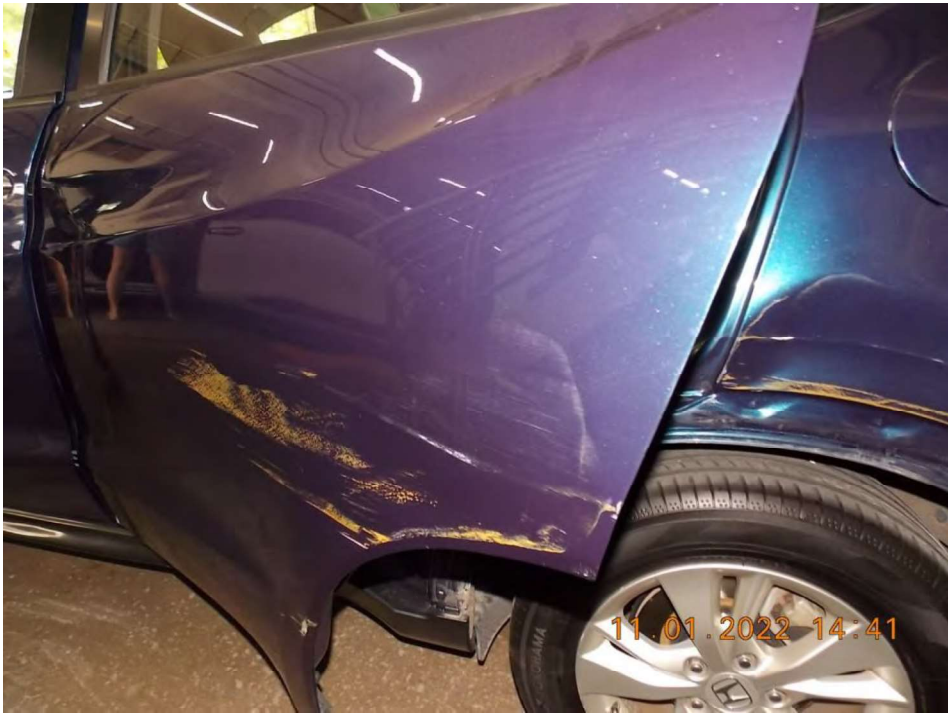
The impact of the collision has damaged/affected the left rear door, left rear fender, left rear wheel arch garnish, left rear wheel, left rear bumper side face and rear bumper face etc. Please refer to the Annex for a detailed account of the damages and photographs taken.

Mainly on the near-side rear portion.
