# AUTOMAX SURVEY

## THIRD PARTY SURVEY

ACCIDENT OCCURED ON 11 DEC 2020

Model : TOYOTA ESTIMA 3.0

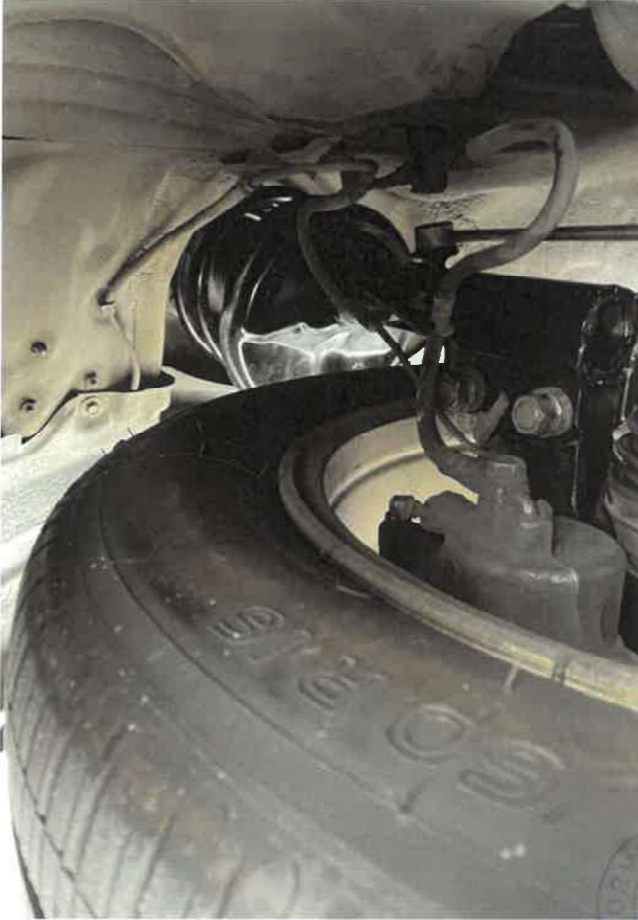
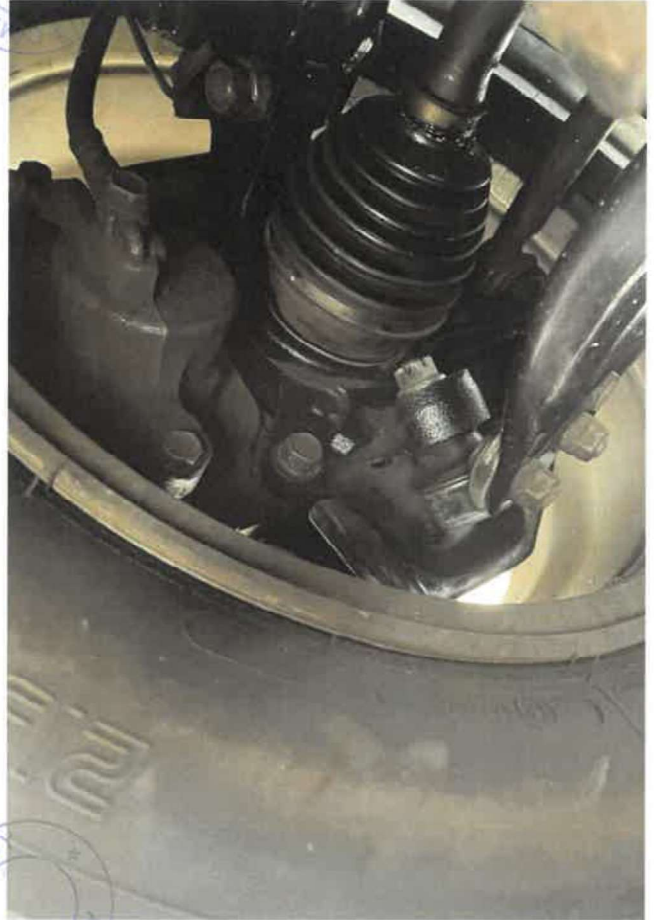
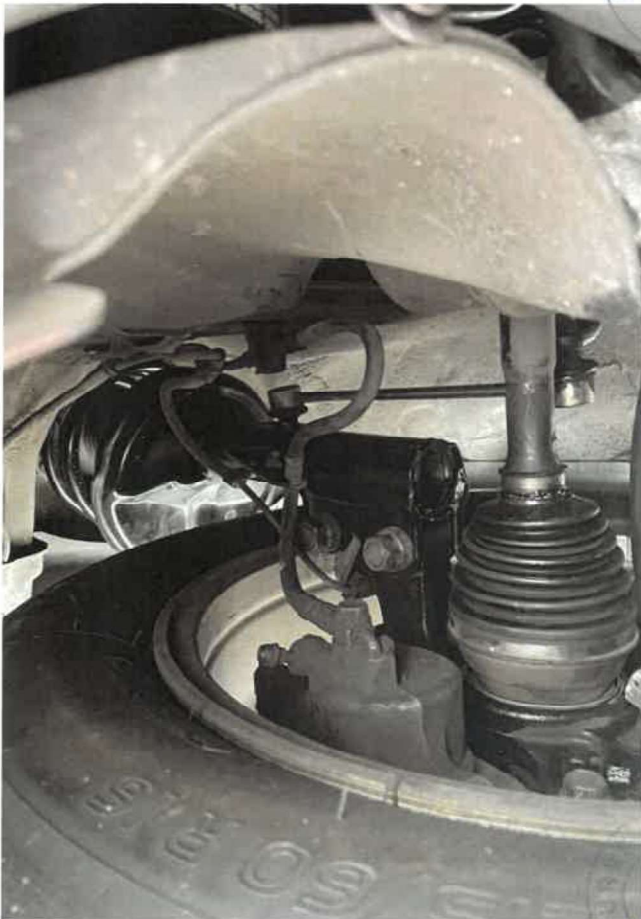
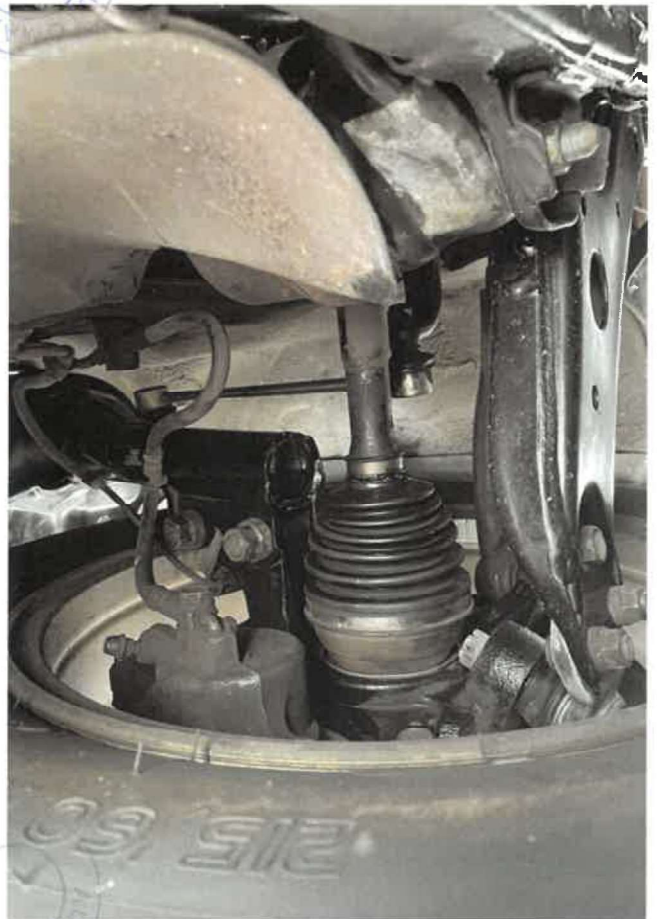
At the time of inspection, we noted that the vehicle has sustained an impact damages on the **Front** portion(s). For more detail of the damages, please see photograph attached.
