Report No: 0255-18-N51

## ACCIDENT VEHICLE SURVEY REPORT

### VEHICLE INFORMATION:

| Make & Model: | Honda Vezel 1.5X Auto | Colour: | Blue |

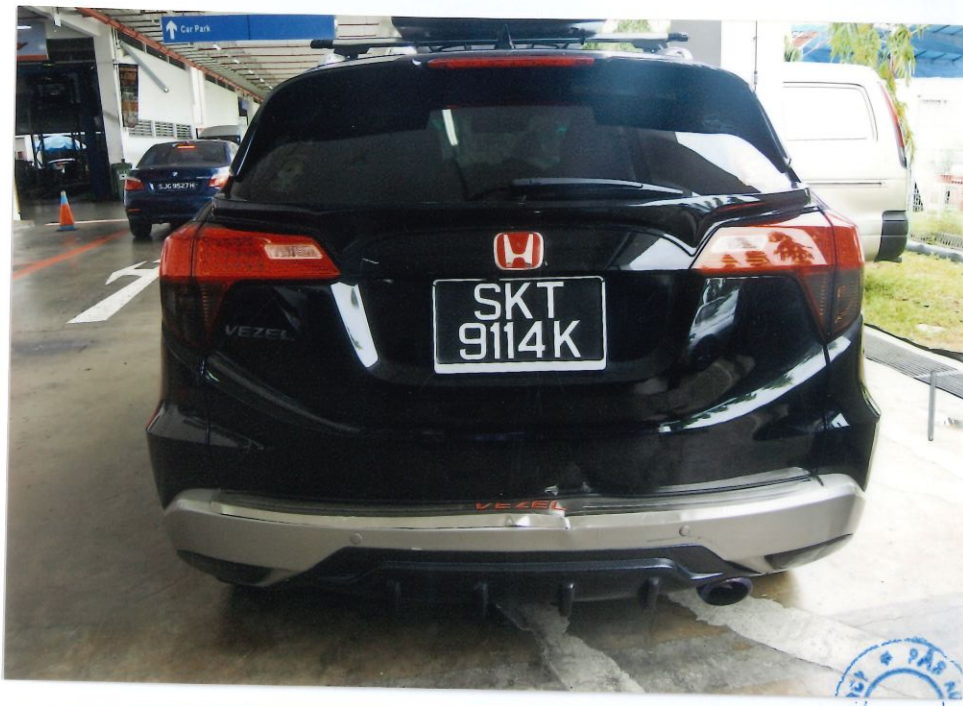
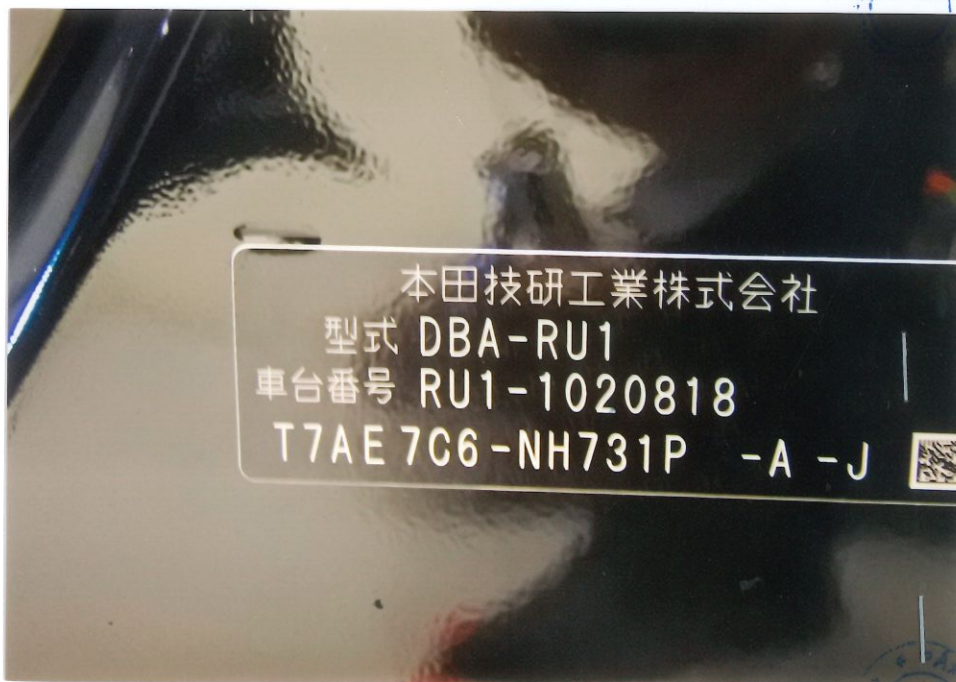
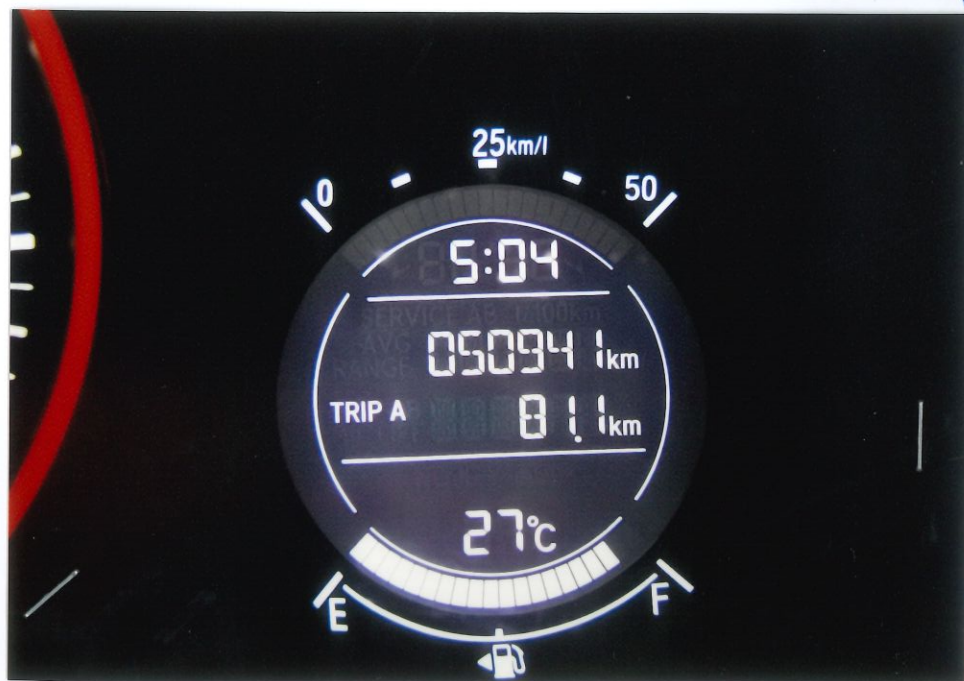
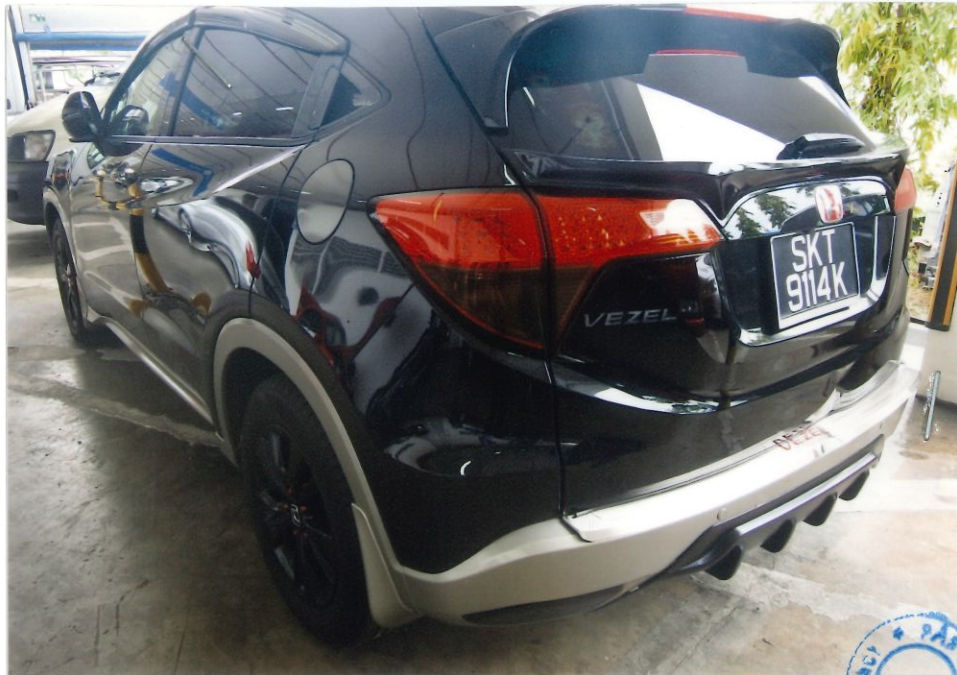
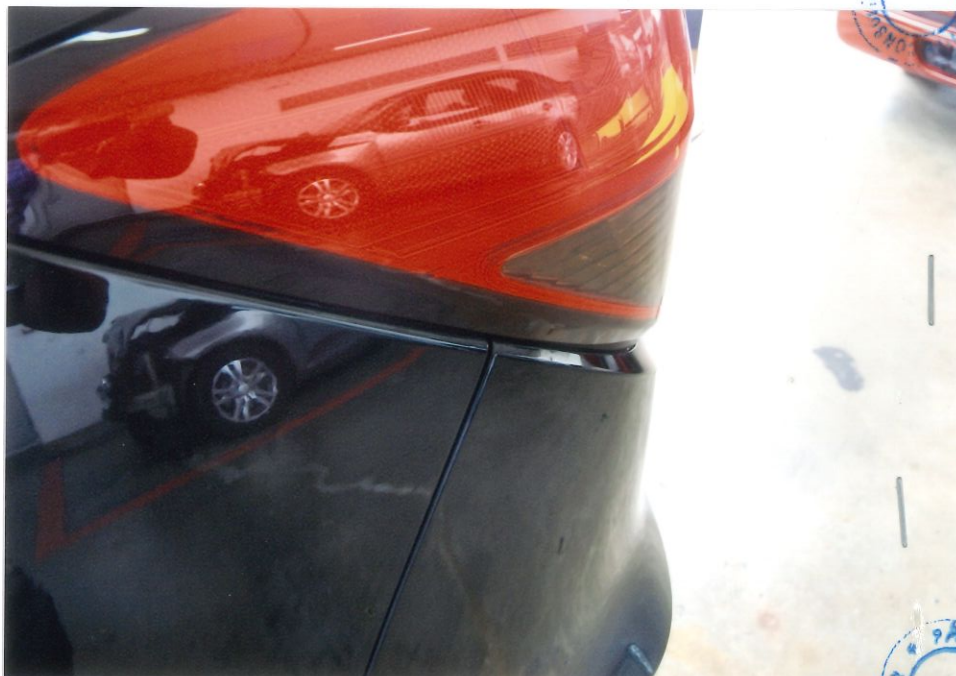
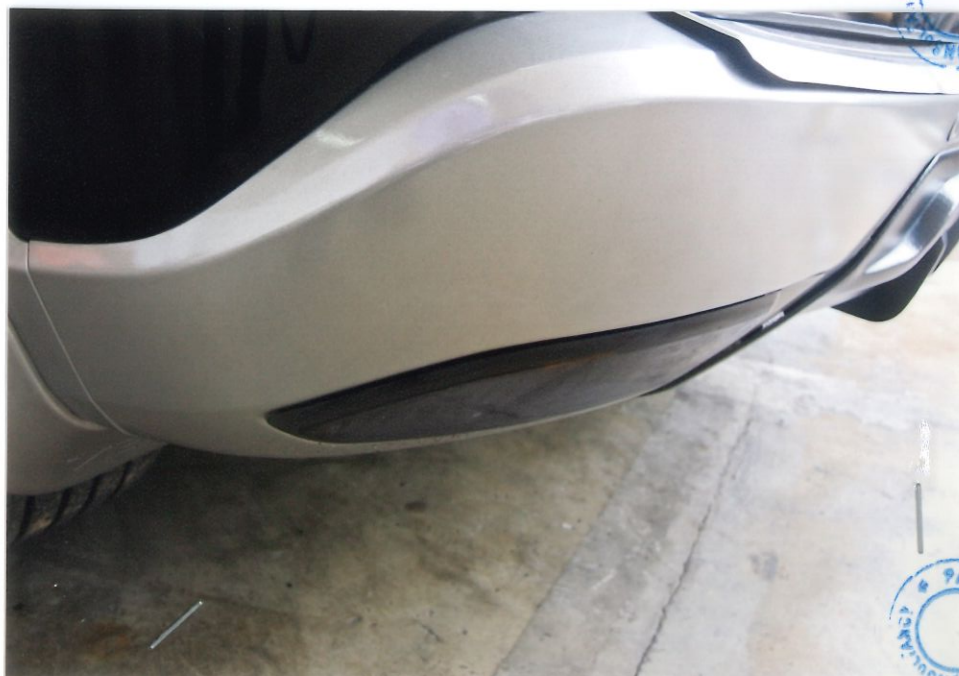
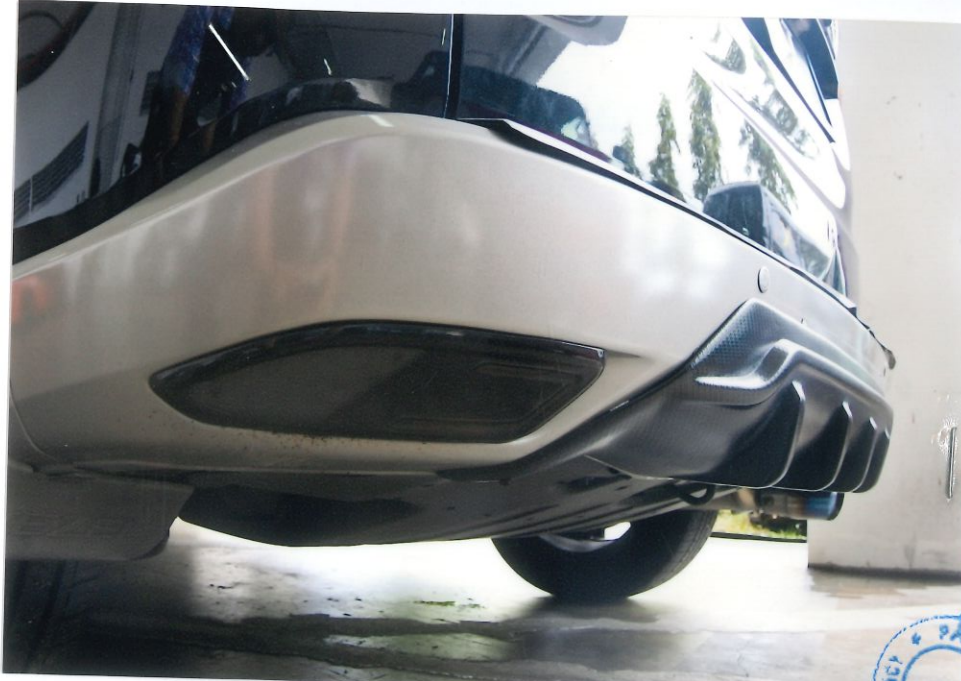
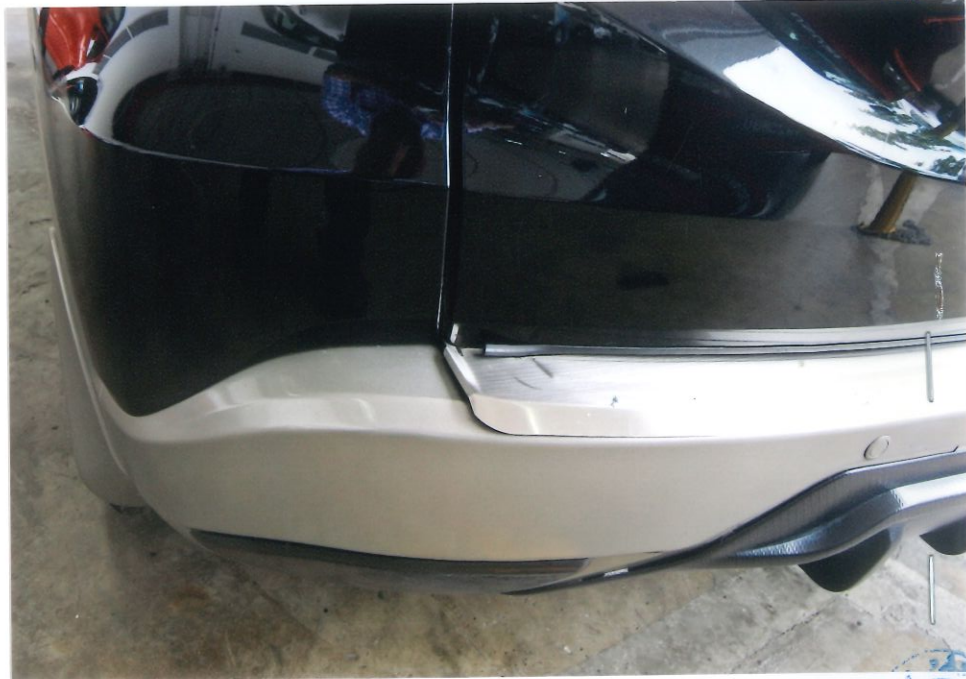
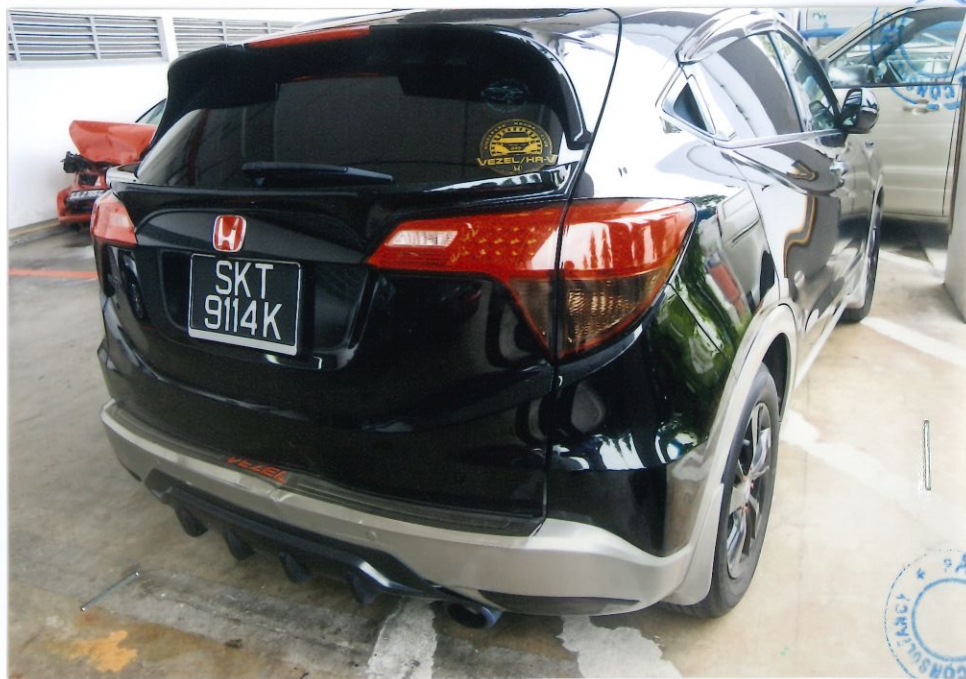
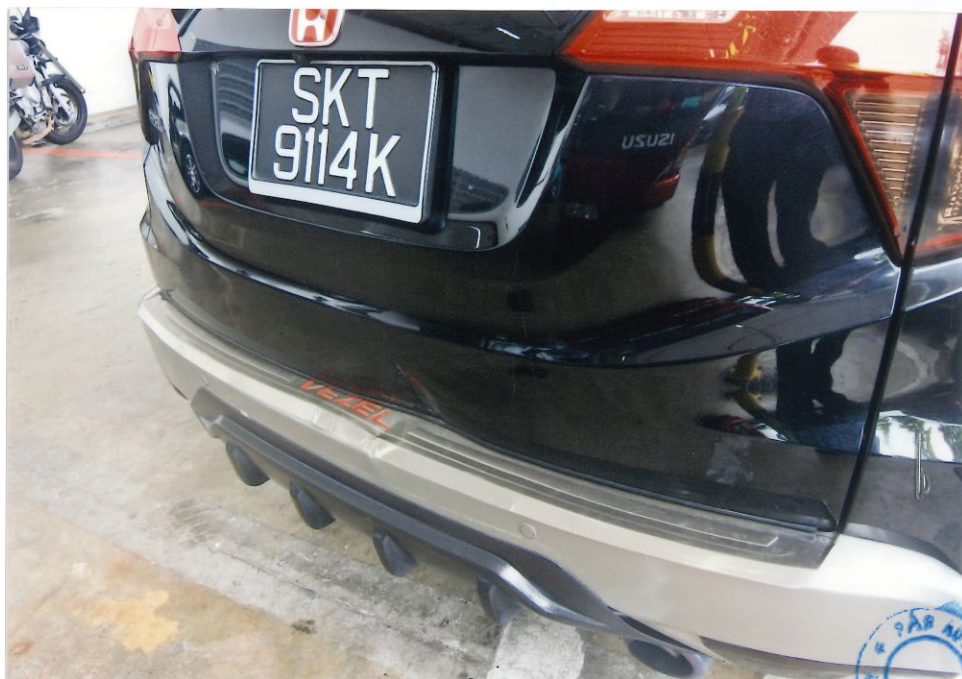
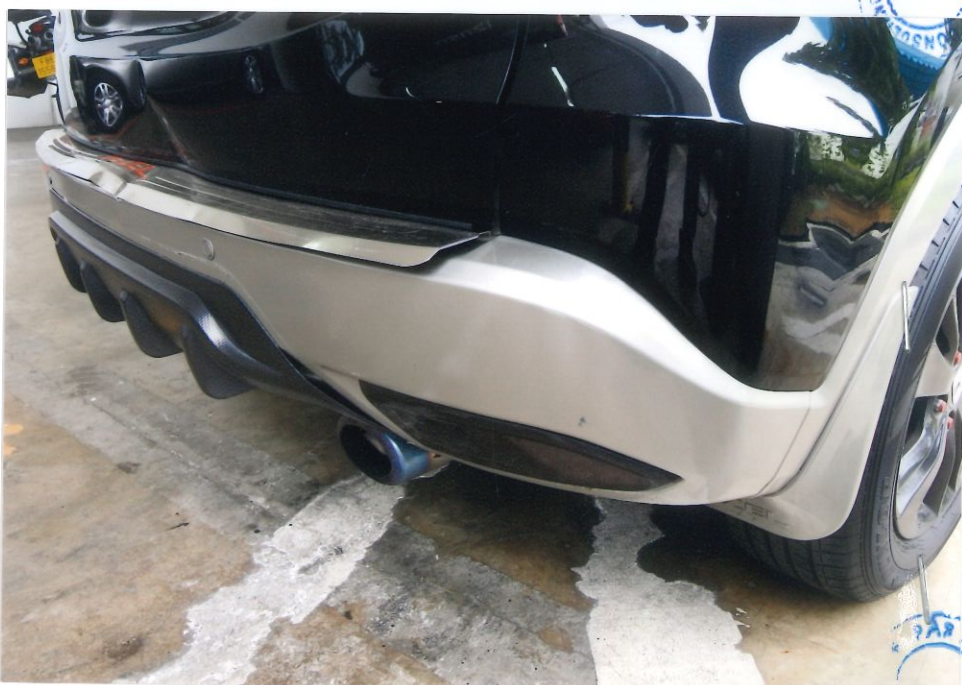
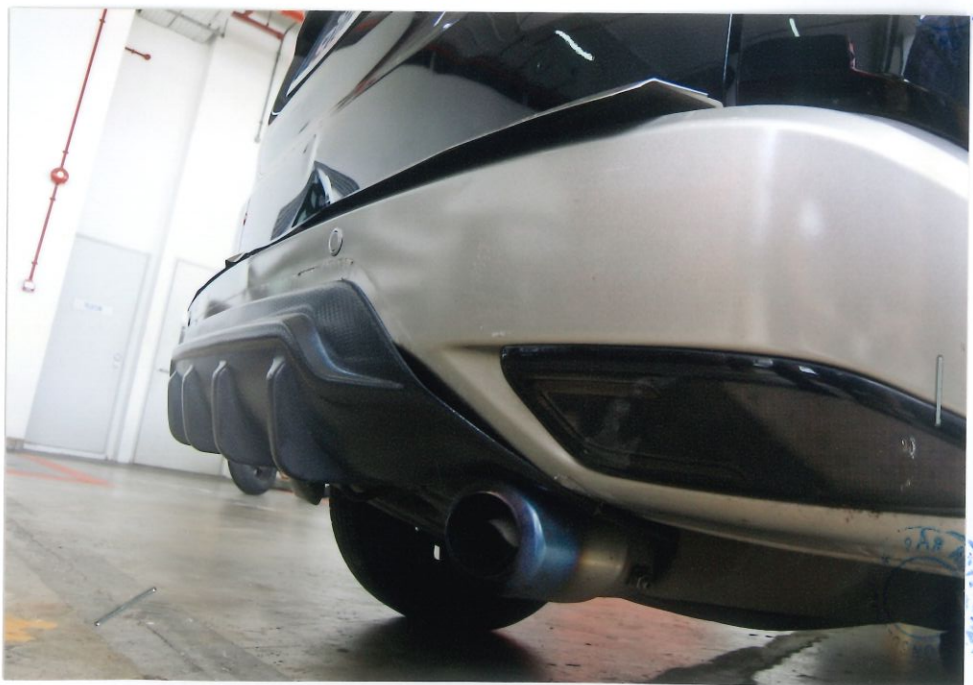
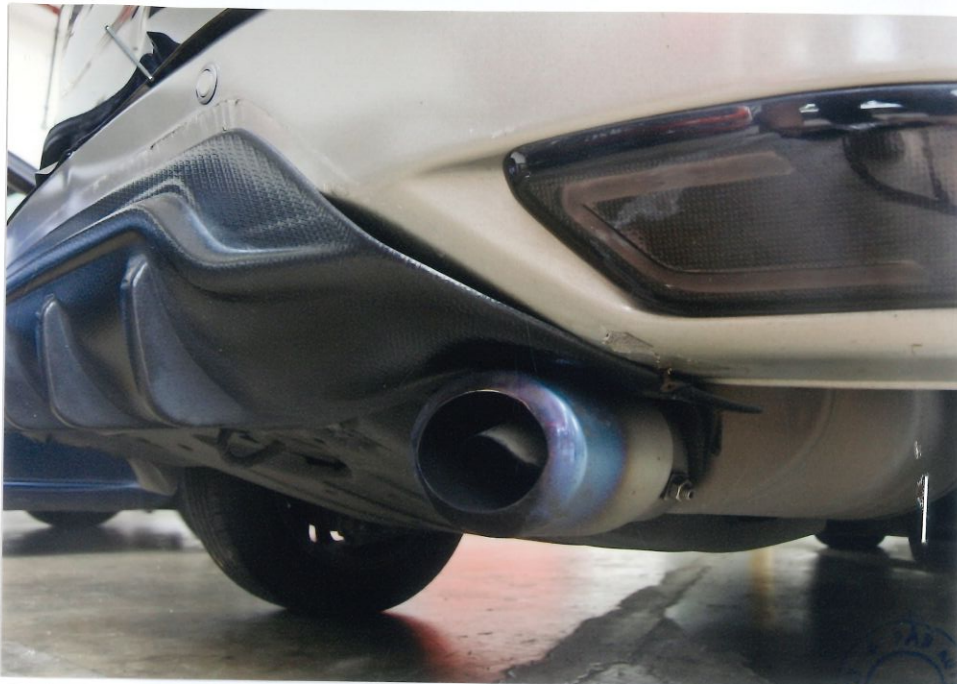
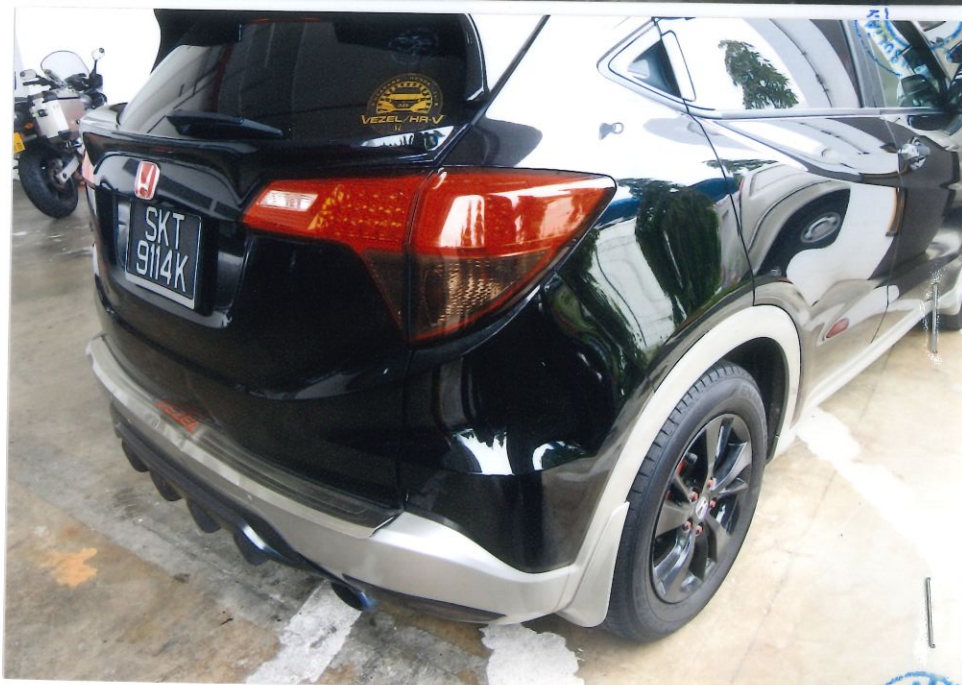
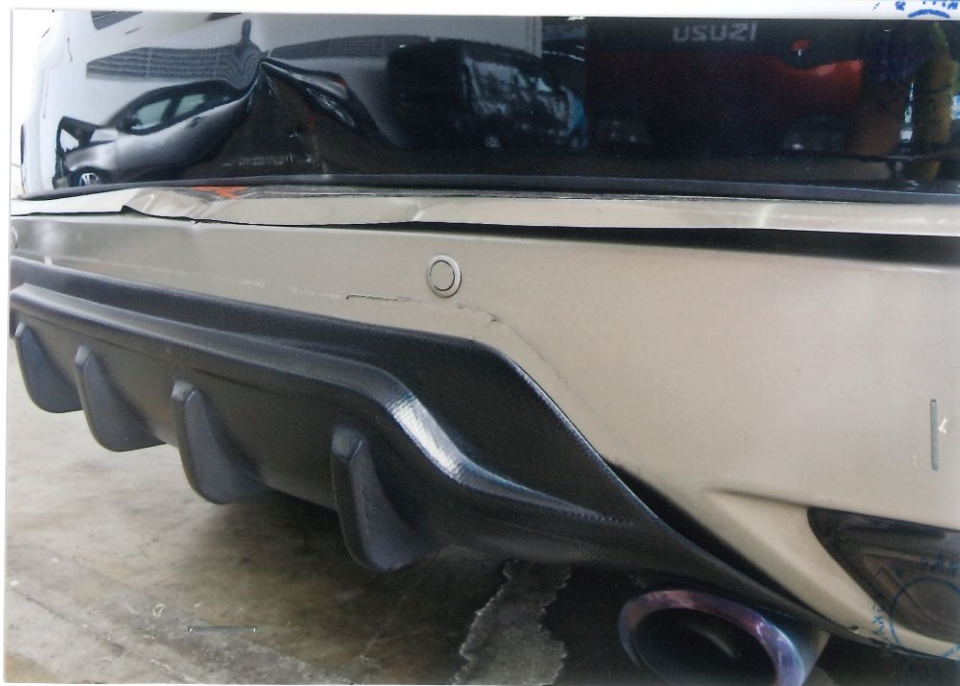
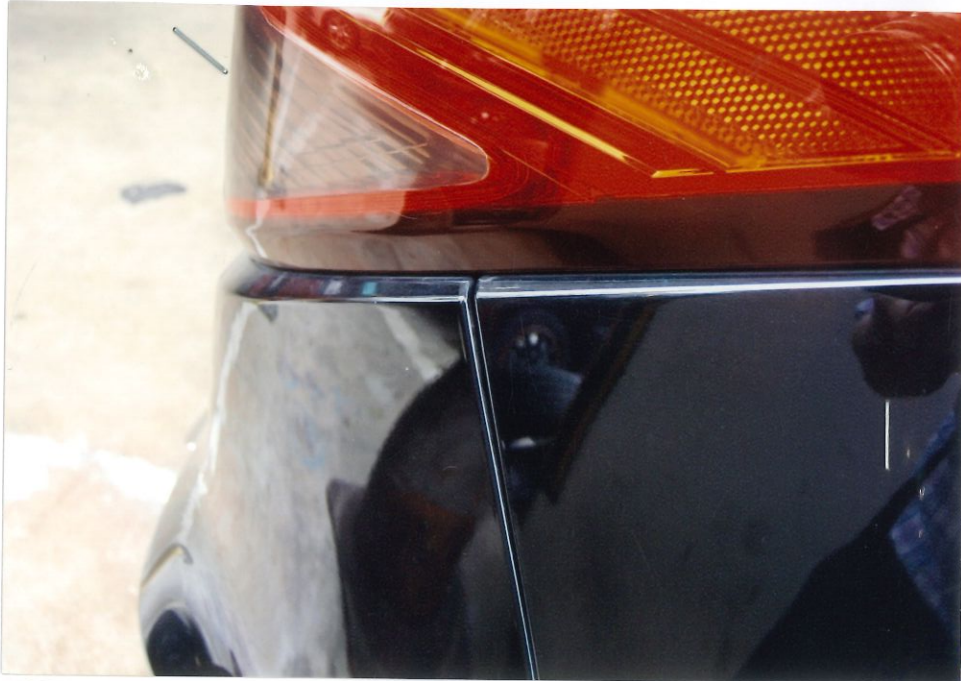
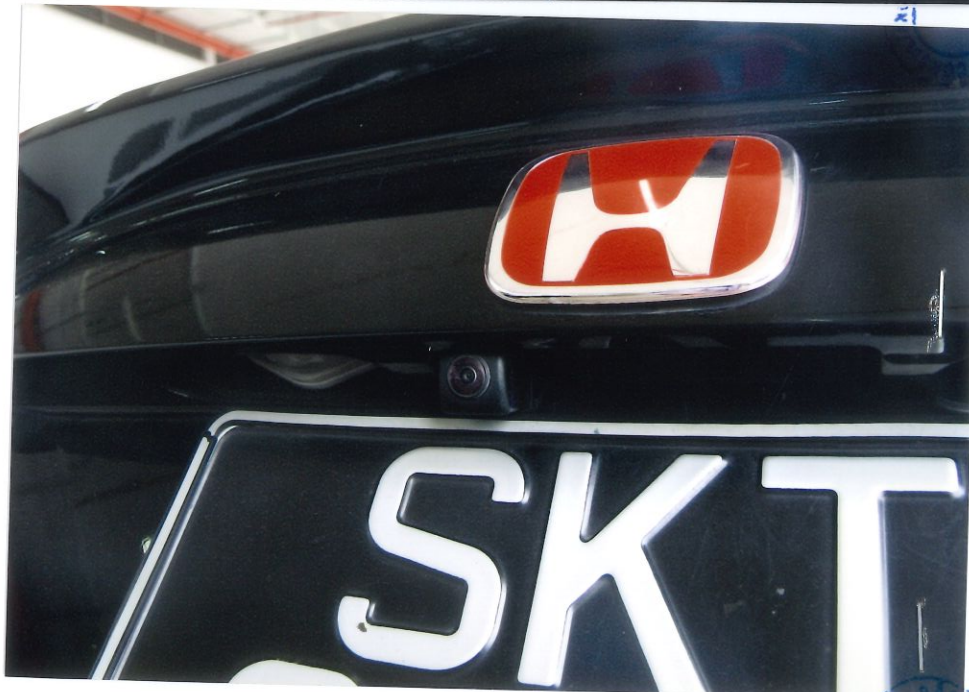
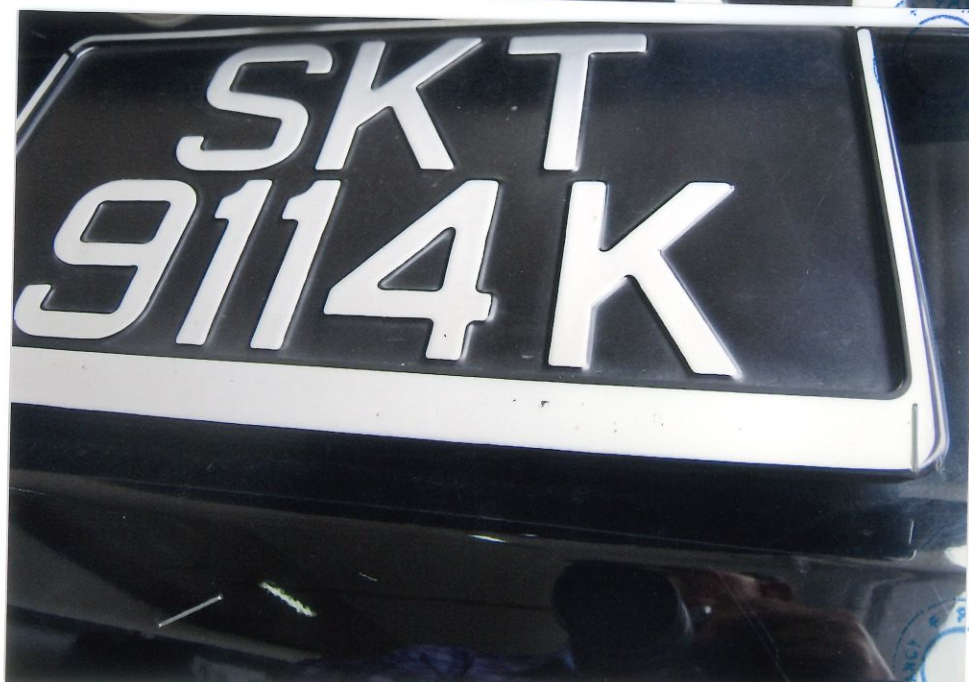
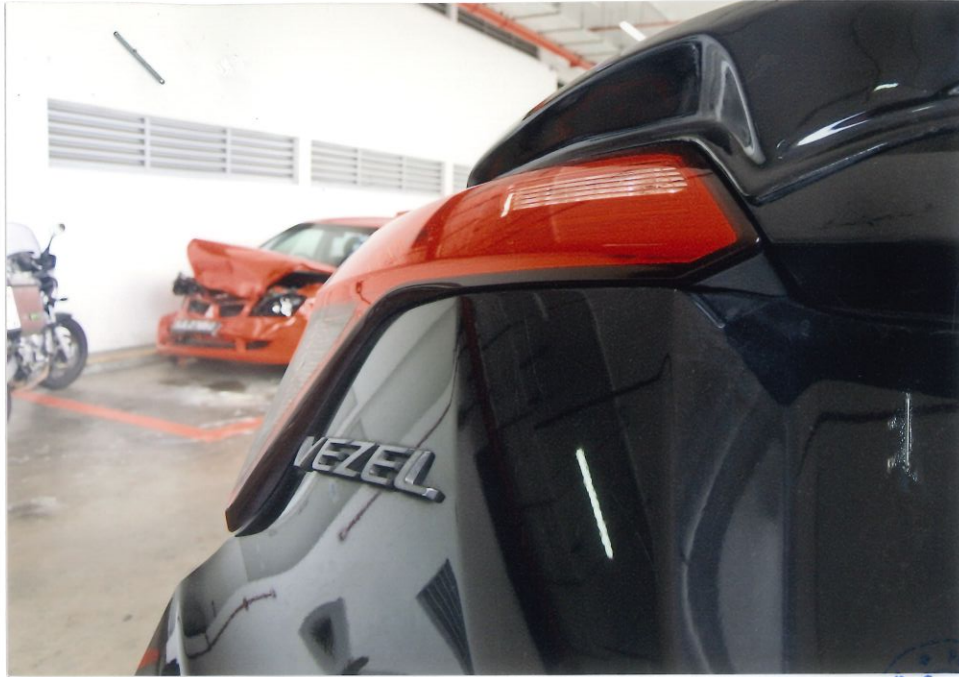
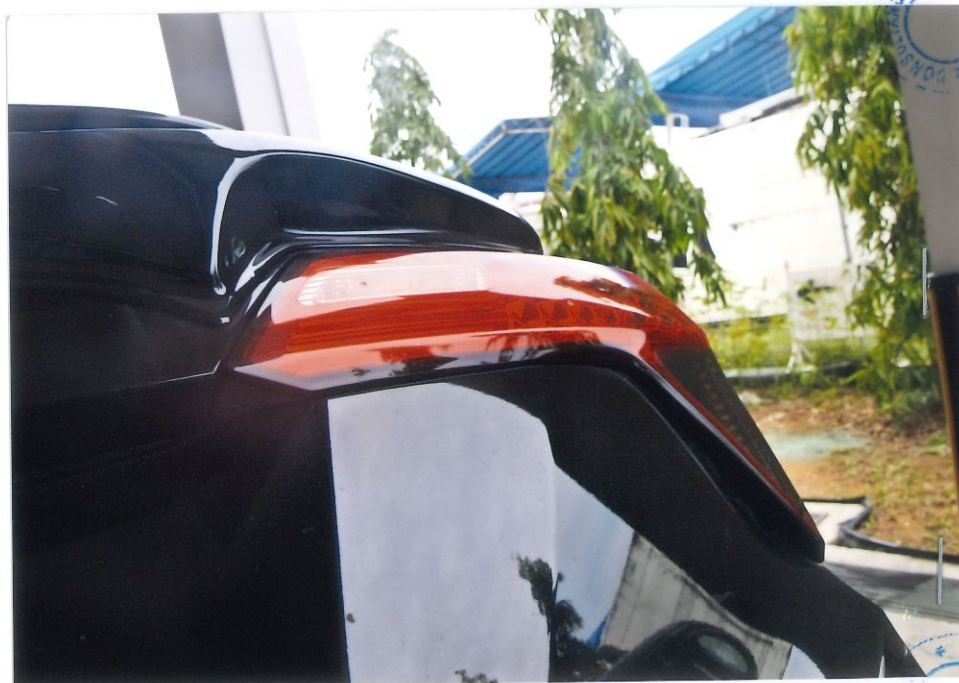
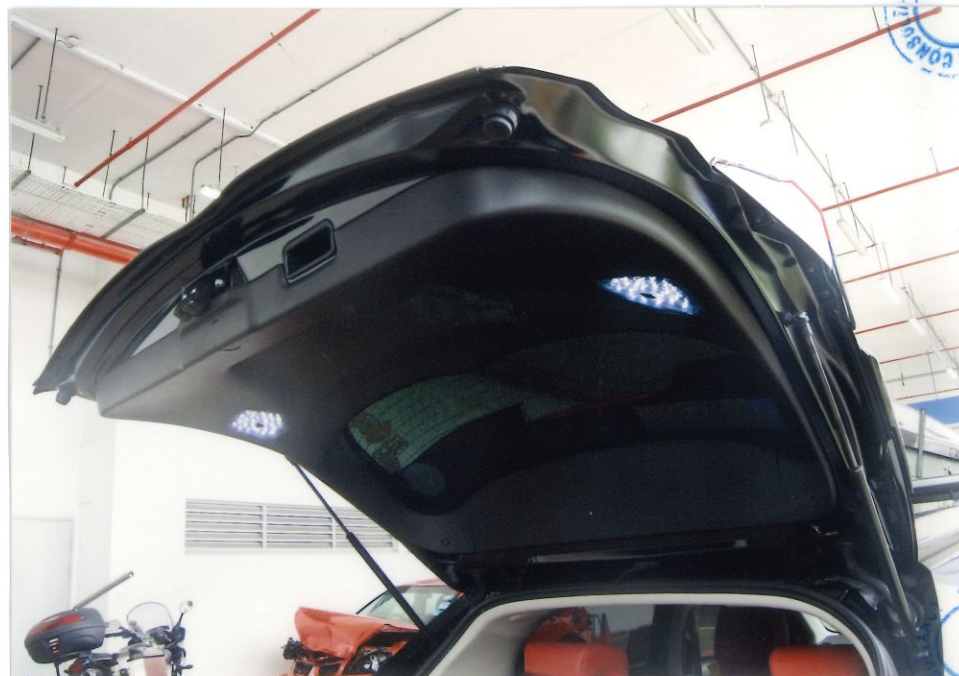
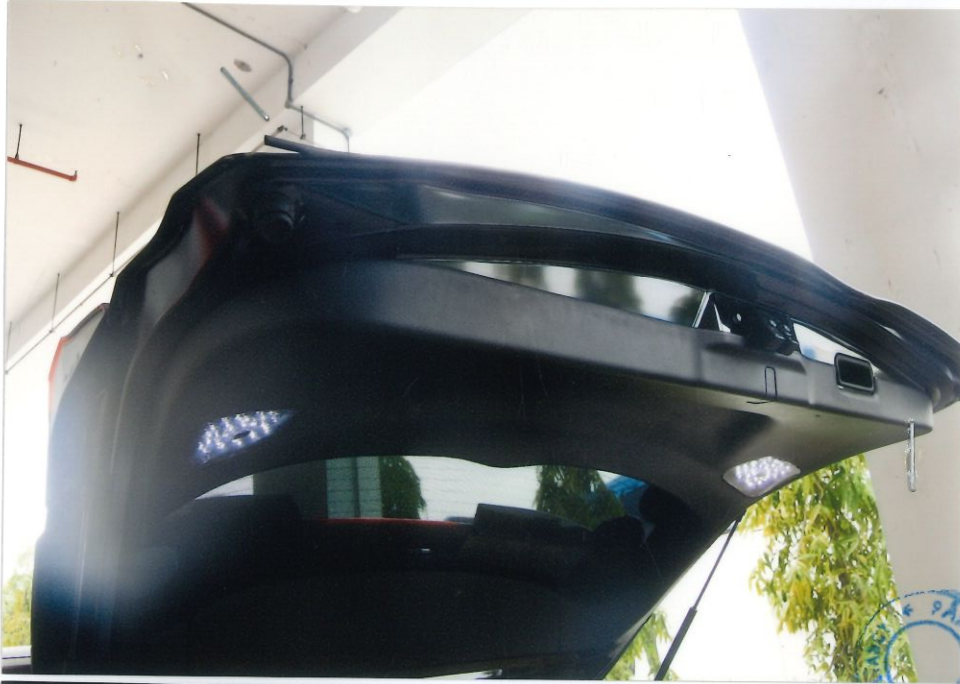
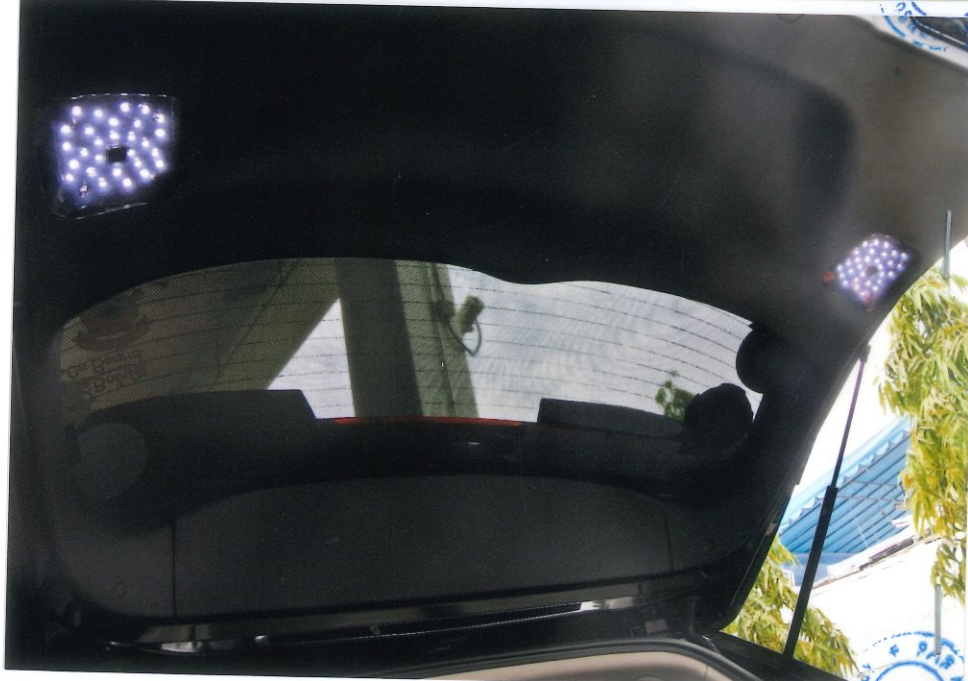
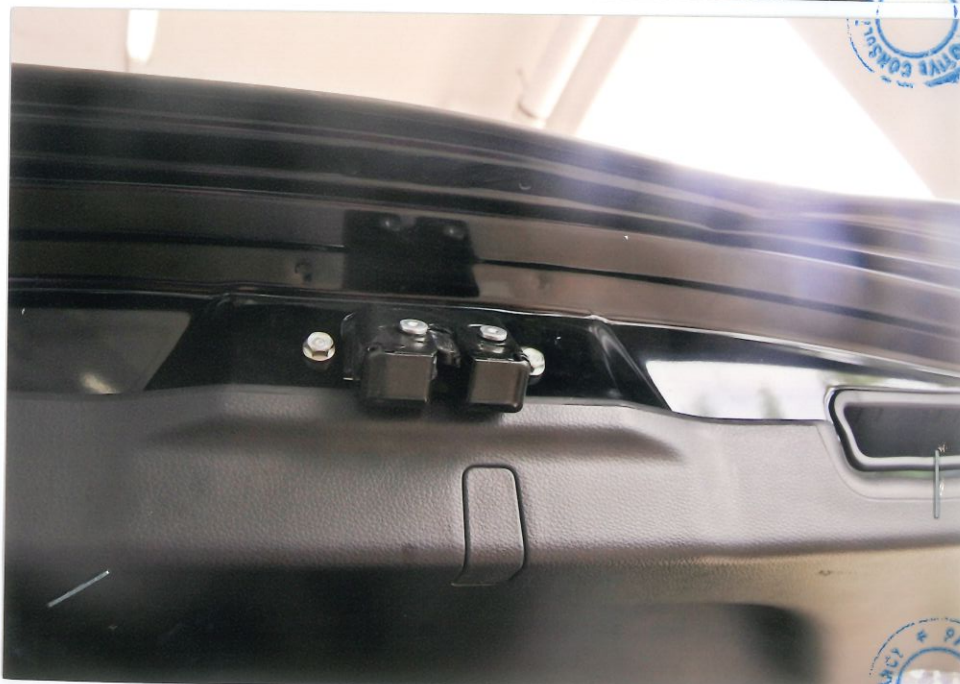
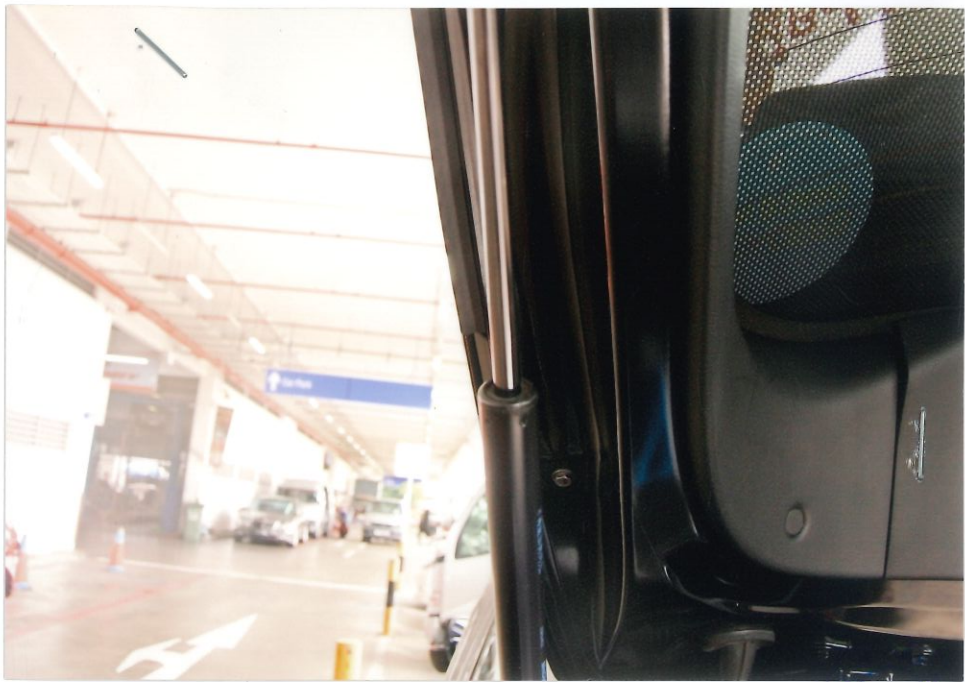
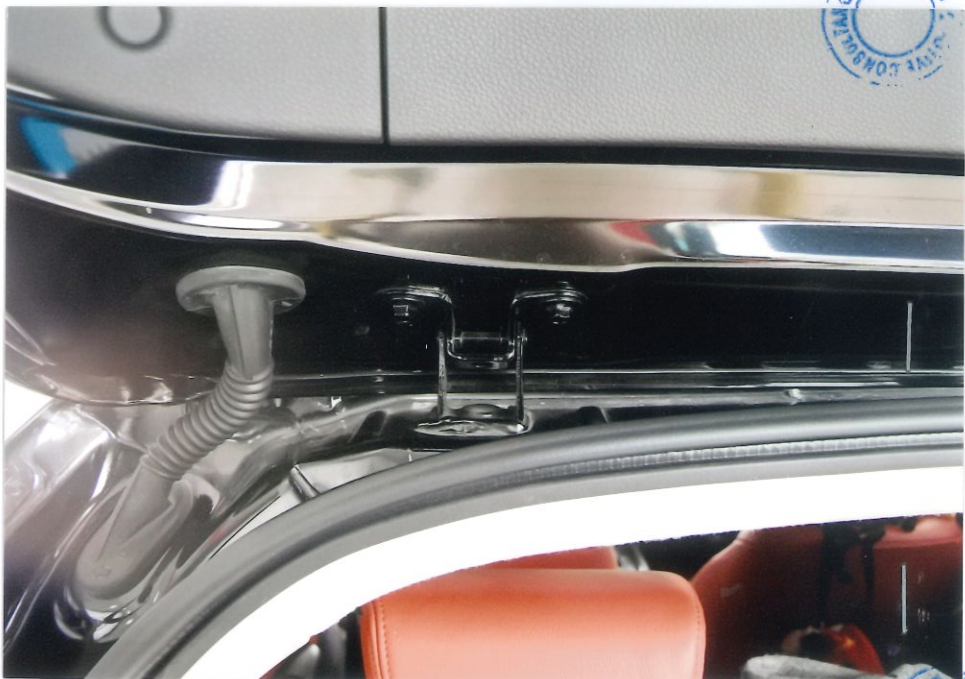
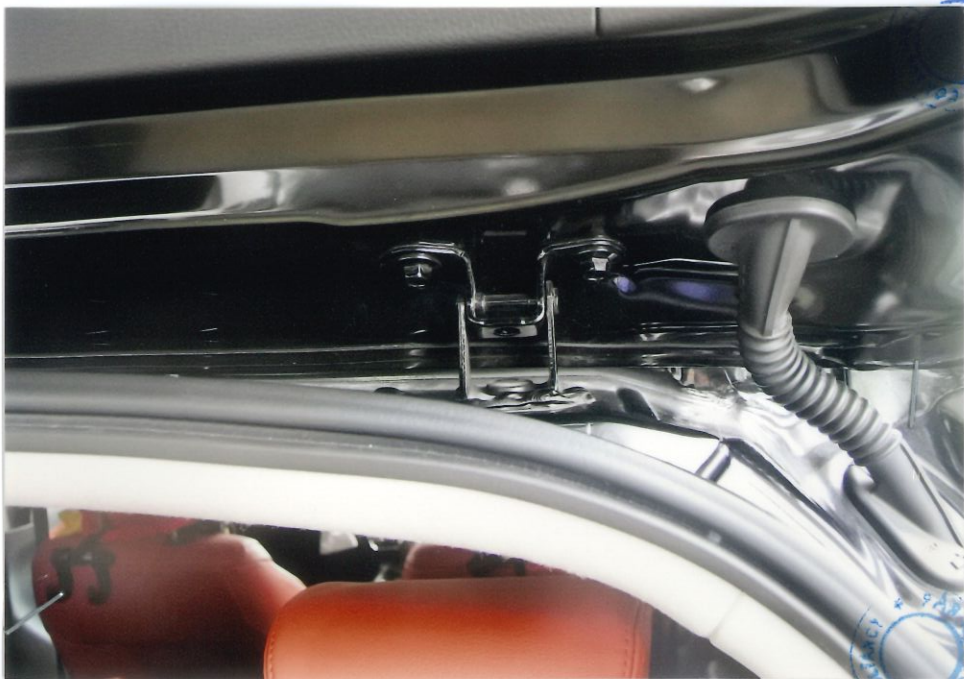
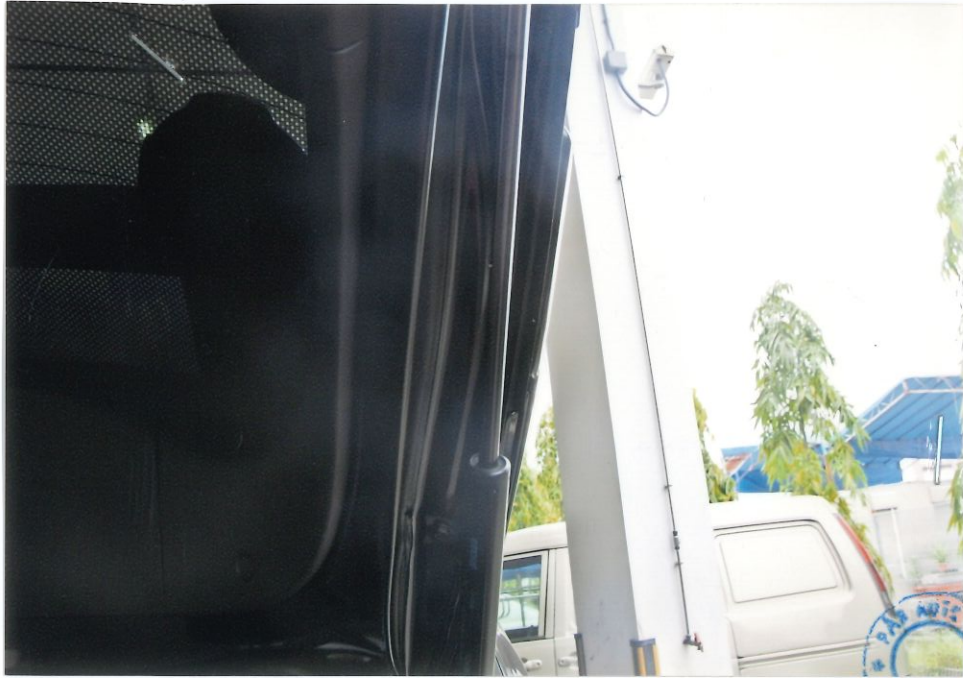
We had carried out re-inspection during works in progress and post repair inspection on the above vehicle. Attached in Annex B are the re-inspection photos, showing the work in progress and our re-inspection to the hidden part that were damaged.
