# PAR Automotive Consultancy

## ACCIDENT VEHICLE SURVEY REPORT

| Vehicle Reg No.: | SKT9114K | Odometer: | 050941km |
| Make & Model: | Honda Vezel 1.5X Auto | Colour: | Blue |

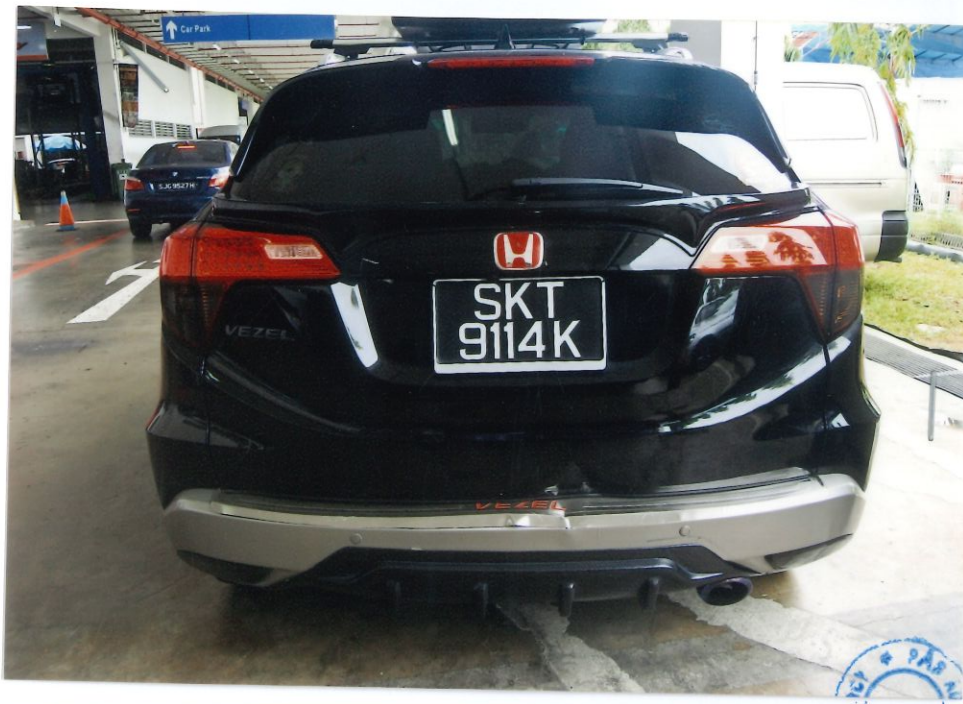
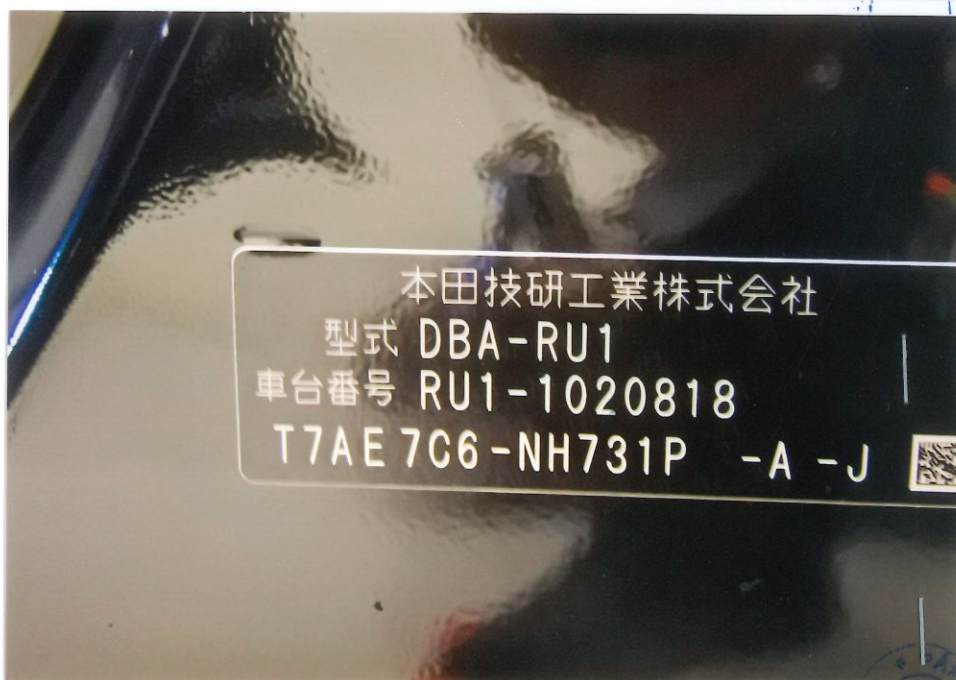
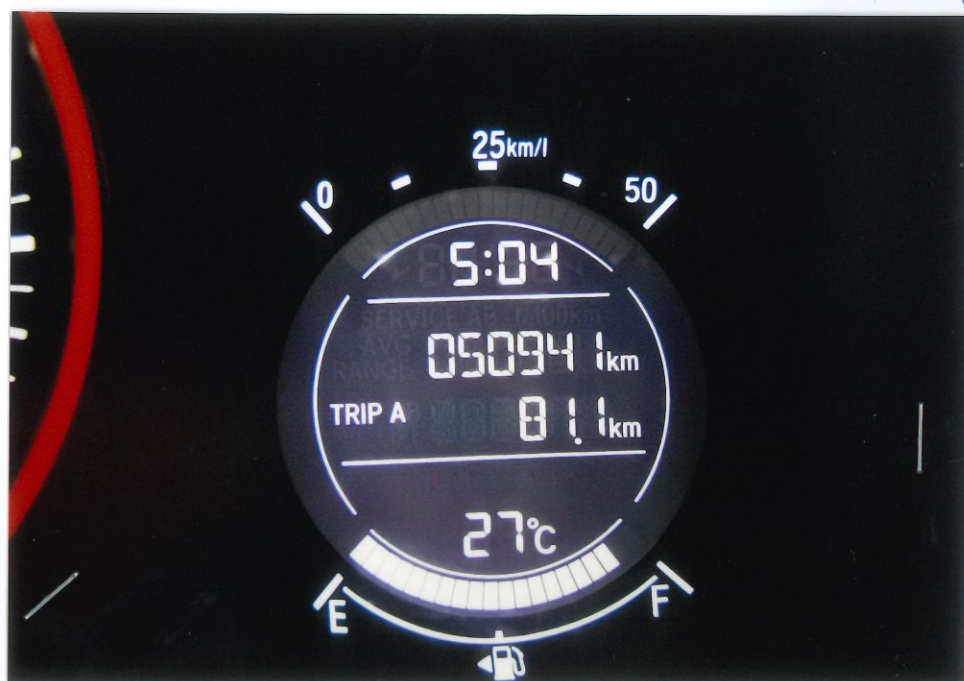
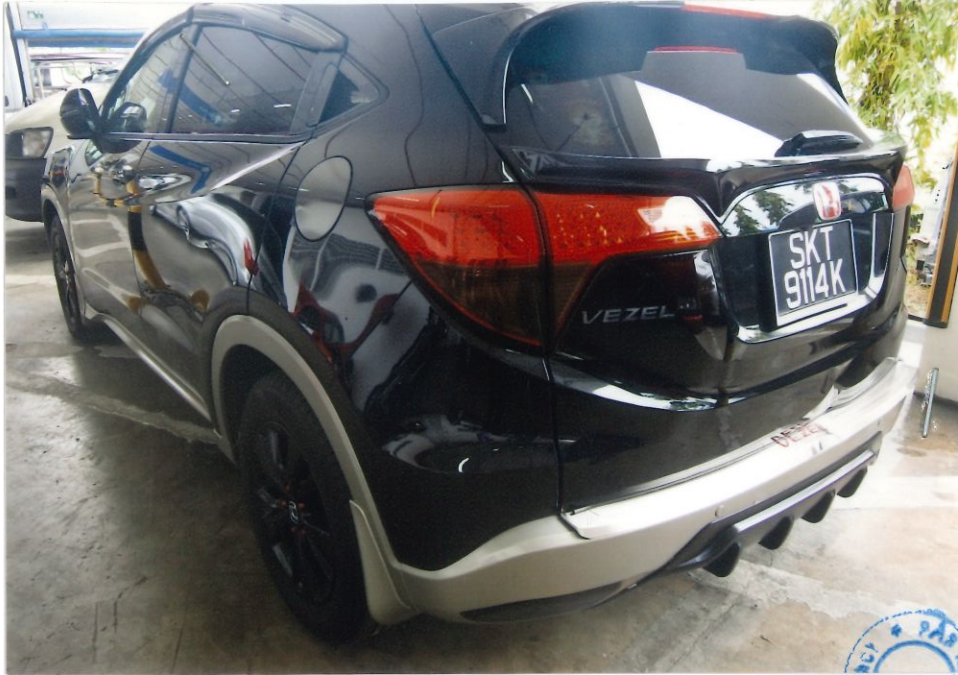
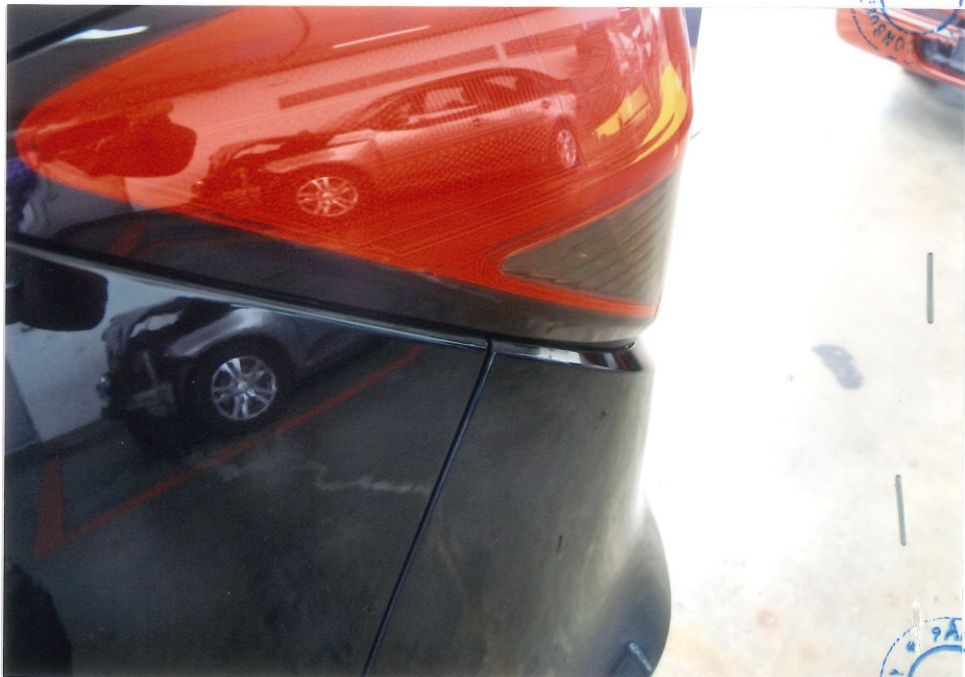
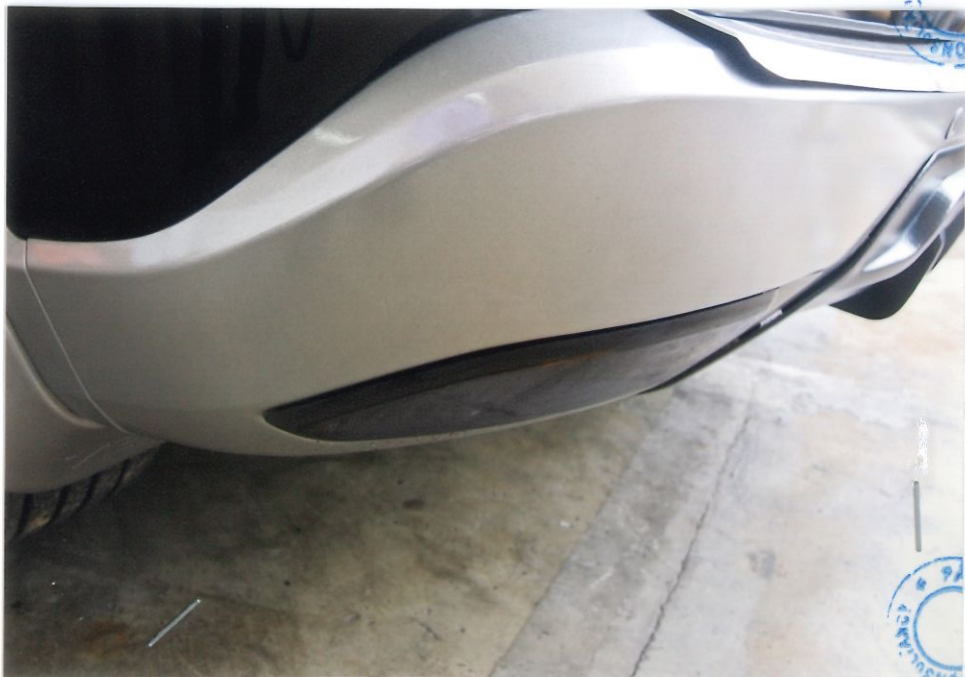
We had carried out re-inspection during works in progress and post repair inspection on the above vehicle. Attached in Annex B are the re-inspection photos, showing the work in progress and our re-inspection to the hidden part that were damaged.
