Report Ref : TP21090035

THIRD PARTY SURVEY ACCIDENT OCCURED ON 30 SEP 2021

Registration No : GBF9630S
Model : MITSUBISHI CANTER
Year / Capacity : APR 2017/ 2998 cc
Chassis No : FEA01BA20519

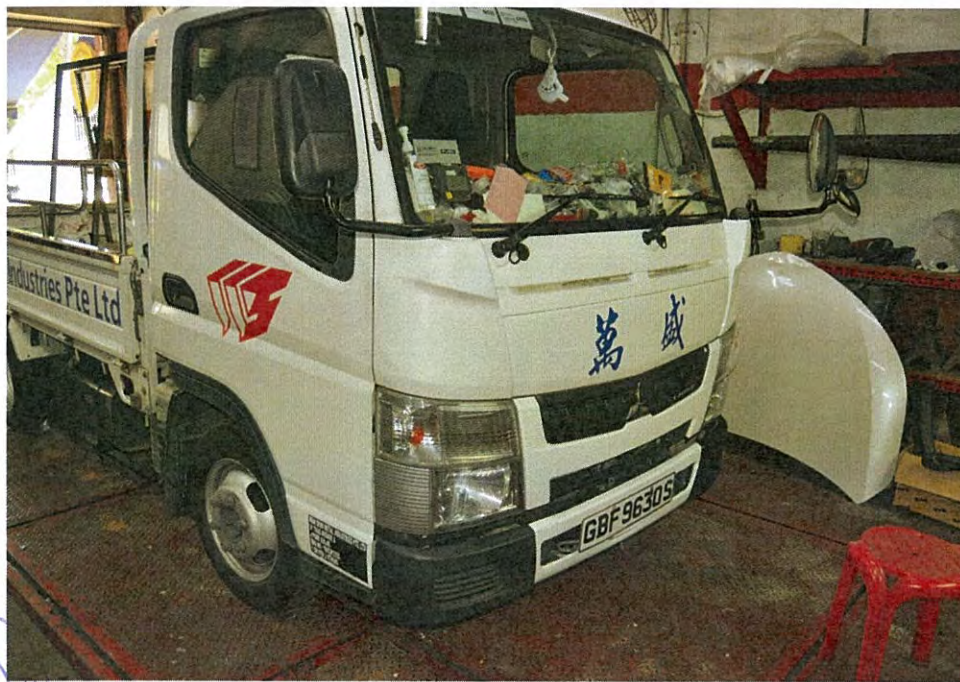
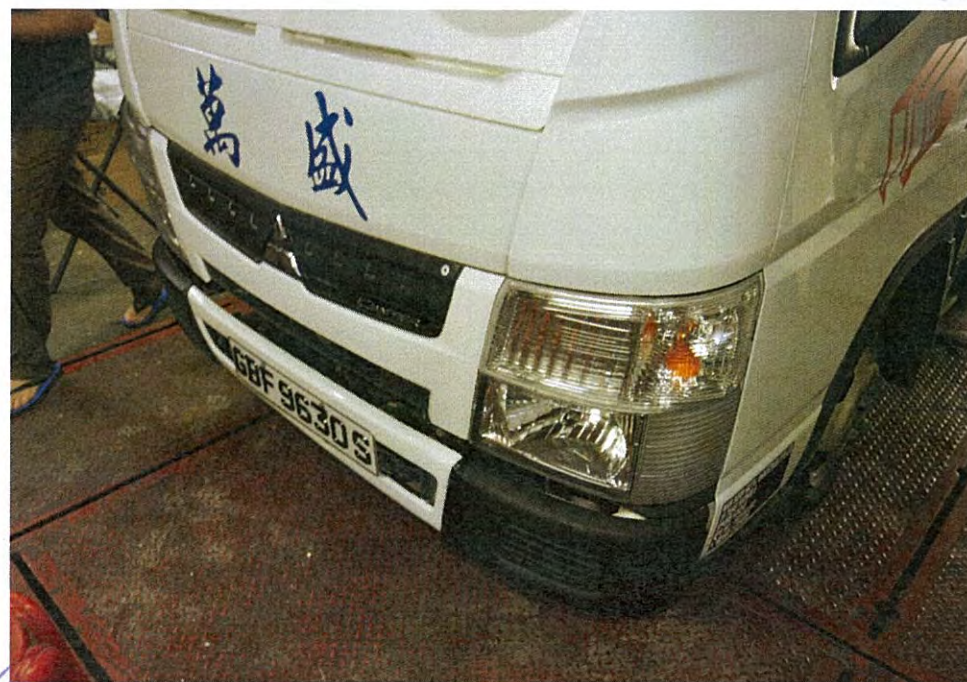
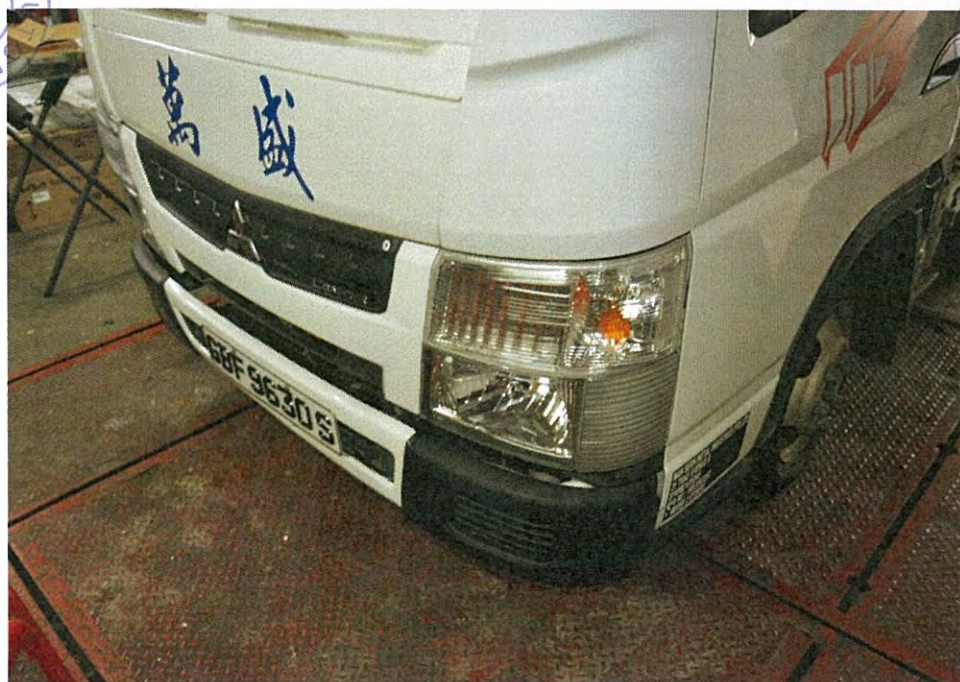
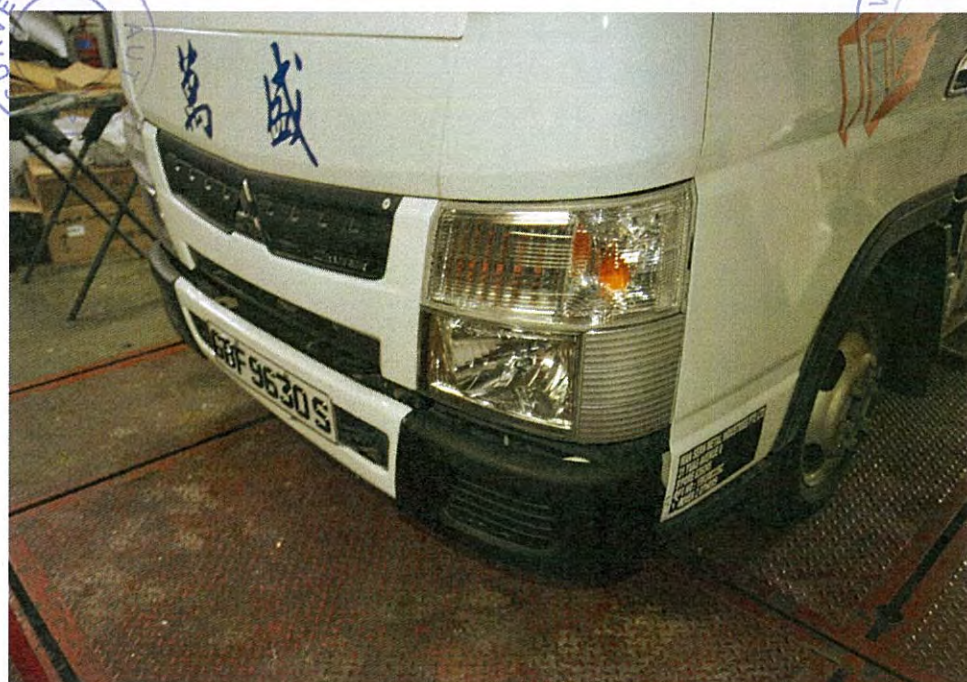
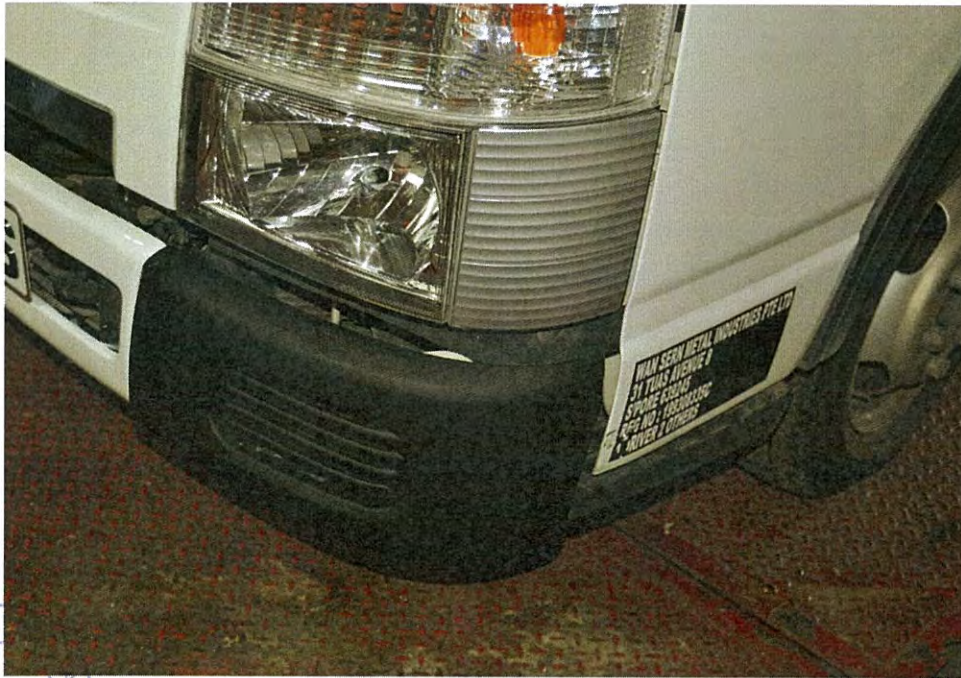
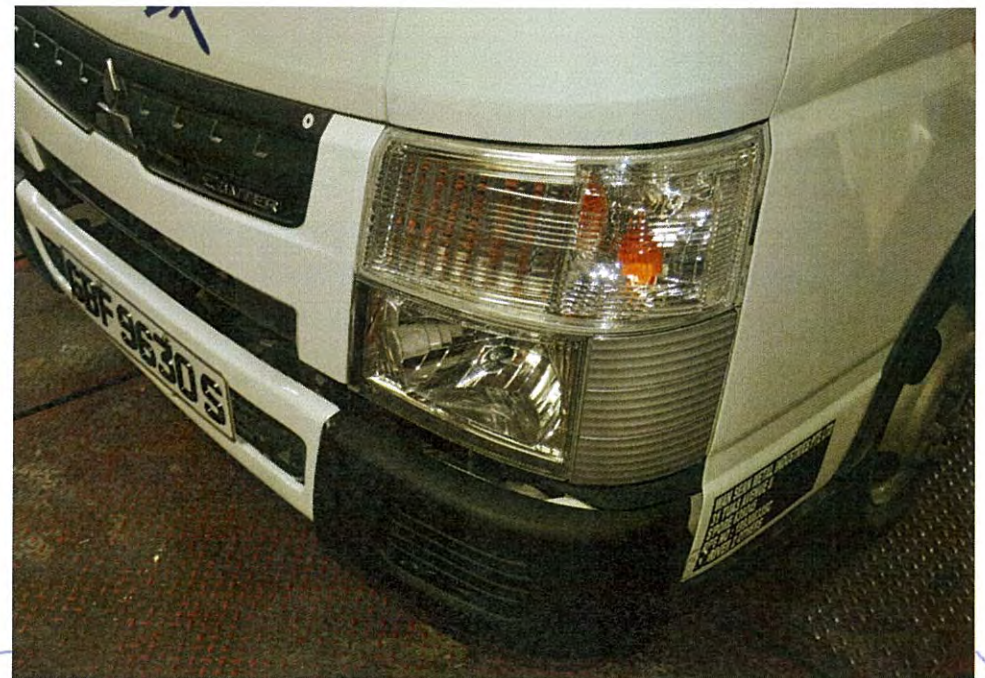
At the time of inspection, we noted that the vehicle has sustained an impact damages on the Front portion(s). For more detail of the damages, please see photograph attached.

1 pc	Front corner panel	Cracked / deformed	\$ 375.00	\$ 375.00
1 pc	Front headlamp assy	deformed	\$ 650.00	\$ 650.00
1 pc	Front signal lamp	Cracked / deformed	\$ 275.00	\$ 275.00
1 pc	Front bumper assy	Warped / deformed	\$ 650.00	\$ 650.00
1 pc	Front bumper side garnish	Warped / deformed	\$ 220.00	\$ 220.00
1 pc	Front Grille	distorted	\$ 340.00	\$ 340.00
4 pcs	Front Grille Clips	necessary	\$ 40.00	\$ 40.00
