DAMAGE ASSESSMENT REPORT

GENERAL INFORMATION			
VAC Ref. No.	: 527286	Claim No.	: D18004220MFSH
Accident Date	: 24/05/2018	Claim Type	: THIRD PARTY
Assignment Date	: 28/05/2018	Policy No.	:
Survey Date	: 28/05/2018		
Report Date	: 28/05/2018	Insured Veh.	: SHA4557J
VEHICLE PARTICULARS			
Vehicle No.	: SKJ6080X	Chassis No.	: WVWZZZ13ZCV034933
Registration Date	: 08/08/2012	Engine No.	: CAV409329
Make	: VOLKSWAGEN	Engine Cap.	: 1390CC
Model	: SCIROCCO 1.4L AT TS	Transmission	: AUTOMATIC
		Colour	: MATT GREY
CONDITION OF VEHICLE DURING SURVEY (VISUAL and STATIC TEST ONLY)			
Foot Brake	: SERVICEABLE	Steering	: SERVICEABLE
Hand Brake	: SERVICEABLE	Modification	: NONE
Mileage	: 123779		
TYRES	SIZE	MAKE	BALANCE (mm)
FRONT RH	235/40 R18	GOODYEAR	6
FRONT LH	235/40 R18	GOODYEAR	6
REAR RH	235/40 R18	GOODYEAR	6
REAR LH	235/40 R18	GOODYEAR	6
SURVEY CONDUCTED AT			
N51 AUTO P/L K BUKIT AUTOHUB 2 K BUKIT AVE 2 #01-18 S417921 MELODY:68420051			
REMARKS

Annex B: Comments

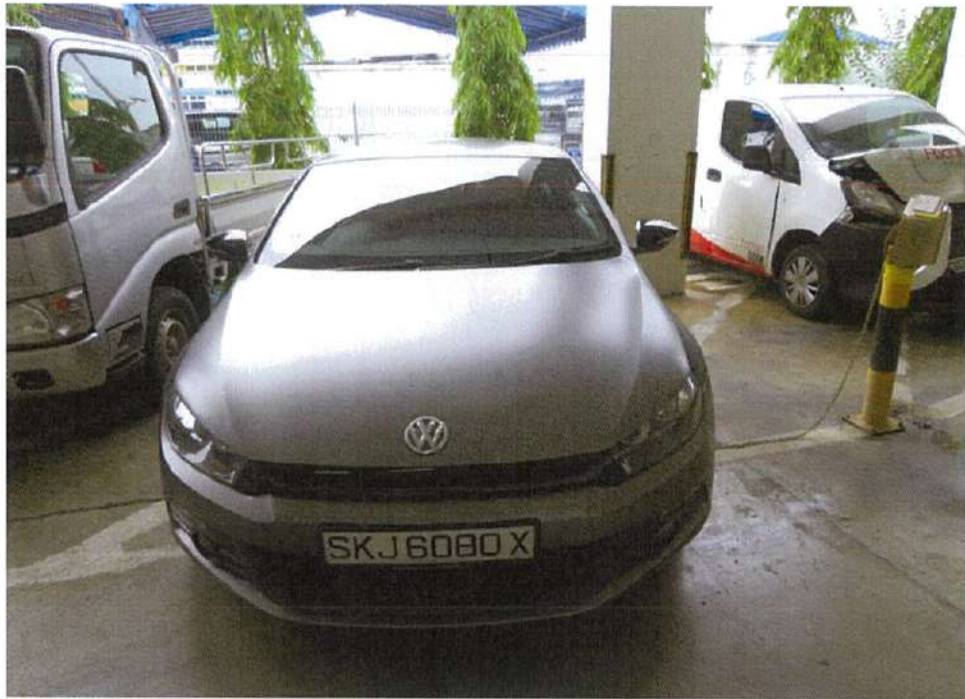
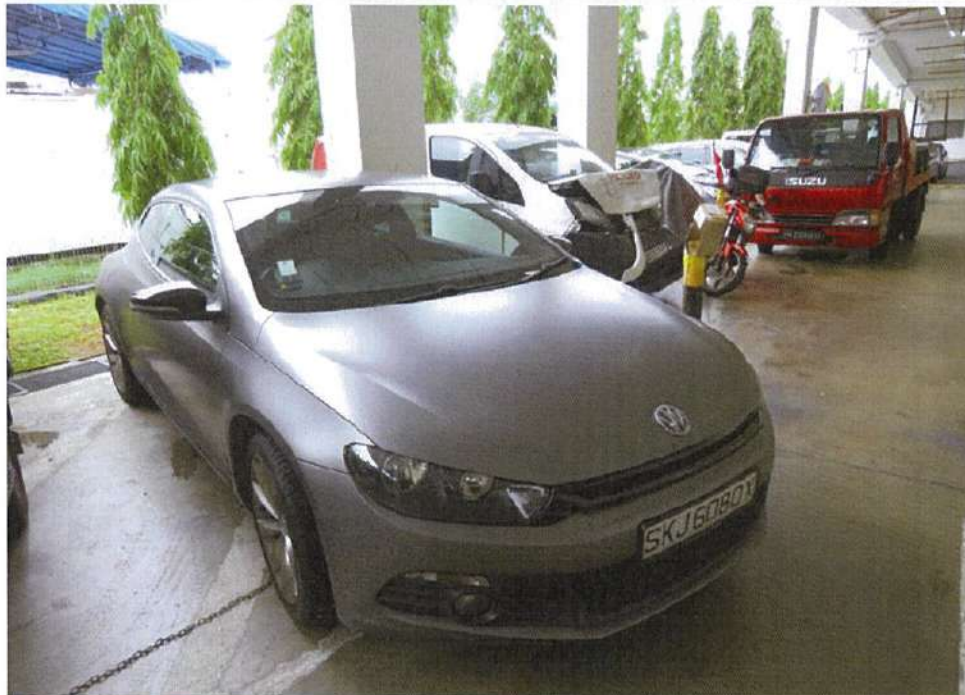
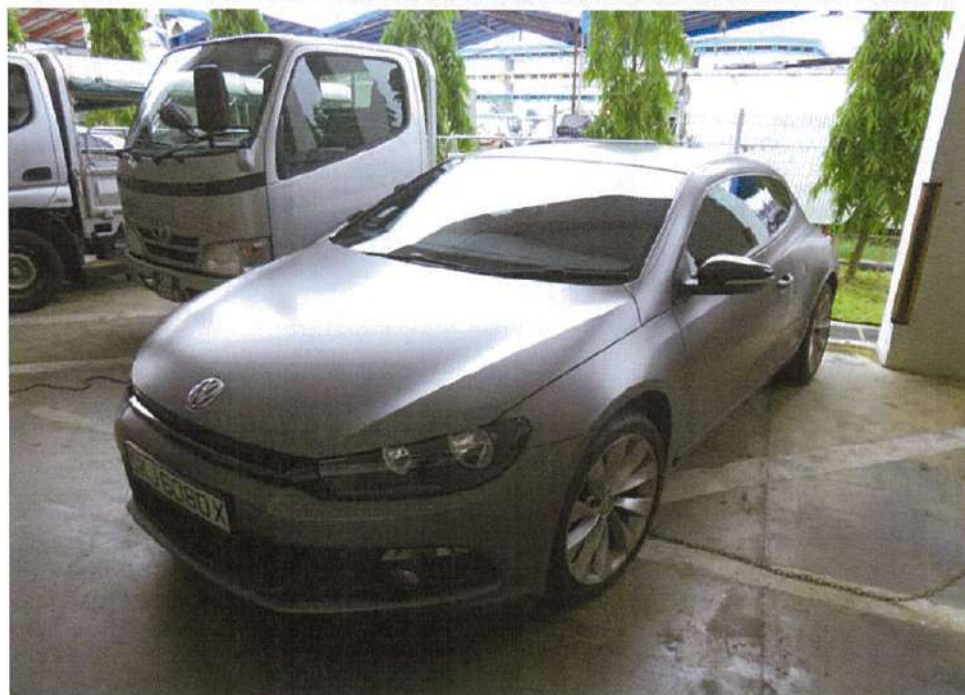
At the place of inspection, we saw this vehicle sustained left hand portion damage.

The damages seen during our survey were door (lh), door protector (lh), rear fender (lh), rear fender protector (lh), rear bumper, rear wheel rim (lh) and surrounding areas. A fuller detailed description of the damages is in Annex A of this damage assessment report.
