## LKK Auto Consultants Pte Ltd

### PROFESSIONAL SERVICE FEE

Vehicle No. GBH 5371E  
Insured Veh. YQ 3695P  
Claim No. SNM22D201039/C02  
Policy No. DMCVSNA00119112101  
Accident Date 10/02/2022  
Inspection Date 17/03/2022

## ADJUSTMENT ON REPAIR COST FOR VEHICLE NO. GBH 5371E

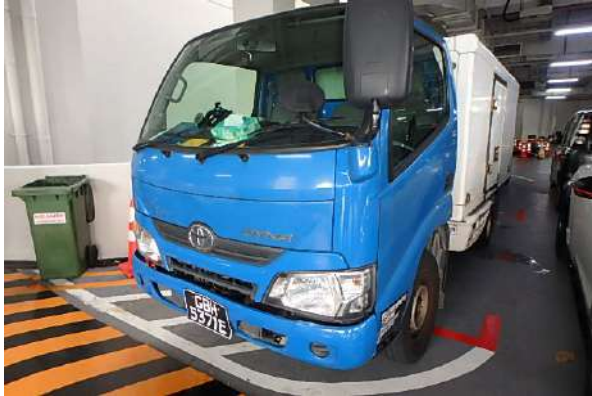
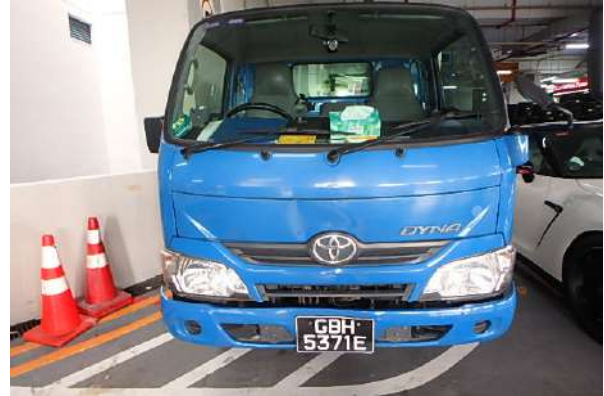
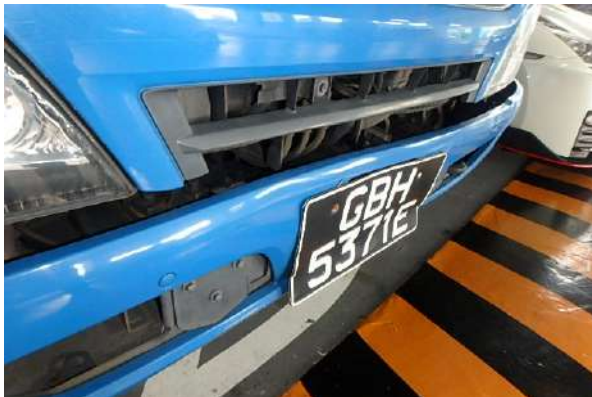
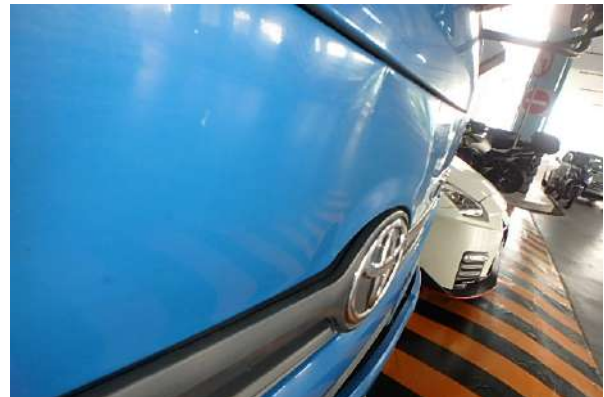
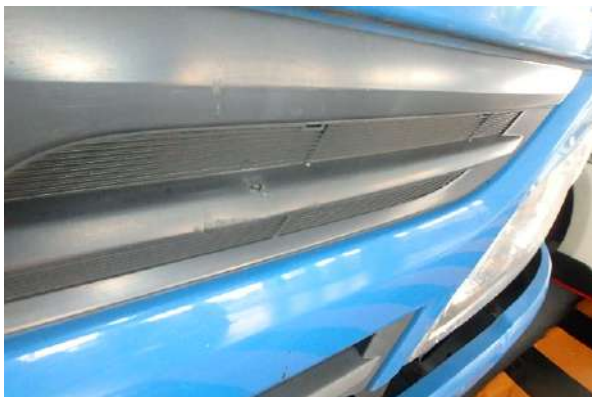
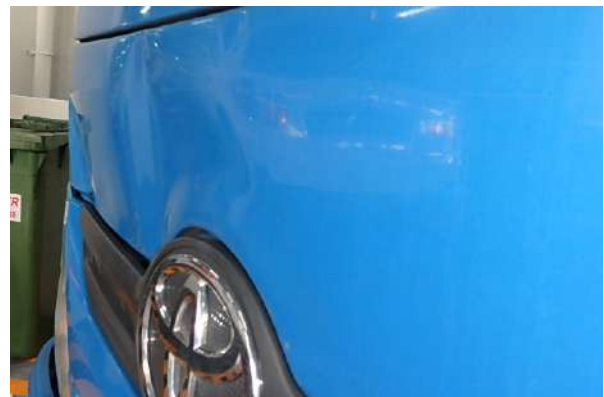
### INSPECTION

| Affiliated to Federation Internationale Des Experts En Automobile | | | | |
|---|---|---|---|--|
| THE VEHICLE SUSTAINED DAMAGES AT THE FRONT PORTION.<br>DAMAGES SEE DETAILS. | | | | |

### PHOTOGRAPHS FOR VEHICLE NO. GBH 5371E

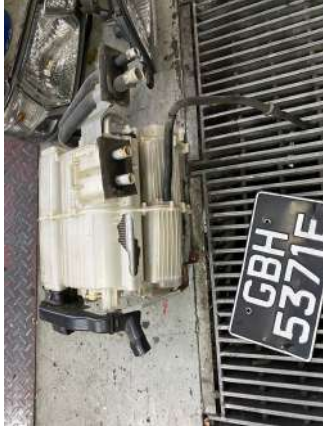
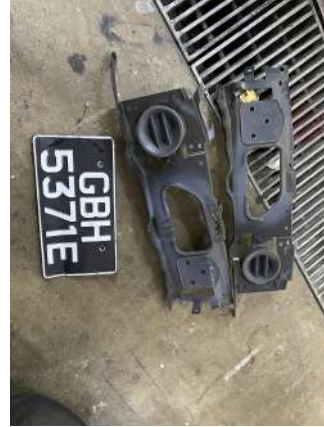
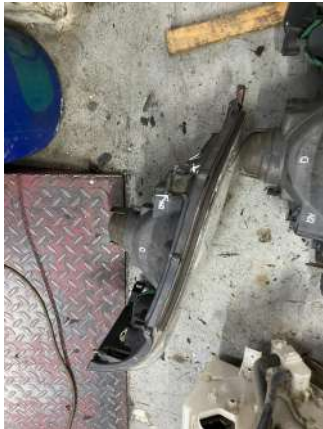
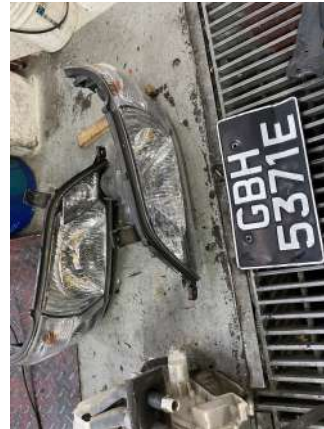
### RE-INSPECTION

### PHOTOGRAPHS FOR VEHICLE NO. GBH 5371E
