## LKK Auto Consultants Pte Ltd

Vehicle No. SLS 1489A  
Insured Veh. SJL 731S  
Claim No. SNM22D201230/C02  
Policy No. DMPCSNW00059322100  
Accident Date 09/02/2022  
Inspection Date 16/02/2022

## ADJUSTMENT ON REPAIR COST FOR VEHICLE NO. SLS 1489A

### PHOTOGRAPHS FOR VEHICLE NO. SLS 1489A

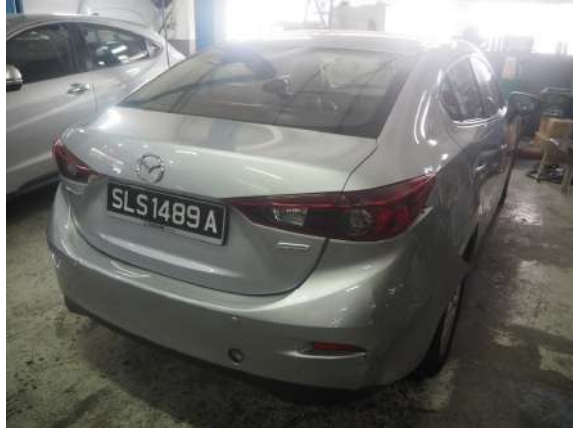
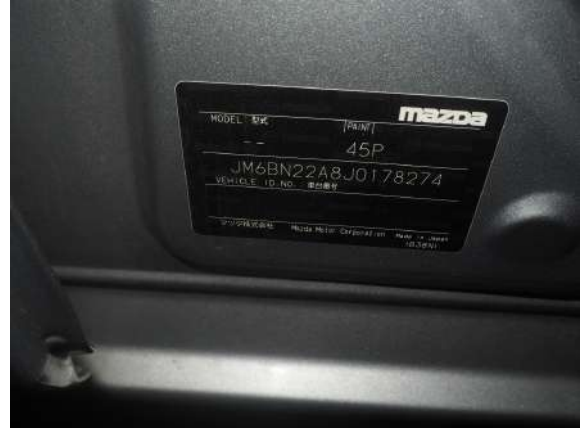
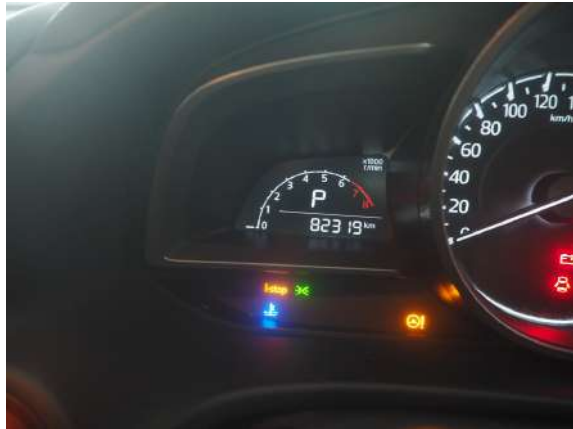
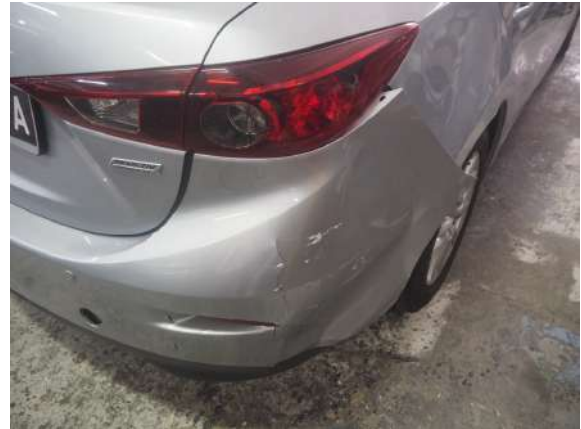
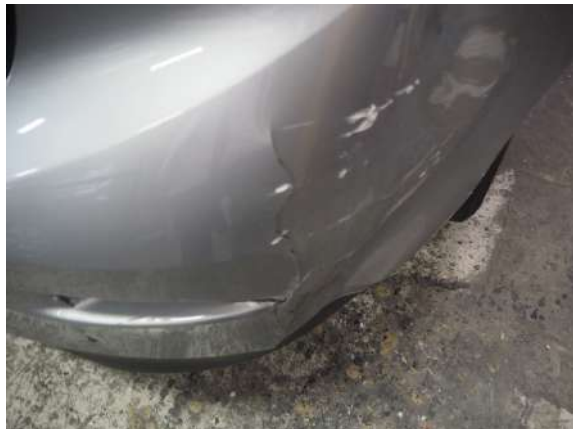
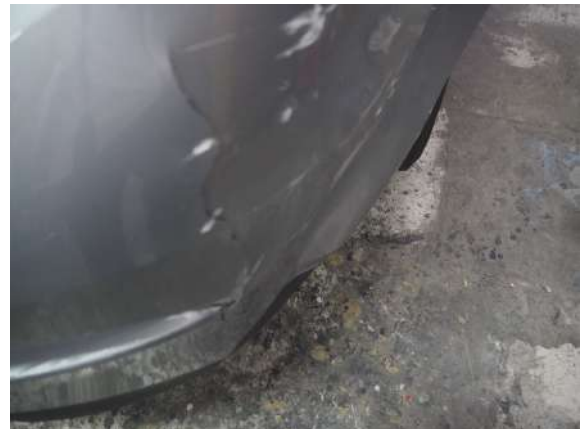
### INSPECTION

| Affiliated to Federation Internationale Des Experts En Automobile | | | | |
|---|---|---|---|---|
| THE VEHICLE SUSTAINED DAMAGES AT THE REAR O/S PORTION. | | | | |
