## VEHICLE DAMAGE ASSESSMENT REPORT

| Third party vehicle | : SLT4267Z | Date of Accident | : 16/11/2021 |

| Model / Make | : Honda Freed Hybrid | Pre-accident damage | : NIL |

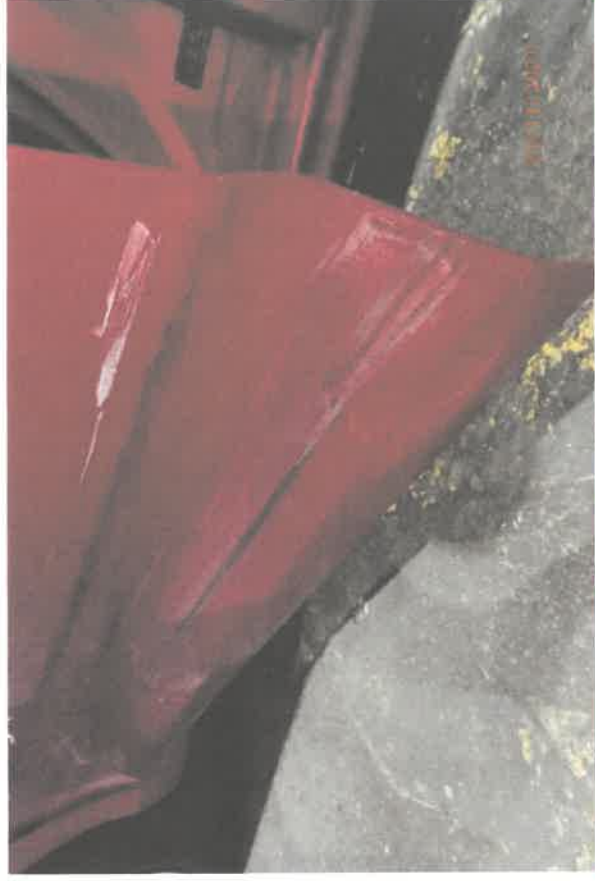
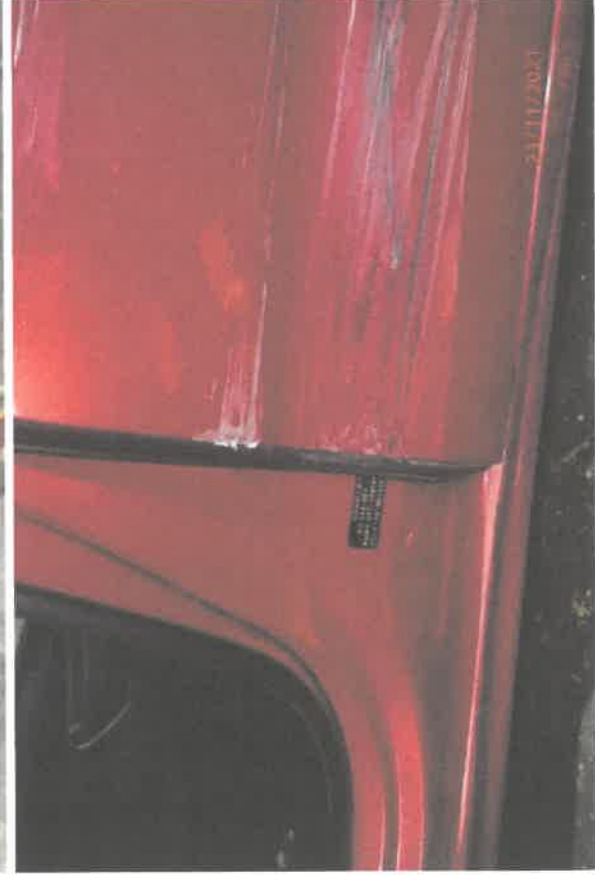
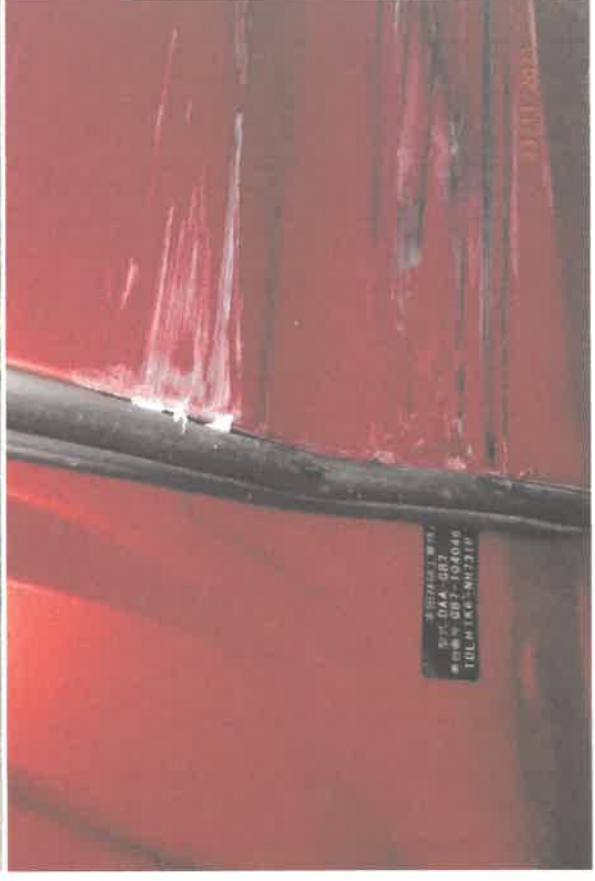
## A close-up photograph of a red car's body panel, likely a fender or door. A large, irregular white scratch or gouge mark is visible on the side of the panel. The scratch appears to be made of a hard material, possibly a rock or metal, and has a rough, textured appearance. The red paint is visible around the edges of the scratch. The background is dark and out of focus.

Front lh fender scartch, front lh door, lh sliding door, rear lh fender dented. Rear lh sport rim grazed, rear lh tyre wall torn, lh undercarriage push in etc.

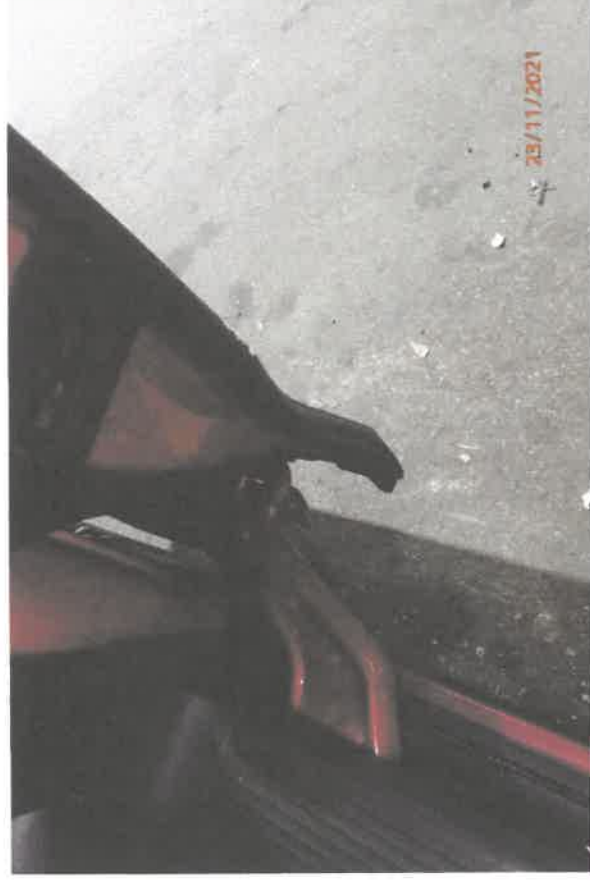
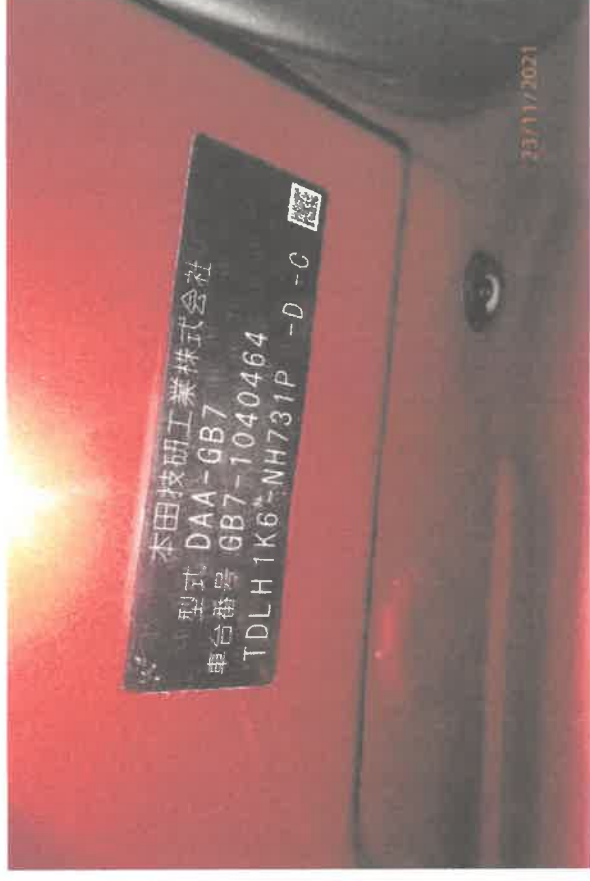
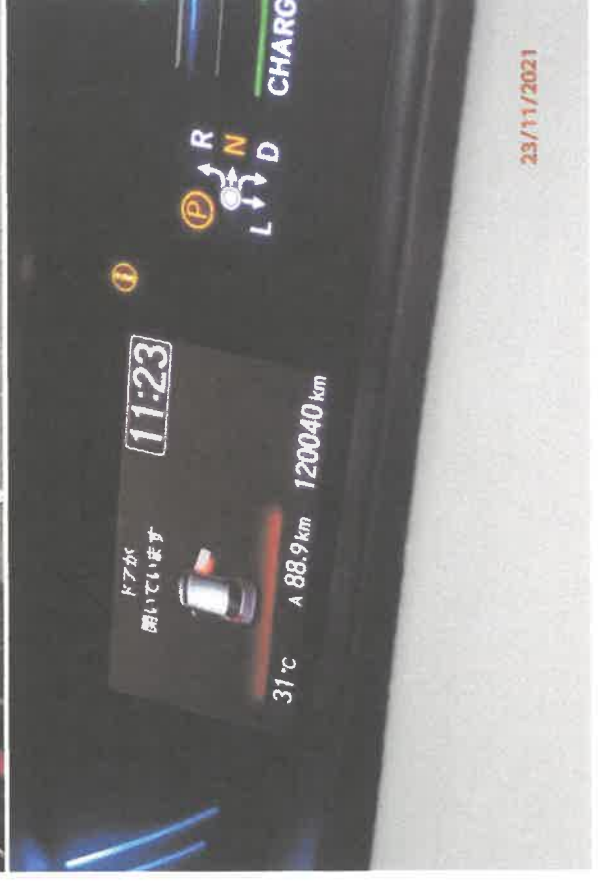
# INSPECTION PHOTOS

At the time of inspection, this vehicle sustained damages to the **Lh portion**.
