## ADJUSTMENT ON REPAIR COST FOR VEHICLE NO. SHD 6077Z

PHOTOGRAPHS FOR VEHICLE NO. SHD 6077Z

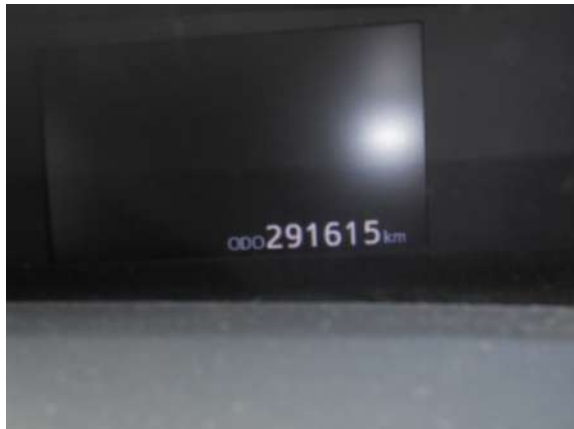
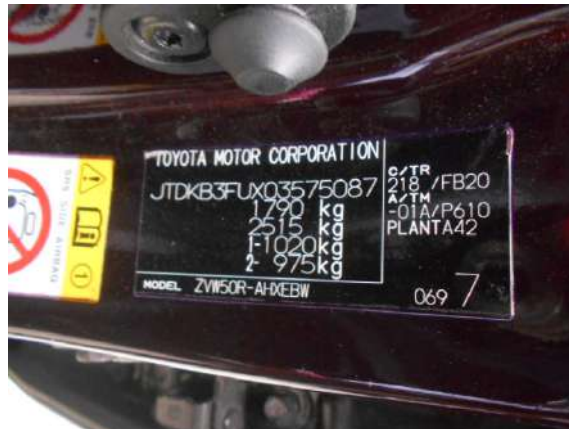
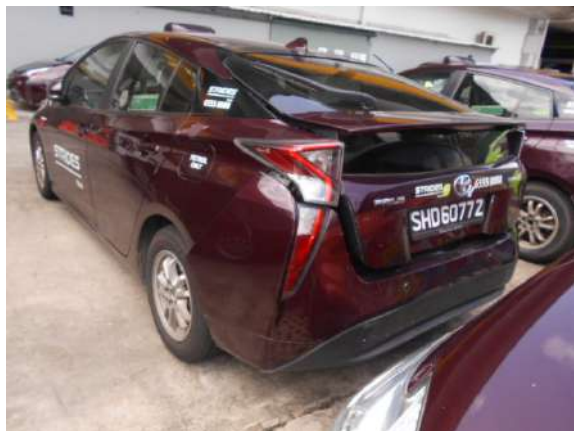
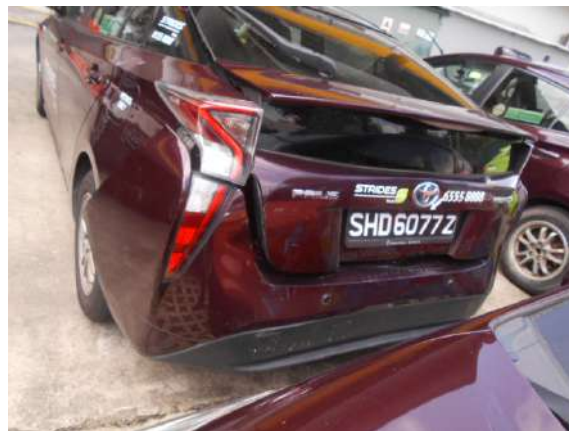
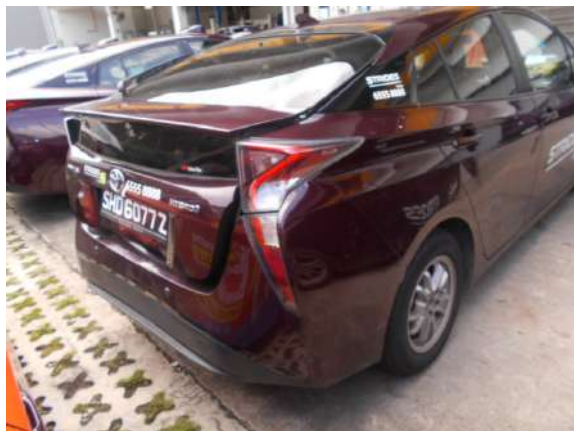
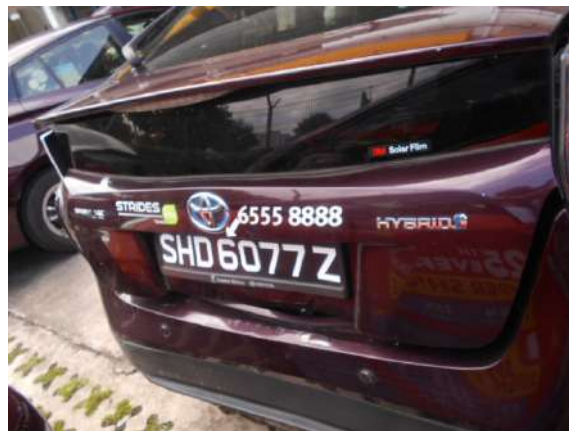
| Affiliated to Federation Internationale Des Experts En Automobile | | | | |
|---|---|---|---|--|
| THE VEHICLE SUSTAINED DAMAGES AT THE FRONT AND REAR PORTION.<br>DAMAGES SEE DETAILS. | | | | |

INSPECTION
