## LKK Auto Consultants Pte Ltd

### PROFESSIONAL SERVICE FEE

Vehicle No. SMC 9657B  
Insured Veh. GZ 2054L  
Claim No. SNM22D201547/C02  
Policy No. DMCVSNA00004752201  
Accident Date 01/03/2022  
Inspection Date 02/03/2022

### ADJUSTMENT ON REPAIR COST FOR VEHICLE NO. SMC 9657B

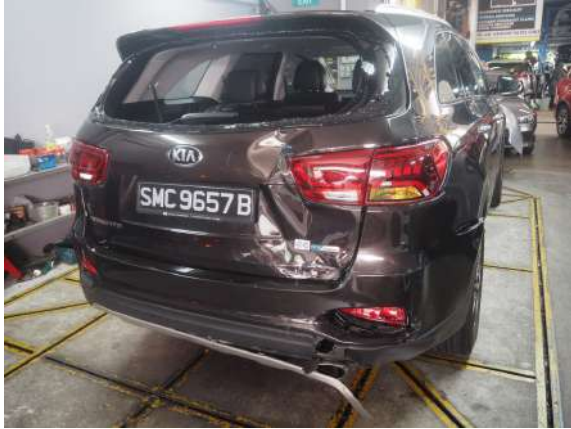
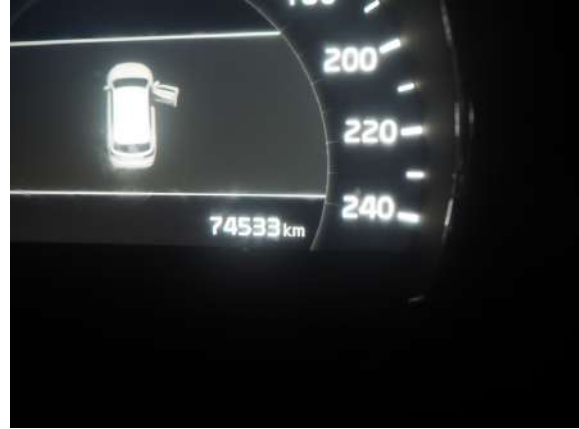
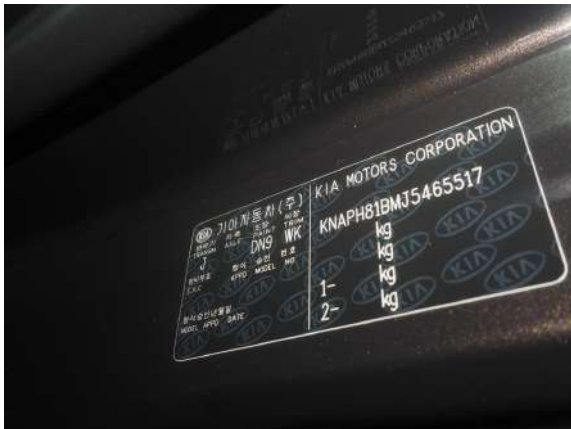
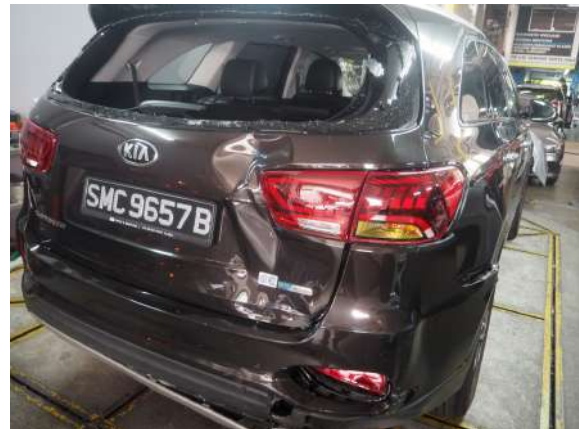
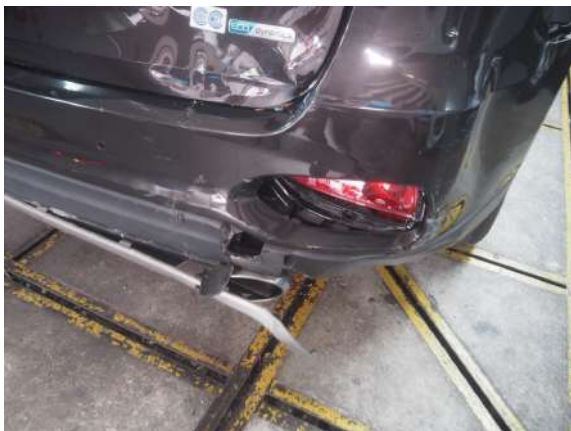
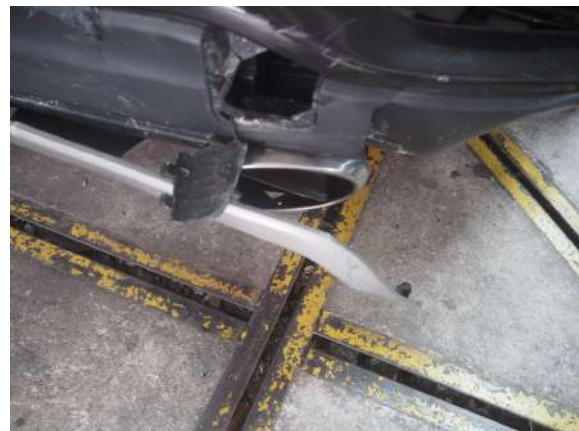
### PHOTOGRAPHS FOR VEHICLE NO. SMC 9657B

| Affiliated to Federation Internationale Des Experts En Automobile | | | | |
|---|---|---|---|--|
| THE VEHICLE SUSTAINED DAMAGES AT THE REAR PORTION.<br>DAMAGES SEE DETAILS. | | | | |

### INSPECTION
