Report Reference : TP / 19022-04/AY / 2019
Date of Report : 14 May 2019

THIRD PARTY SURVEY ACCIDENT HAPPENED ON 10 Apr 2019

Registration No	: SKU 2207 S	Engine No	: F22C1010226
Model	: Honda S2000	Mileage	: 126474
Year / Capacity	: 2008/2156	Colour	: White
Chassis No	: AP2-1100221

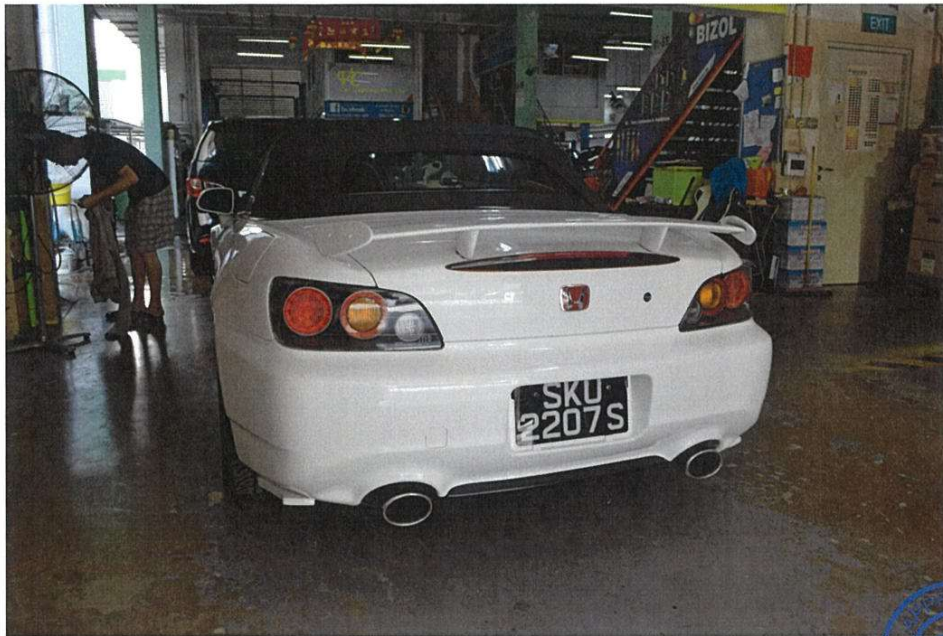
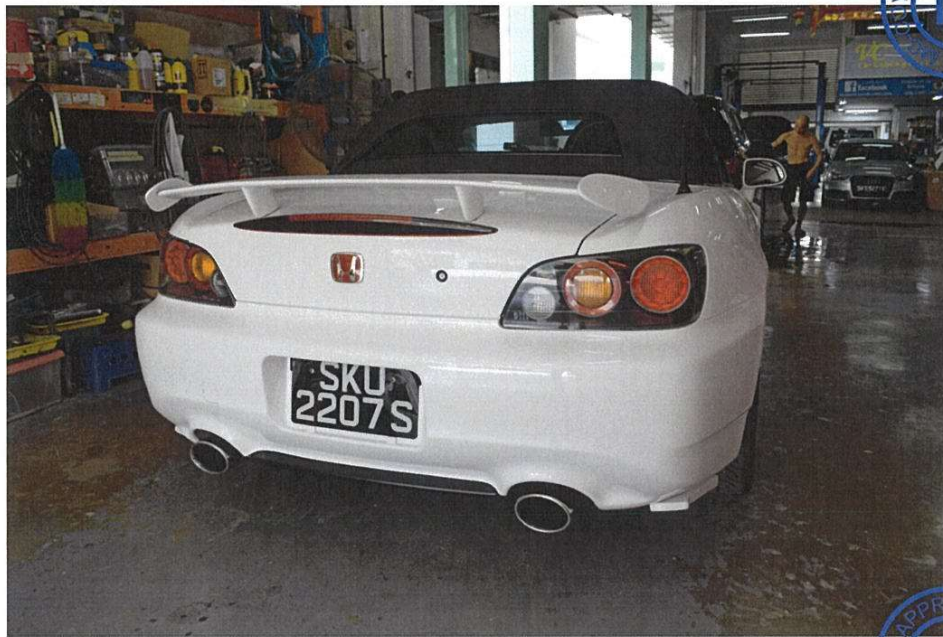
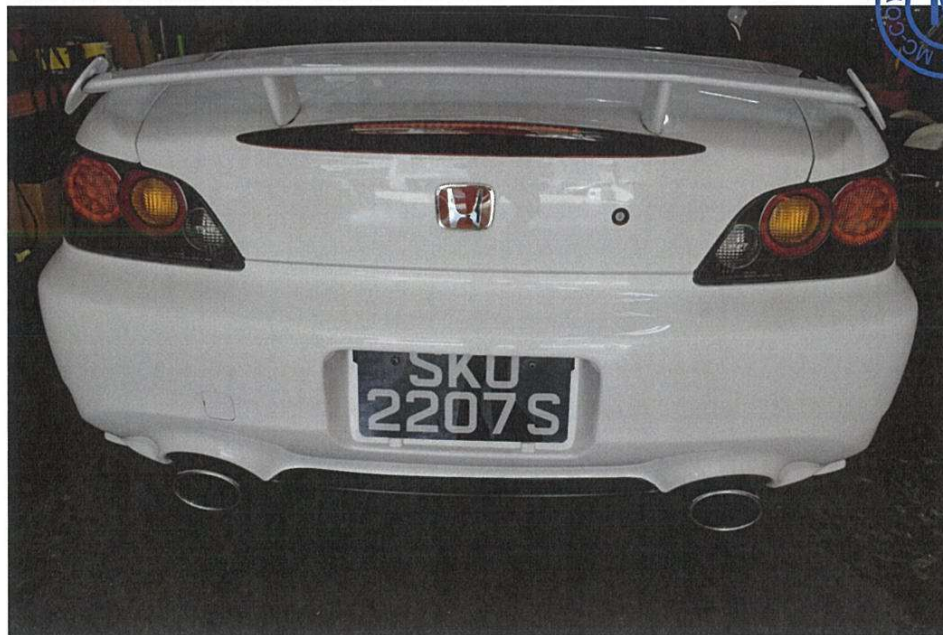
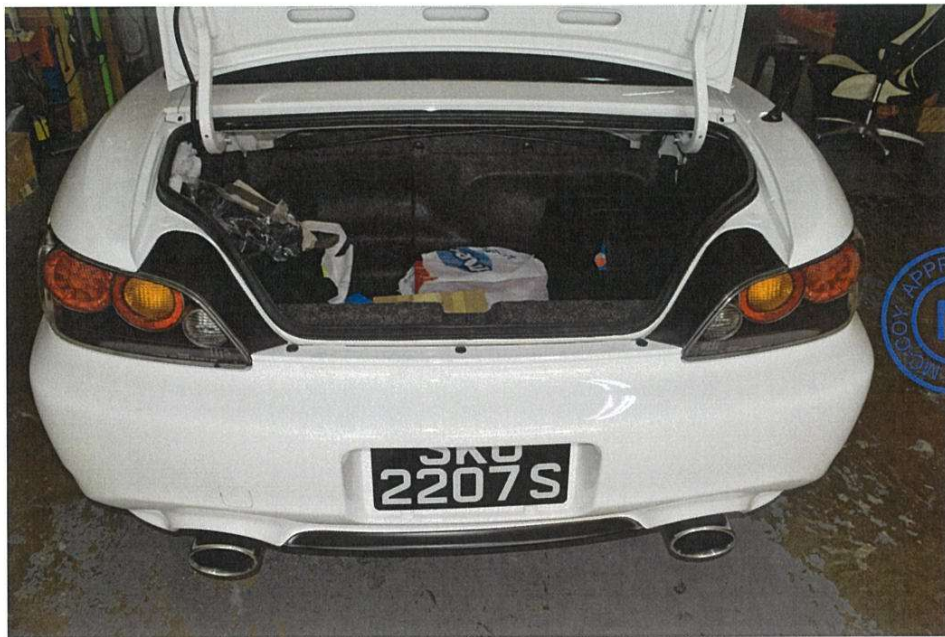
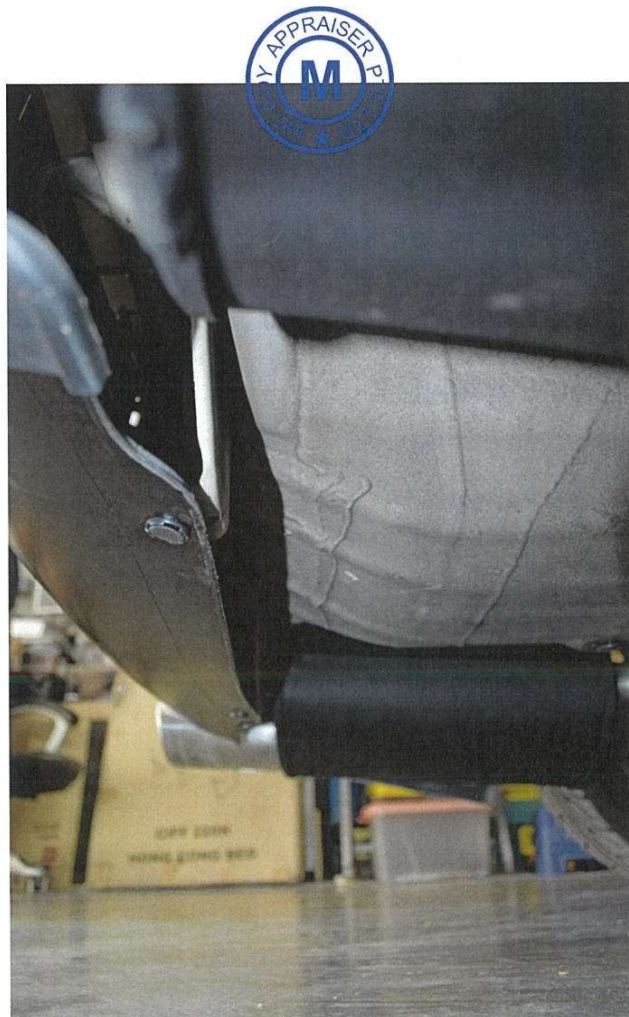
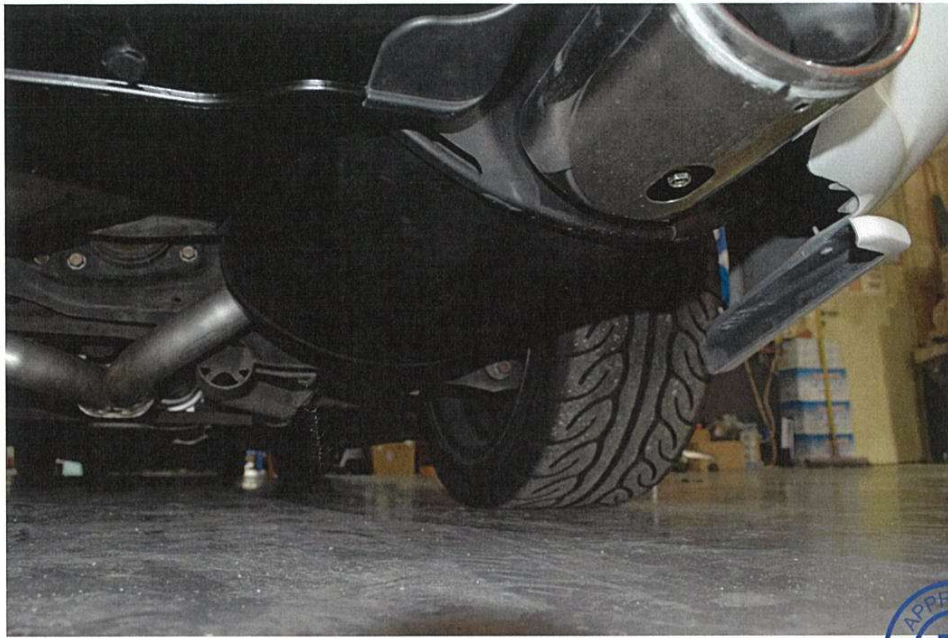
At the time of inspection, we noted that the vehicle has sustained an impact damages on the rear portion(s). For more detail of the damages, please see photograph attached.
