## LKK Auto Consultants Pte Ltd

### PROFESSIONAL SERVICE FEE

## ADJUSTMENT ON REPAIR COST FOR VEHICLE NO. SMJ 4906D

### PHOTOGRAPHS FOR VEHICLE NO. SMJ 4906D

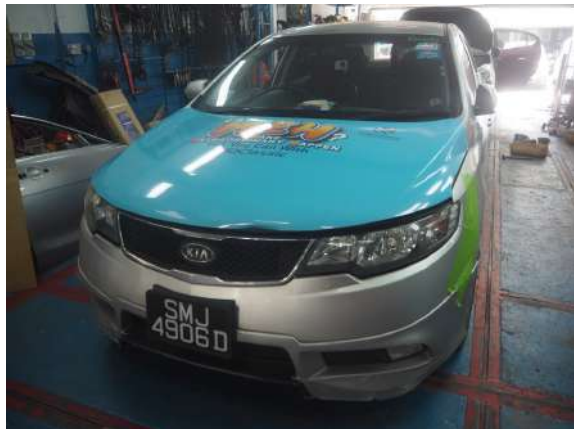
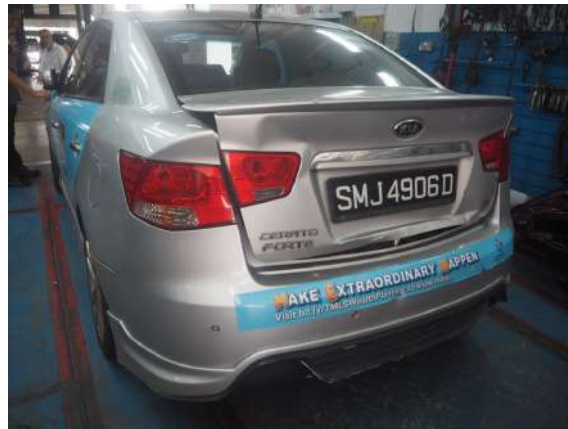
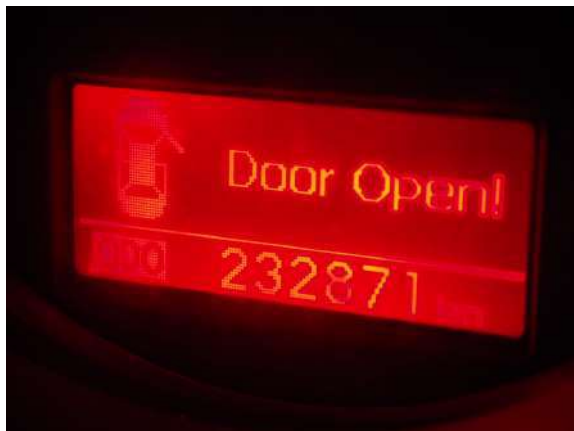
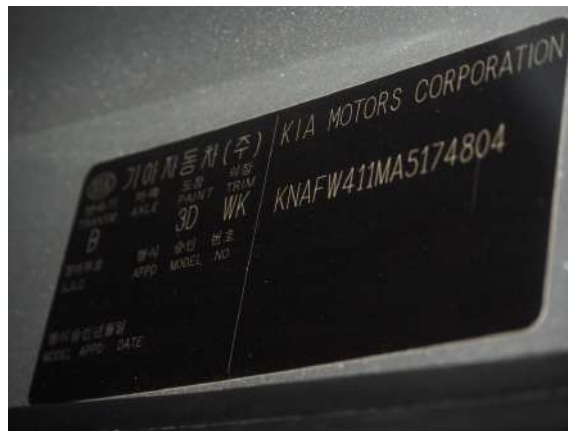
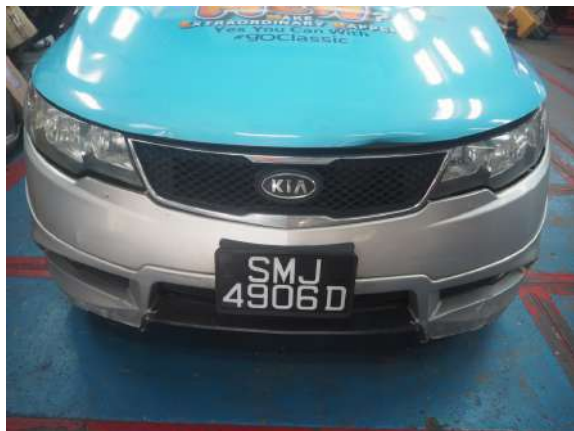
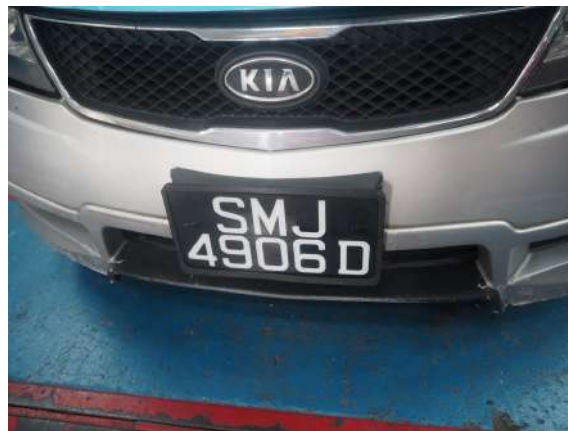
### INSPECTION

| Affiliated to Federation Internationale Des Experts En Automobile | | | | |
|---|---|---|---|--|
| THE VEHICLE SUSTAINED DAMAGES AT THE FRONT AND REAR PORTION.<br>DAMAGES SEE DETAILS. | | | | |
