LKK Auto Consultants Pte Ltd

ADJUSTMENT ON REPAIR COST FOR VEHICLE NO. SGV 3288T

PHOTOGRAPHS FOR VEHICLE NO. SGV 3288T

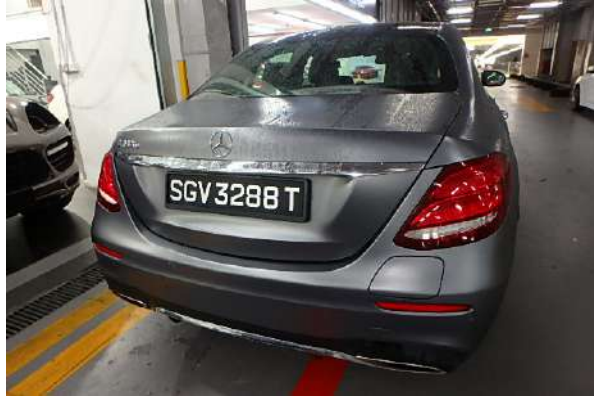
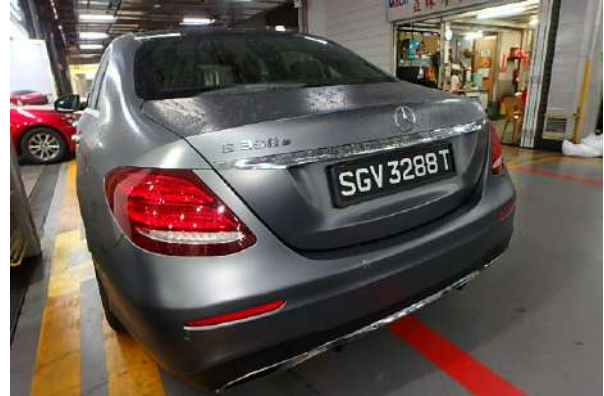
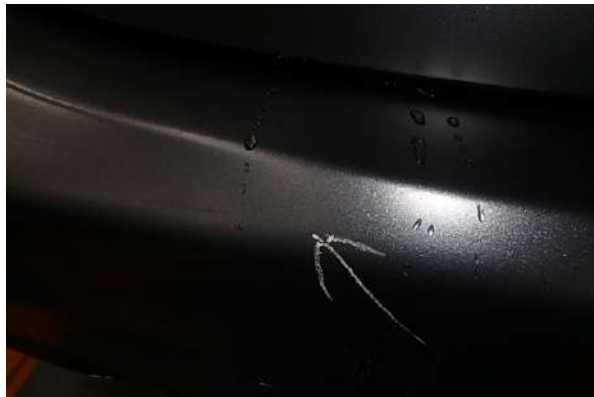
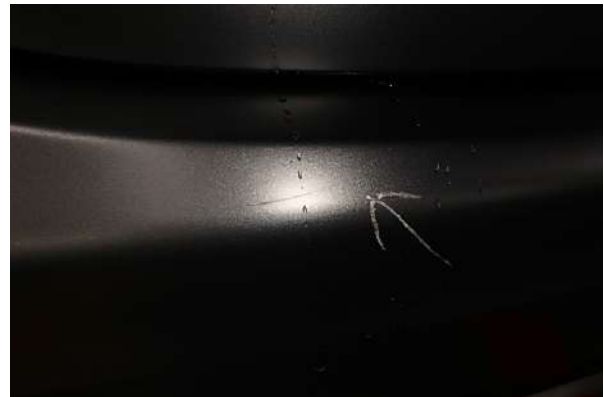
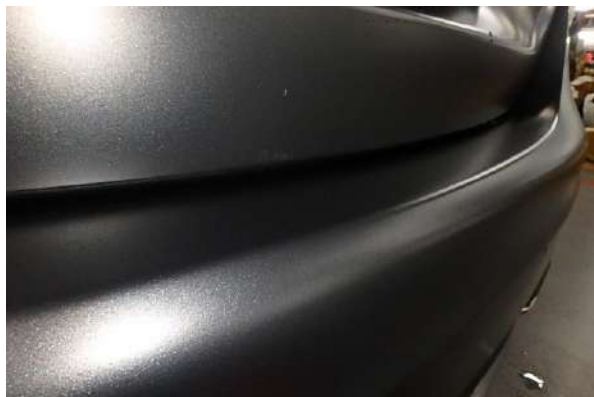
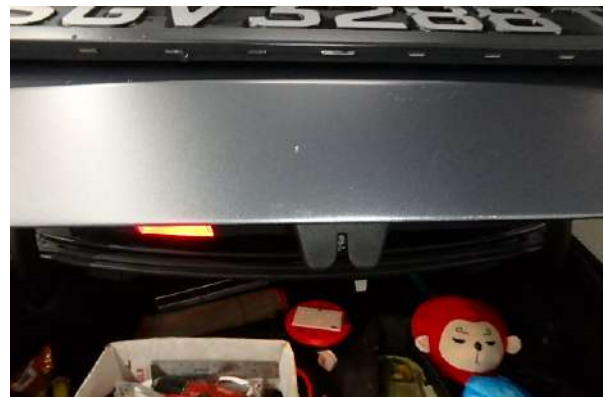
4. Description of Damages				
THE VEHICLE SUSTAINED DAMAGES AT THE REAR PORTION. DAMAGES SEE DETAILS.				
5. General Information				
Accident Date	11/03/2022	Inspection Date	15/03/2022	
Survey held at	OPTIMA WERKZ PTE LTD 9A SERANGOON NORTH AVE 5 SINGAPORE 554500			
5a. Remarks				
A)THE INSPECTION WAS CONDUCTED ON A"WITHOUT PREJUDICE" BASIS. B)IN ACCORDANCE TO YOUR INSTRUCTIONS, WE HAVE NOT AUTHORISED REPAIRS.				
5b. Estimate Days of Repair				
ESTIMATED NORMAL PERIOD FOR REPAIR:			1 Working Days

INSPECTION

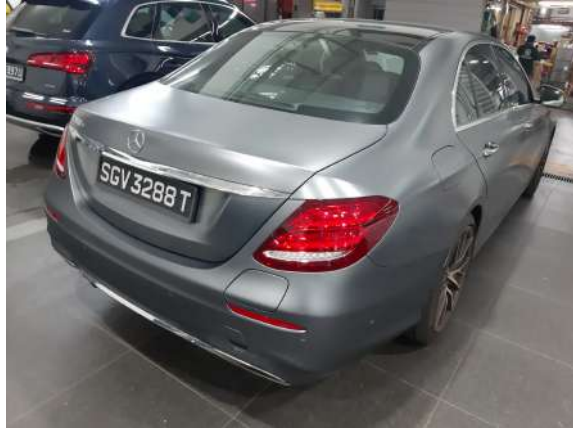
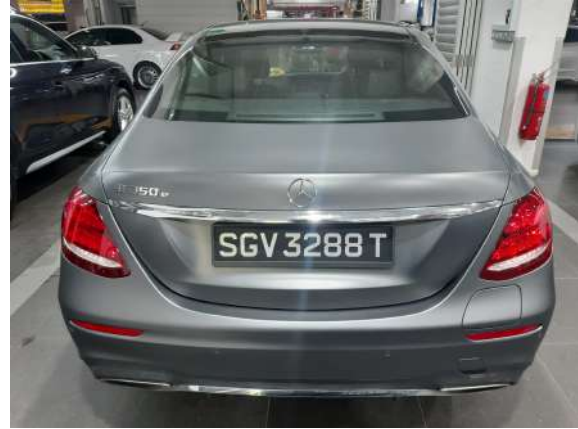
PHOTOGRAPHS FOR VEHICLE NO. SGV 3288T

RE-INSPECTION
