## LKK Auto Consultants Pte Ltd

| Affiliated to Federation Internationale Des Experts En Automobile | | | | |
|---|---|---|---|--|
| <b>1. Policy Particulars :- THIRD PARTY CLAIM</b> | | | | |

## ADJUSTMENT ON REPAIR COST FOR VEHICLE NO. GBJ 3418H

### PHOTOGRAPHS FOR VEHICLE NO. GBJ 3418H

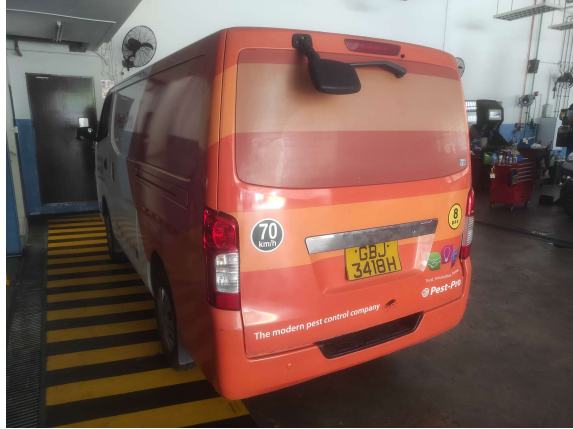
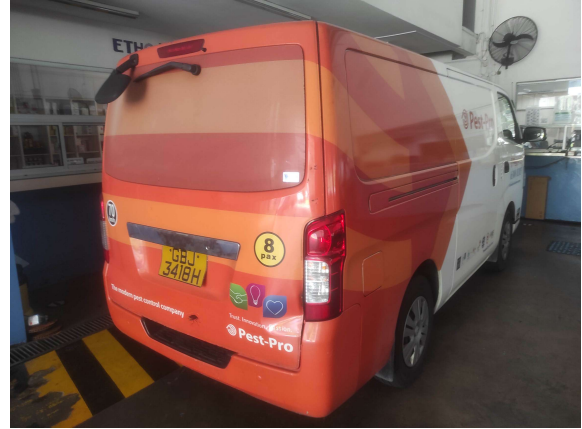
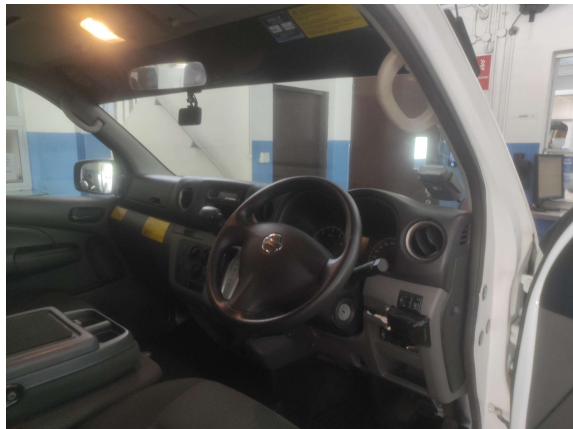
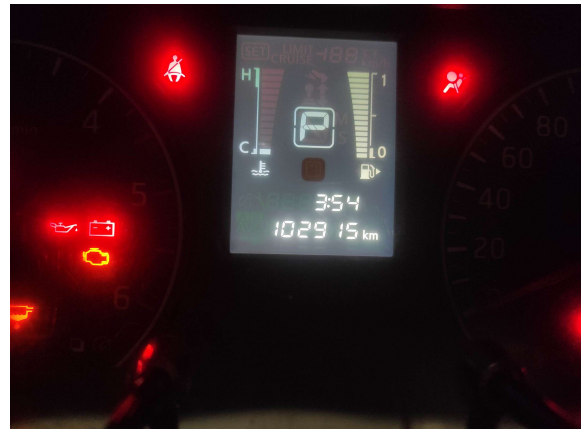
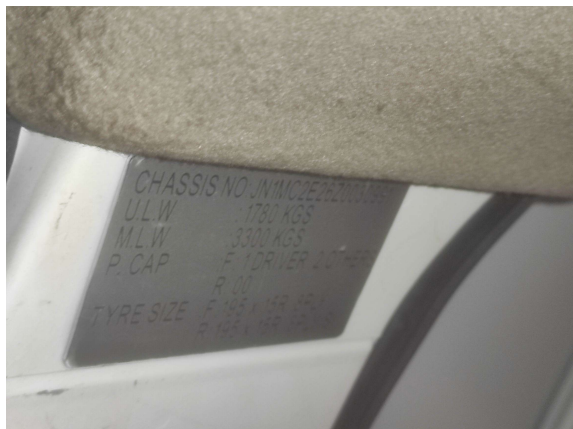
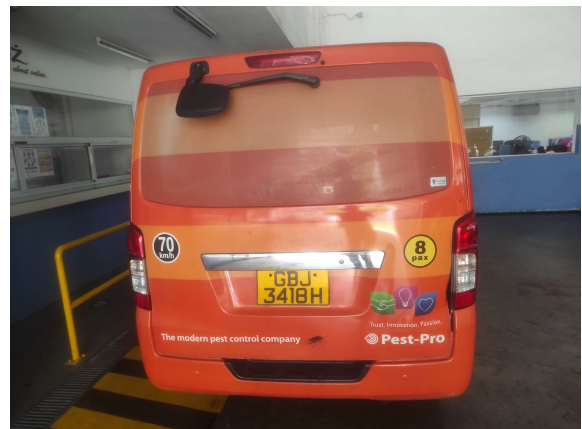
### INSPECTION

| Affiliated to Federation Internationale Des Experts En Automobile | | | | |
|---|---|---|---|--|
| THE VEHICLE SUSTAINED DAMAGES AT THE REAR PORTION.<br>DAMAGES SEE DETAILS. | | | | |

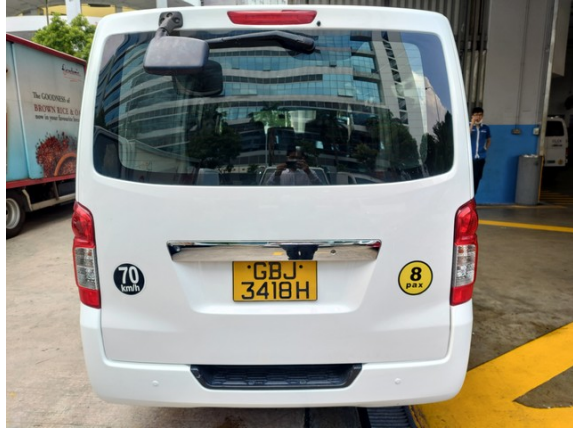
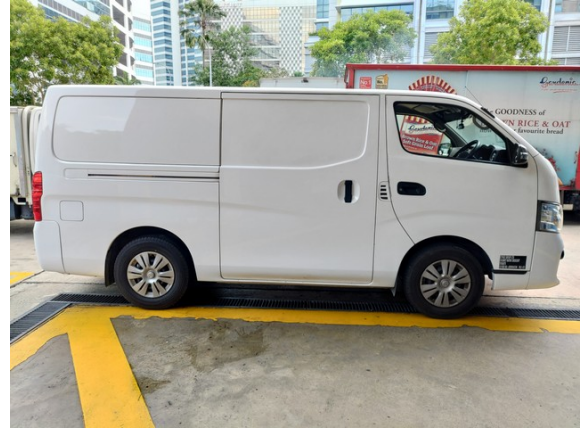
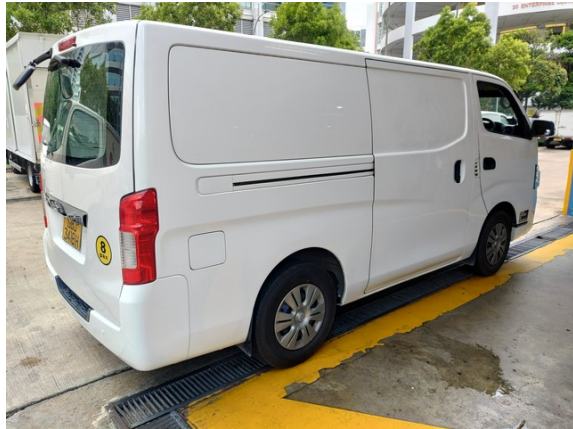
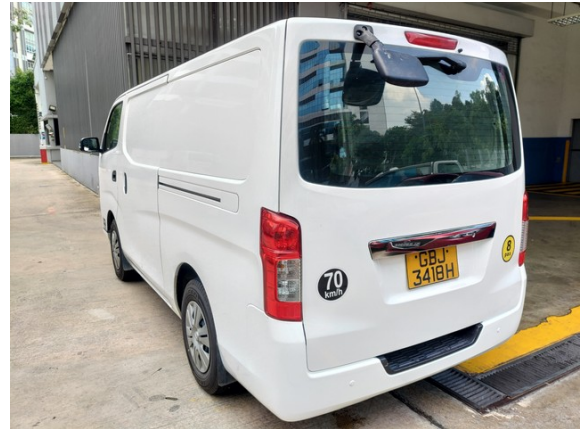
### RE-INSPECTION

### PHOTOGRAPHS FOR VEHICLE NO. GBJ 3418H
