## ADJUSTMENT ON REPAIR COST FOR VEHICLE NO. SMJ 2510A

### PHOTOGRAPHS FOR VEHICLE NO. SMJ 2510A

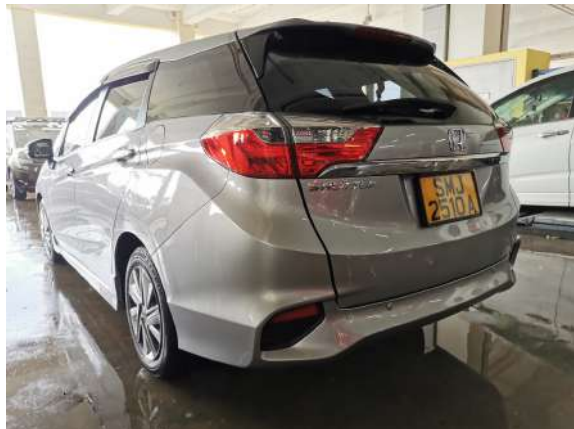
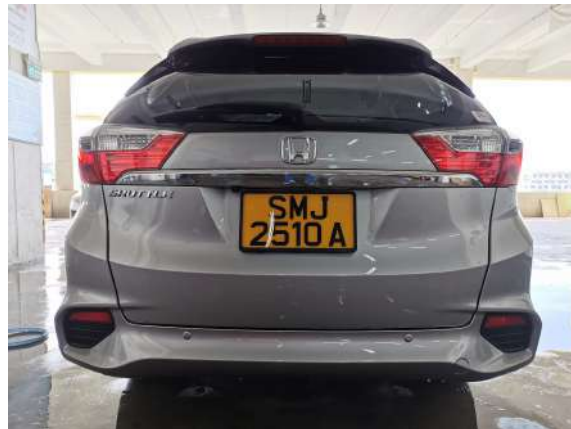
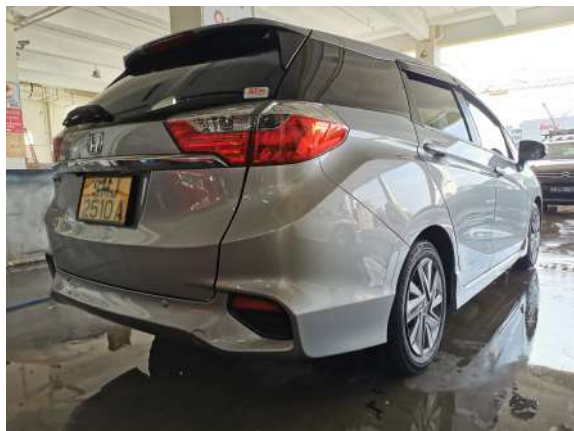
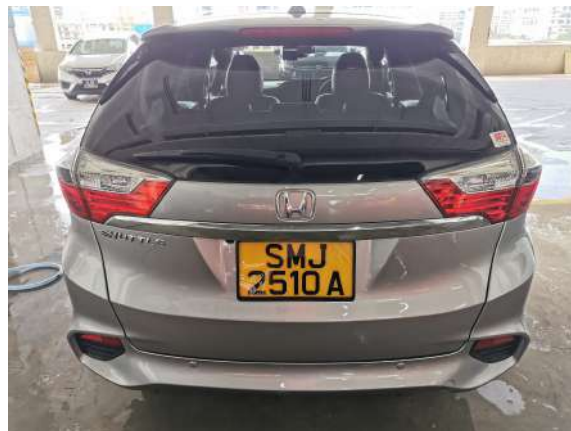
PHOTOGRAPHS FOR VEHICLE NO. SMJ 2510A

RE-INSPECTION

| Affiliated to Federation Internationale Des Experts En Automobile | | | | |
|---|---|---|---|--|
| THE VEHICLE SUSTAINED DAMAGES AT THE REAR PORTION.<br>DAMAGES SEE DETAILS. | | | | |
