LKK Auto Consultants Pte Ltd

1. Policy Particulars :- THIRD PARTY CLAIM

ADJUSTMENT ON REPAIR COST FOR VEHICLE NO. JPM 8077

PHOTOGRAPHS FOR VEHICLE NO. JPM 8077

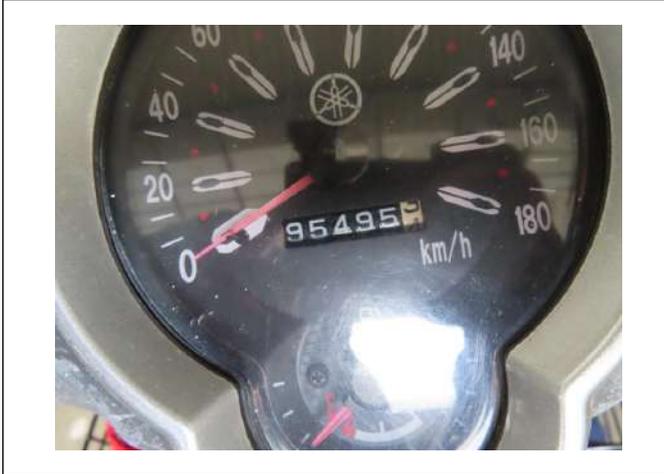
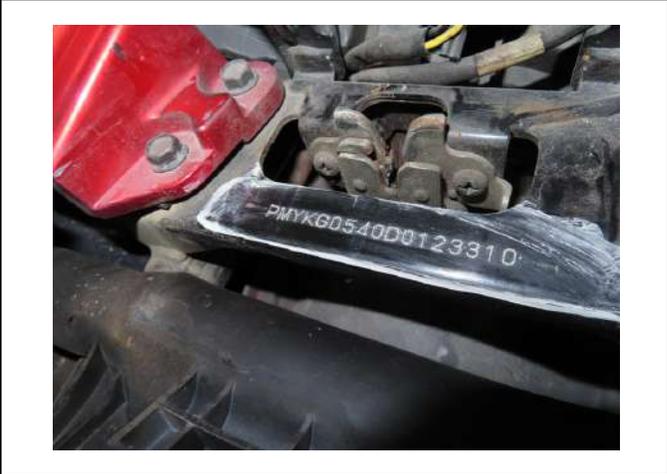
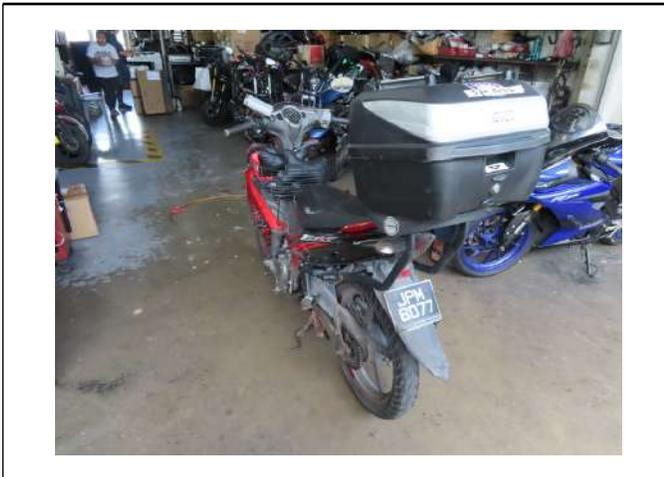
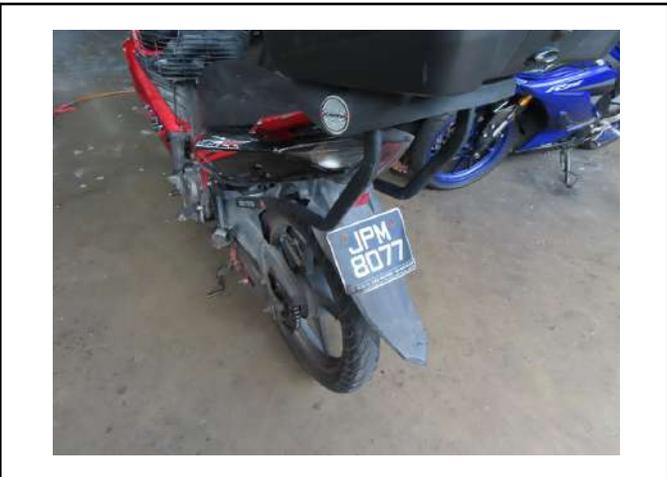
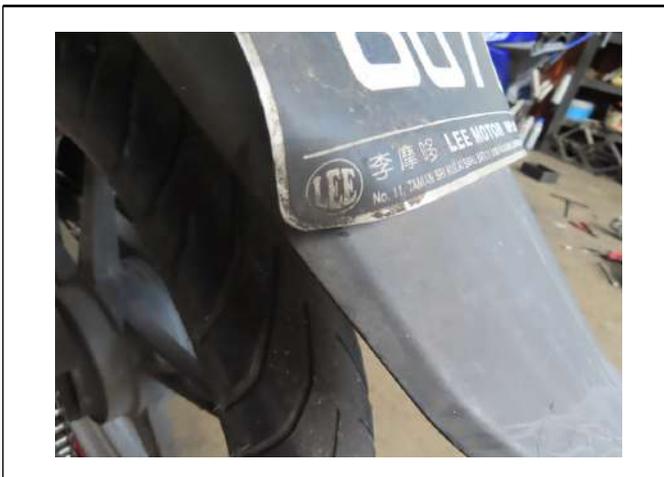
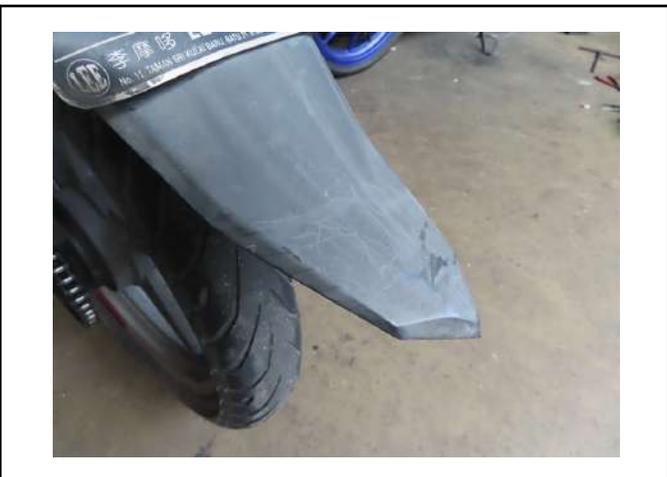
THE VEHICLE SUSTAINED DAMAGES AT THE N/S, O/S BODY AND REAR PORTION.
DAMAGES SEE DETAILS.

INSPECTION

Qty	Description of Parts	Condition	Estimate By Workshop (\$)	Our Adjusted (\$)
	REPLACEMENT OF PARTS			
2	FRONT FORK TUBE ASSY	NOT NECESSARY	640.00	-
1	FORK UNDER BRACKET	NOT NECESSARY	185.00	-
1	HANDLE BAR	BENT	88.00	88.00
1	SET HANDLE BAR ENDS	CUT	78.00	50.00
1	SET HAND GRIP	NOT NECESSARY	75.00	-
1	SET SIDE MIRRORS	BROKEN	110.00	80.00
1	SIDE MIRROR BRACKETS	NOT NECESSARY	80.00	-
1	BRAKE LEVER (CUT)	NOT CONSISTENT WITH THE IMPACT	32.00	-
1	SET FAIRING ASSY	CUT / CRACKED	525.00	450.00
1	FRONT FOOTREST BRACKET	BENT	65.00	65.00
2	FRONT FOOTREST RUBBERS	N/S TORN	70.00	35.00
1	GEAR PEDAL	BENT	58.00	58.00
1	SIDE STAND	NOT NECESSARY	85.00	-
2	REAR FOOTRESTS	N/S CUT	80.00	40.00
2	REAR FOOTREST BRACKETS	BENT / CRACKED	156.00	156.00
1	SET REAR SIGNAL	NOT NECESSARY	150.00	-
1	EXHAUST ASSY	TO REPAIR SEE LABOUR	585.00	-
1	EXHAUST PROTECTOR CAP	SERVICEABLE	75.00	-
1	EXHAUST PROTECTOR - BLACK	MISSING	55.00	55.00
1	REAR WHEEL RIM	BENT / WARPED	380.00	300.00

1	REAR RIM SHAFT	SERVICEABLE	60.00	-
1	REAR RIM BEARING	DAMAGED	52.00	52.00
1	CHAIN COVER	TO REPAIR SEE LABOUR	68.00	-
1	ENGINE COVER	NOT NECESSARY	225.00	-
1	REAR FENDER	DEFORMED	220.00	140.00
1	REAR SWING ARM	TO REPAIR SEE LABOUR	480.00	-
1	REAR HANDLE BAR	CUT	198.00	148.00

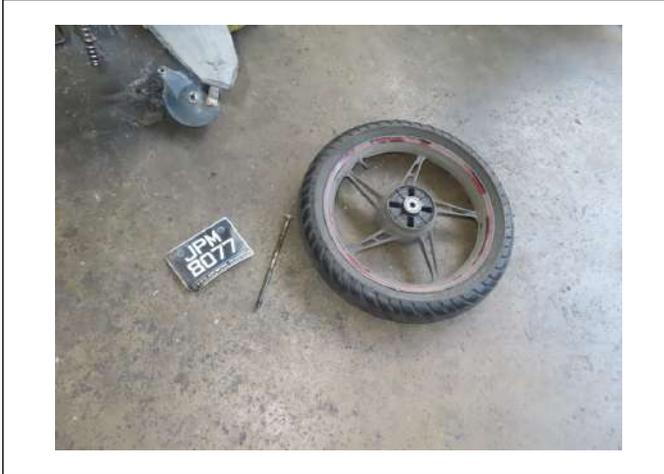
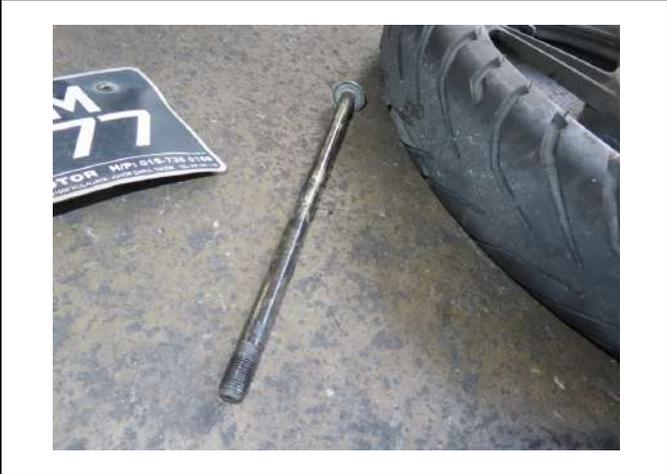
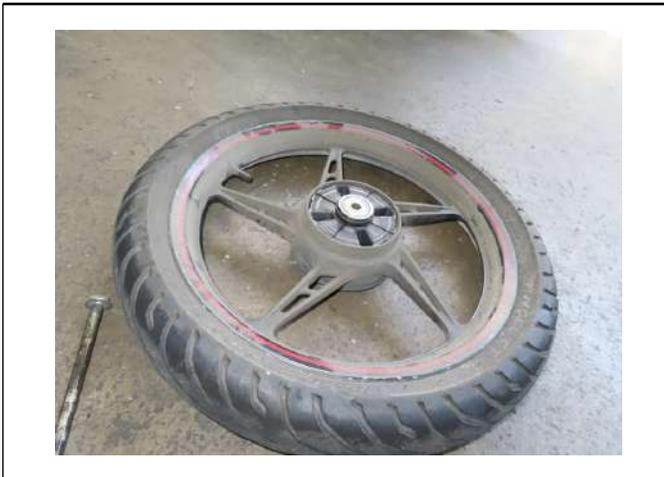
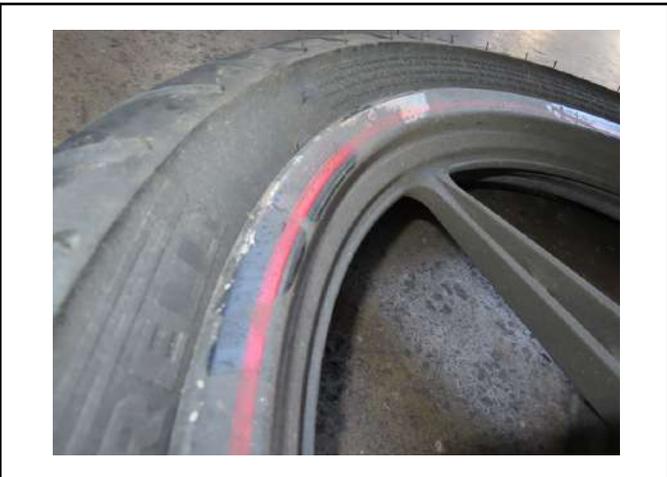
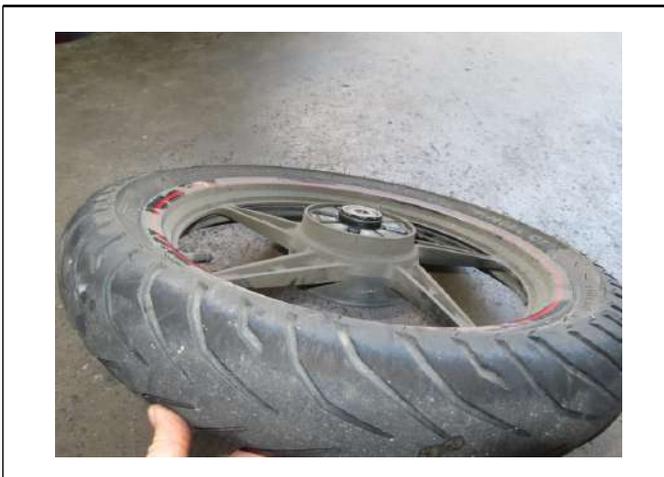
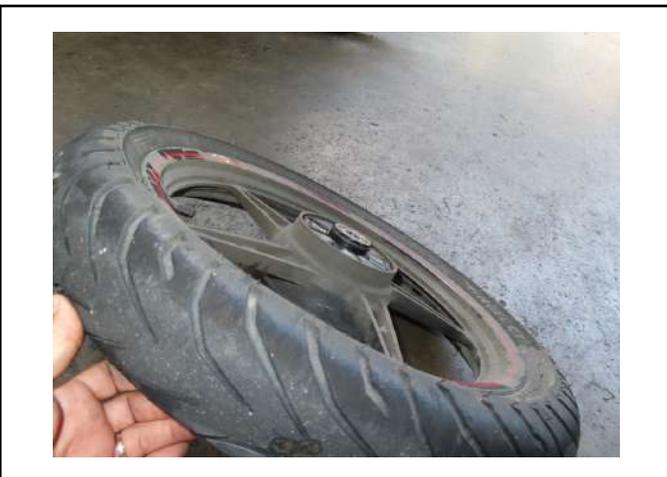
PHOTOGRAPHS FOR VEHICLE NO. JPM 8077

RE-INSPECTION
