## LKK Auto Consultants Pte Ltd

## ADJUSTMENT ON REPAIR COST FOR VEHICLE NO. GBA 4653K

### PHOTOGRAPHS FOR VEHICLE NO. GBA 4653K

### INSPECTION

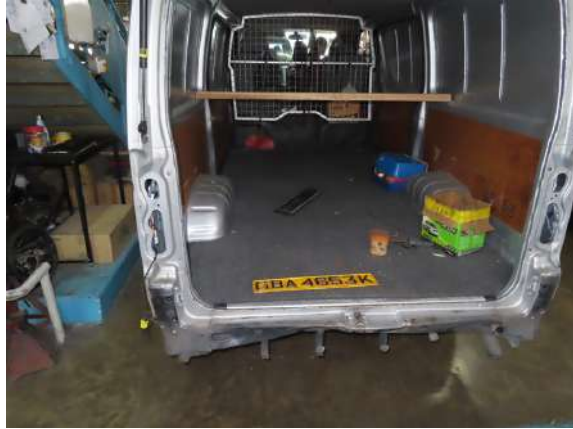
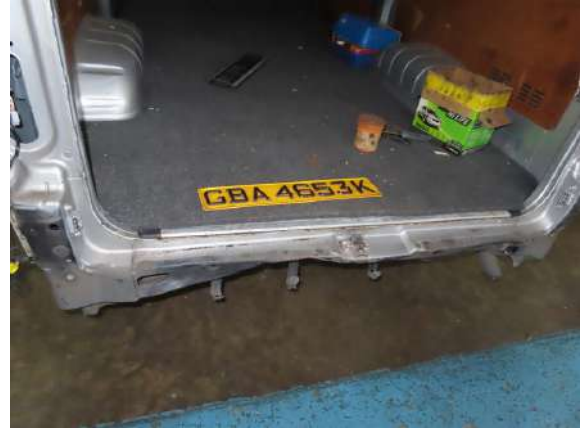
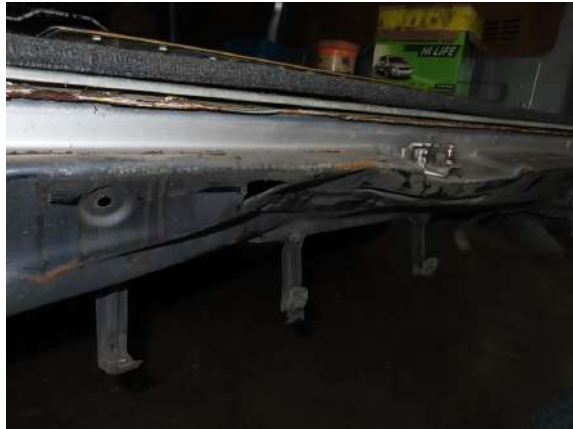
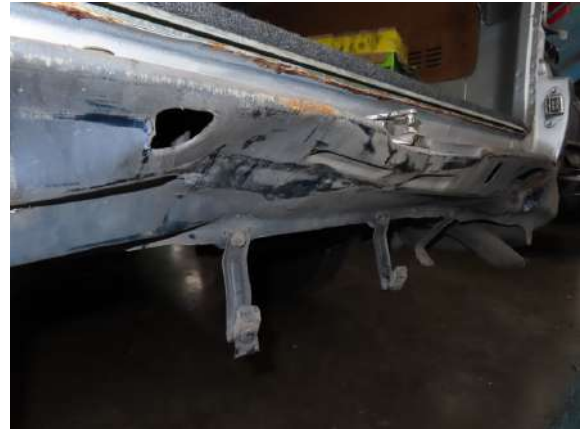
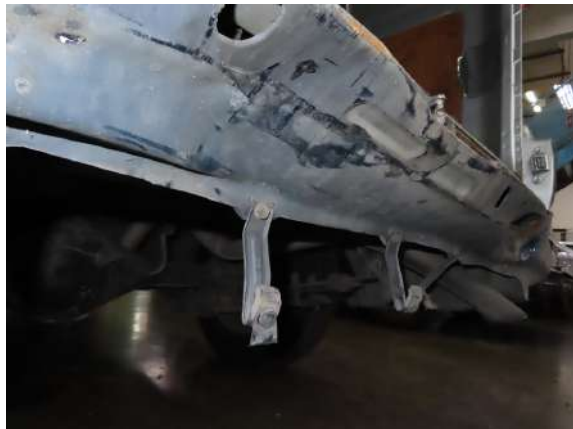
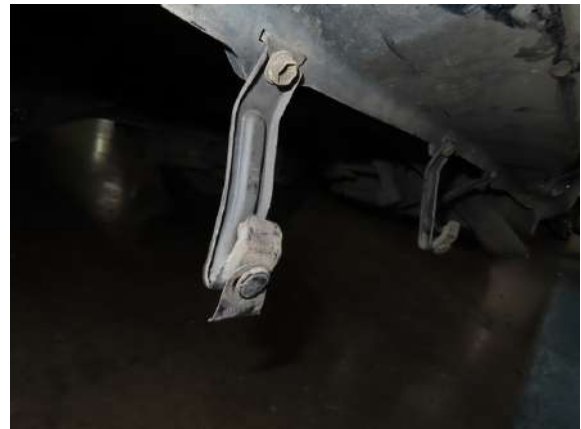
PHOTOGRAPHS FOR VEHICLE NO. GBA 4653K

RE-INSPECTION

| Affiliated to Federation Internationale Des Experts En Automobile | | | | |
|---|---|---|---|--|
| THE VEHICLE SUSTAINED DAMAGES AT THE REAR PORTION.<br>DAMAGES SEE DETAILS. | | | | |

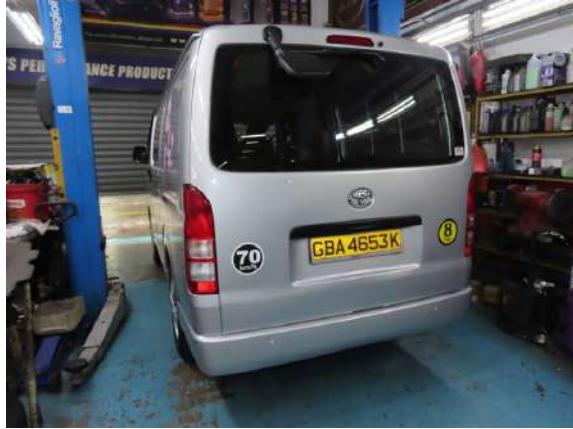
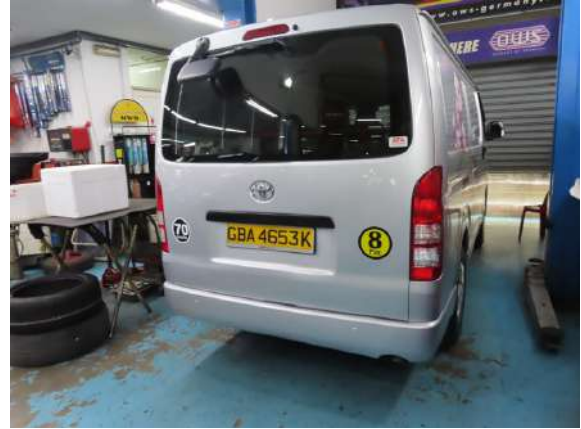
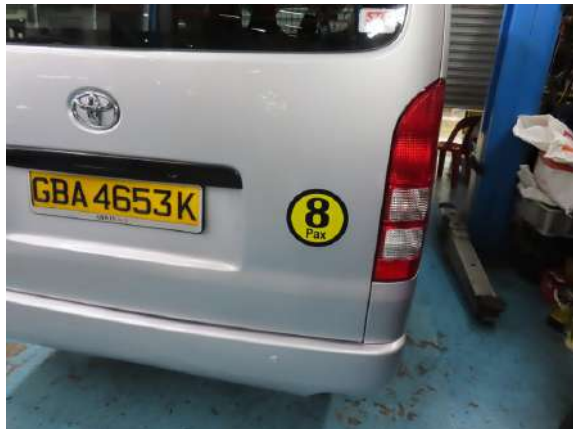
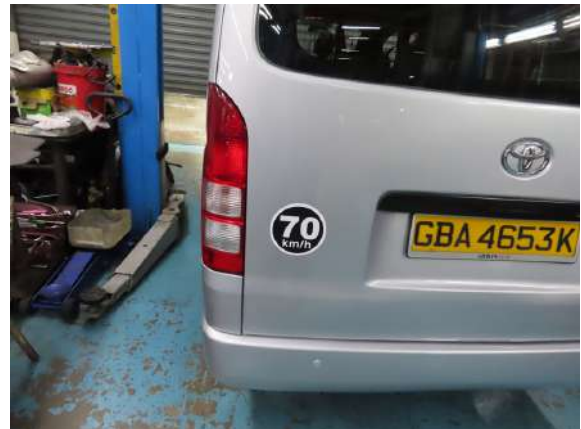
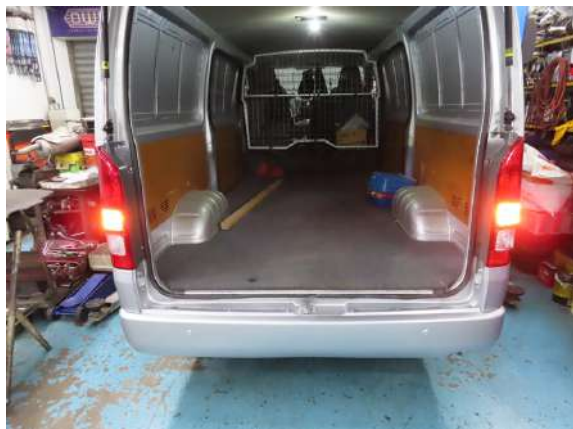
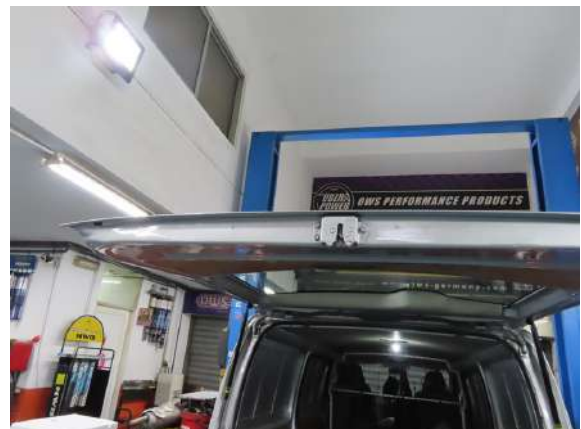
PHOTOGRAPHS FOR VEHICLE NO. GBA 4653K

RE-INSPECTION
