HOCK MOTORS WORKSHOP

INVOICE

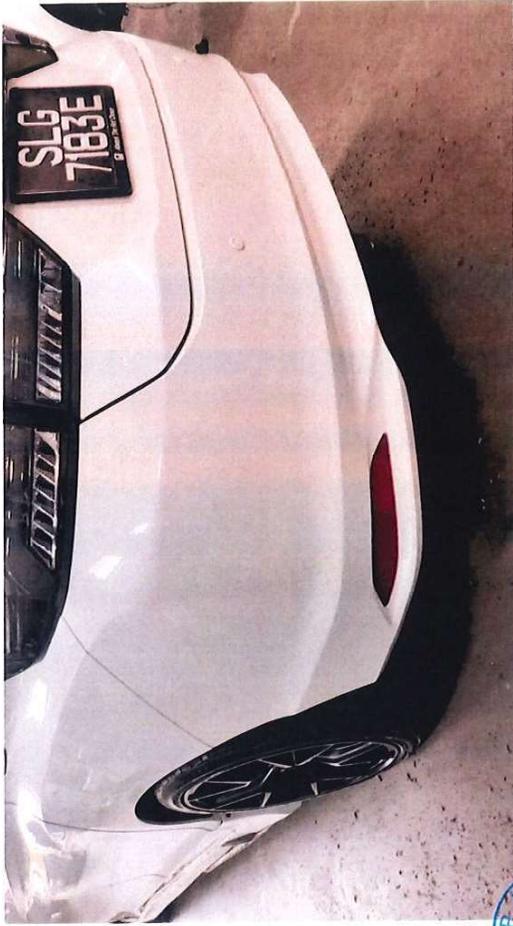
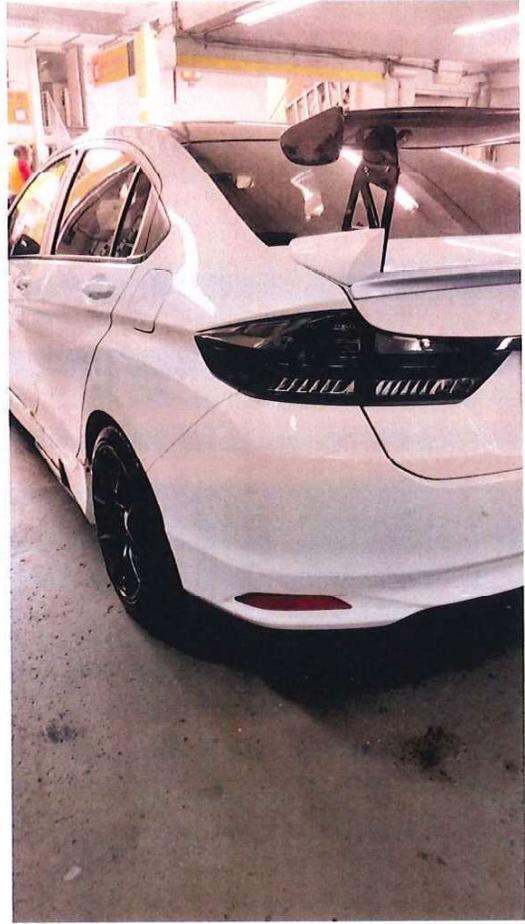
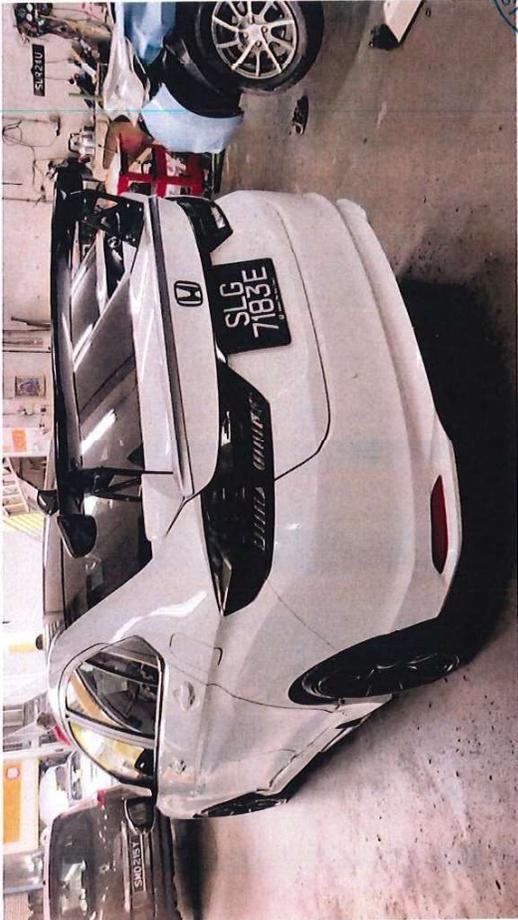
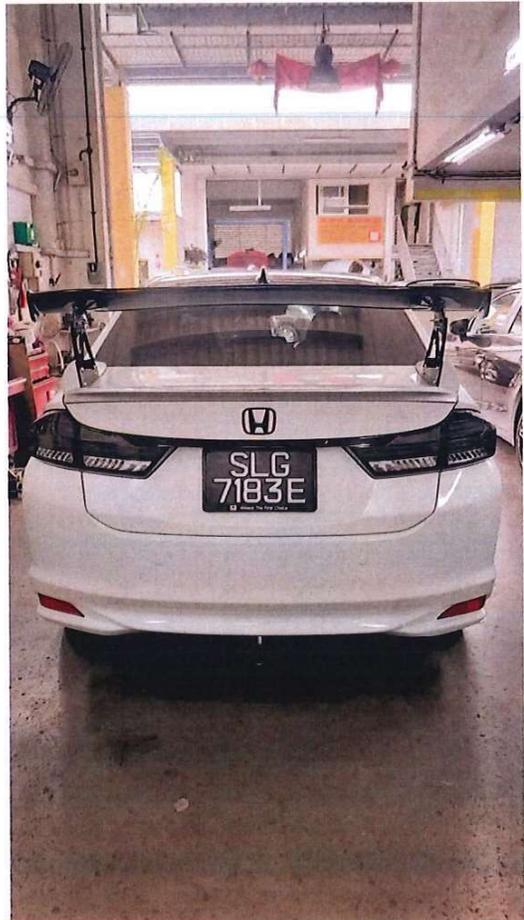
The impact damages sustained on the vehicle at the time of inspection is on the rear n/s portion.
(Details refer to the photographs attached)
