AUTOMAX SURVEY

Report Ref : TP19100012

THIRD PARTY SURVEY

ACCIDENT OCCURED ON 30 October 2019

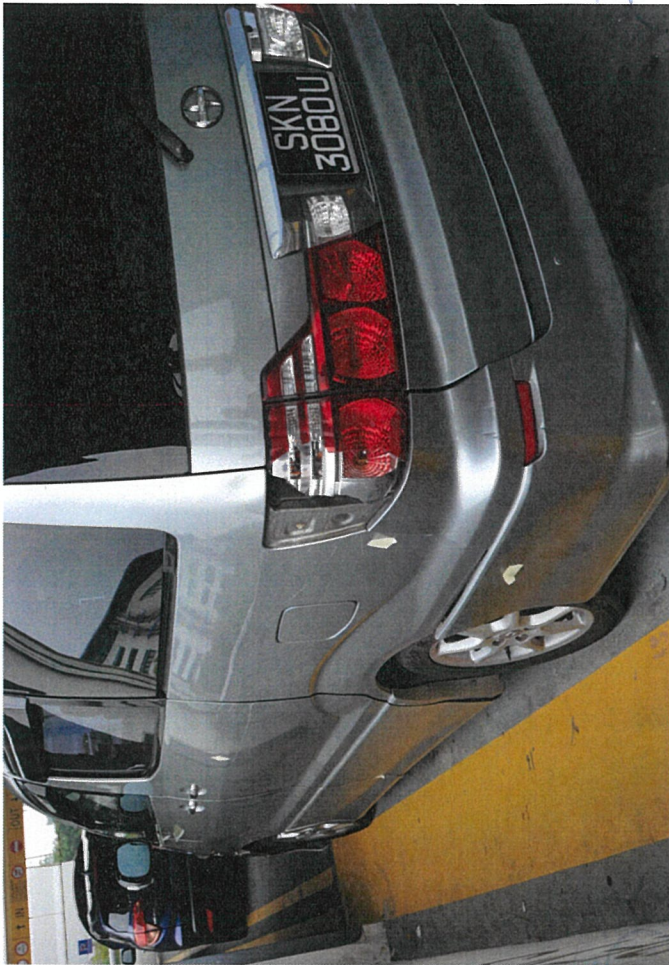
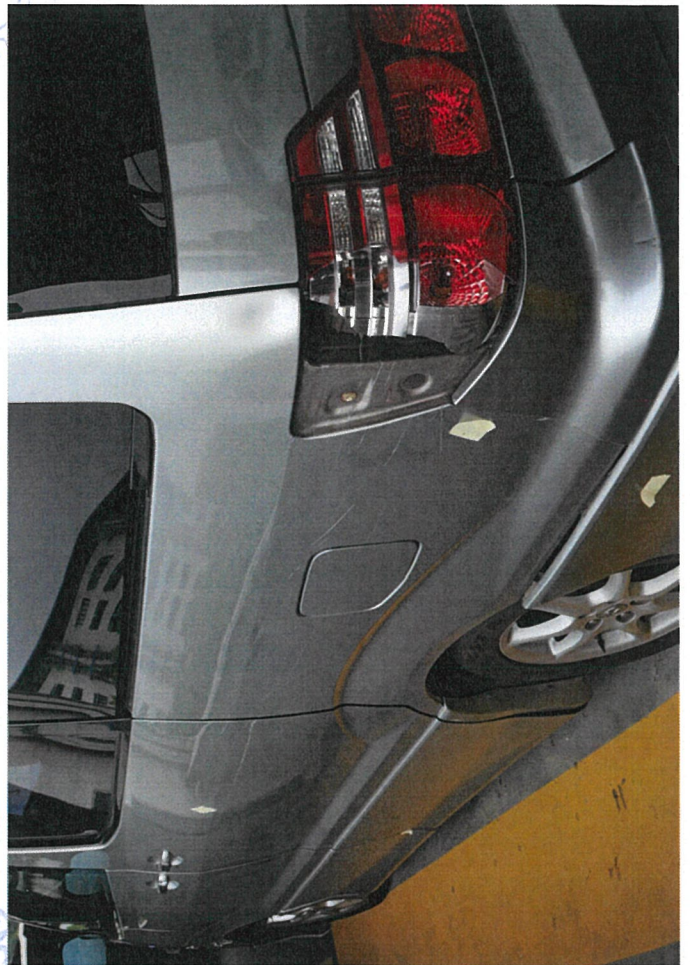
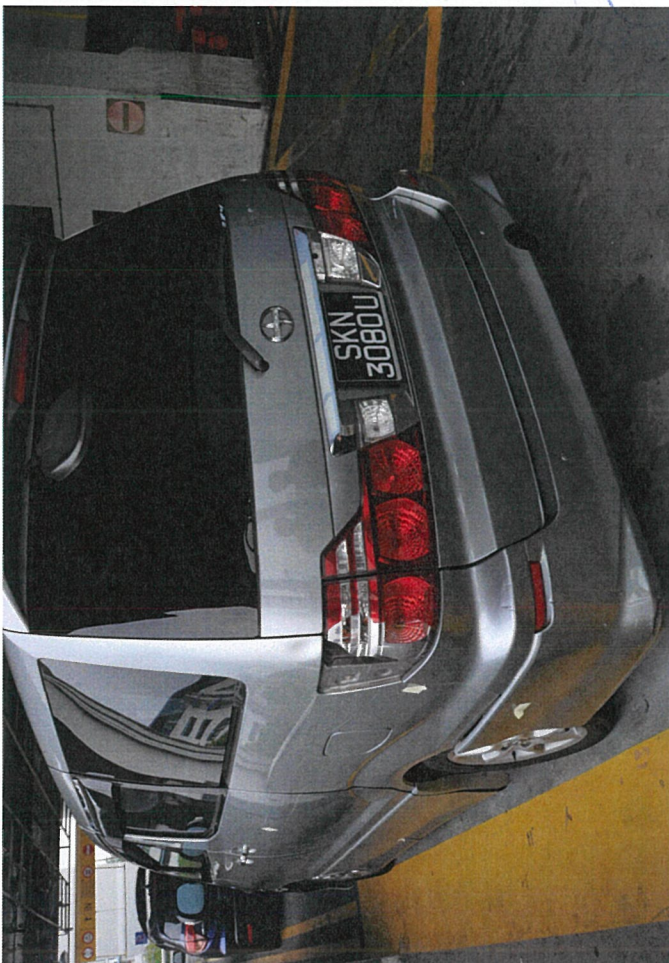
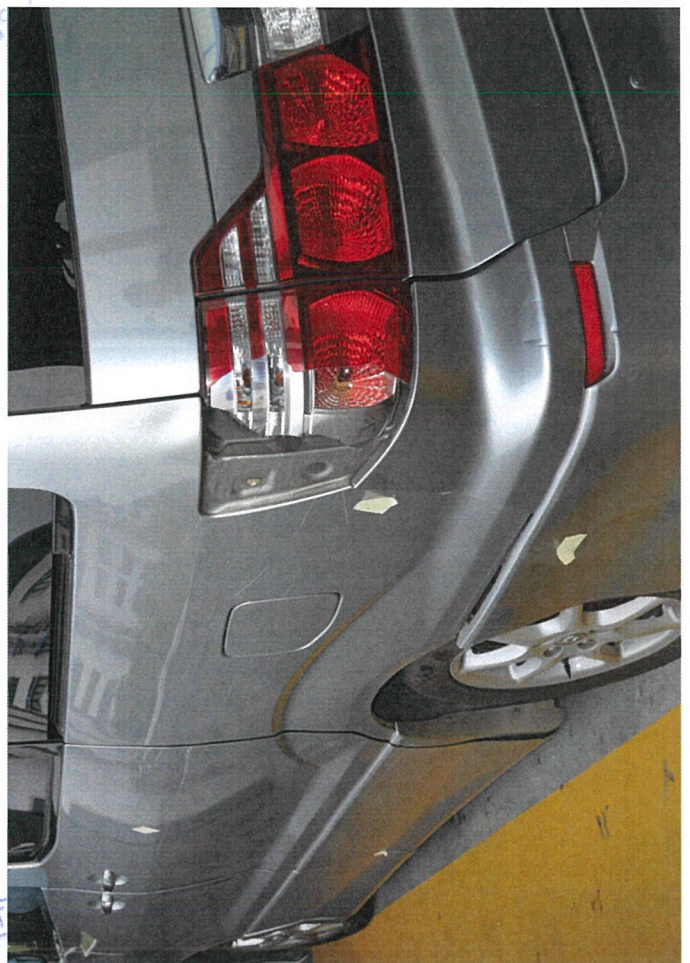
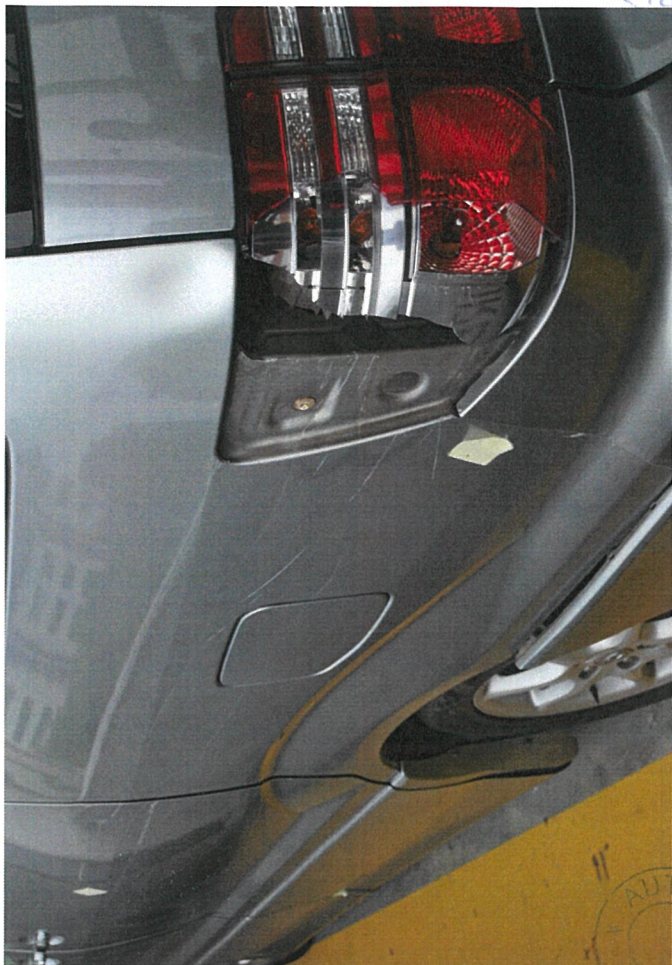
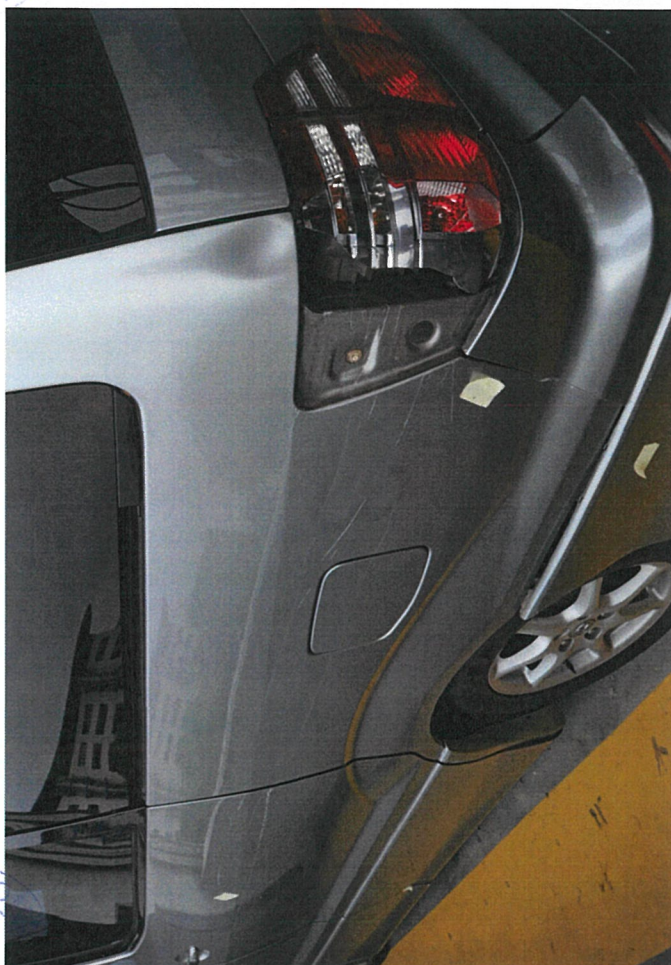
At the time of inspection, we noted that the vehicle has sustained an impact damages on the rear side portion(s). For more detail of the damages, please see photograph attached.
